# *Vista Prune Assessment, Feasibility and Recommendations Report*

**James and Holly Rader**

**5 Merrill Street**

**November 5, 2024**

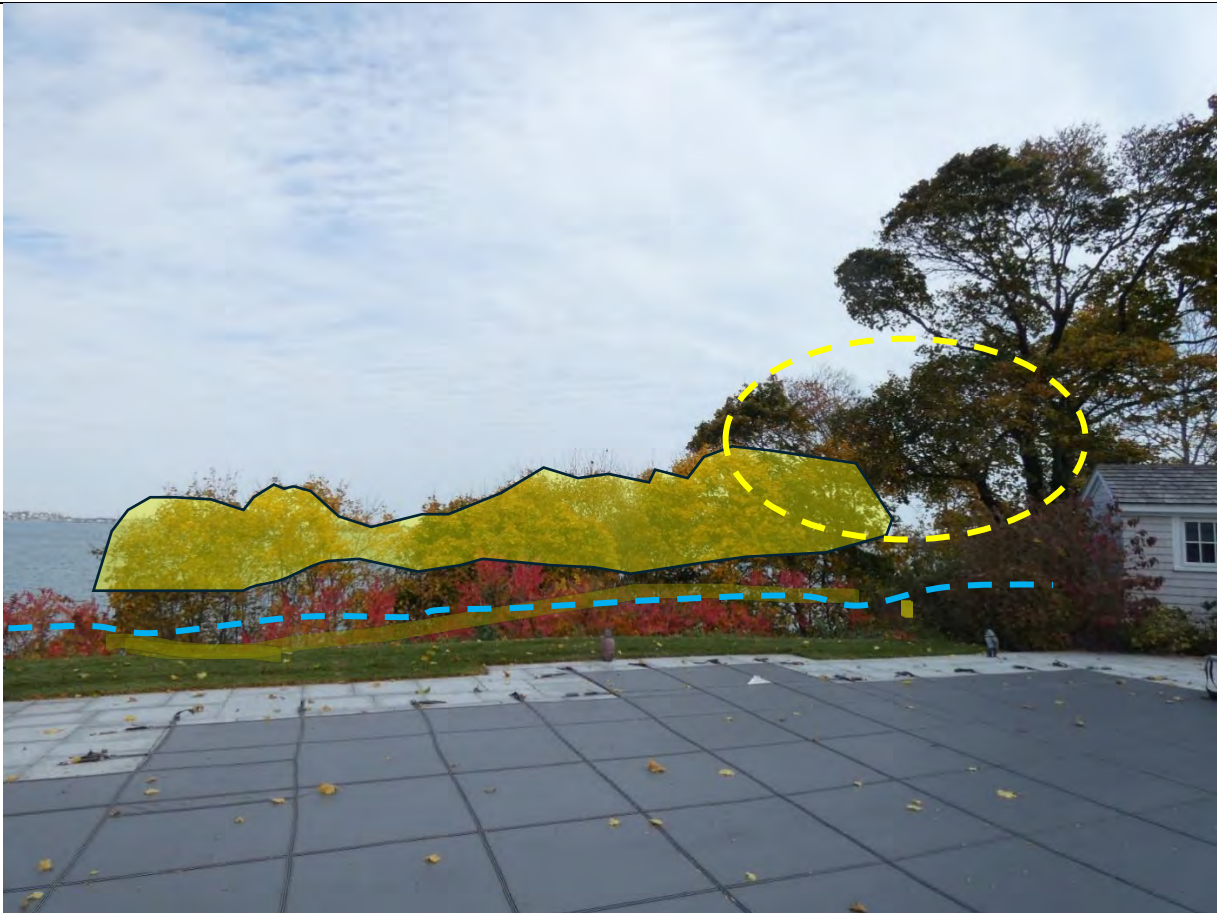
**North view from the pool area with the estimated recommended reduction pruning scope (shaded yellow for the trees and a blue line for the shrubs on top of the slope). The circled area can be thinned for a view through the trees.**

Because Norway maples are fast, aggressive growers, they can be pruned more aggressively than some other trees – especially our native oaks and maples. If pruning is to be done to expose the view, I would recommend reducing the crowns by up to 40 percent and done in such a way as to encourage more lateral growth as opposed to vertical growth. This is termed ‘Reduction Pruning’ and done by cutting back the upright branches to lateral branches large enough to sustain the remaining branch (usually about 1/3 the thickness of the cut branch). Pruning cuts should be limited to 4 inches in diameter or less, which shouldn’t be an issue since these are relatively small, young trees with few upper branches larger than that. The diagram below illustrates the reduction pruning method.<sup>2</sup>

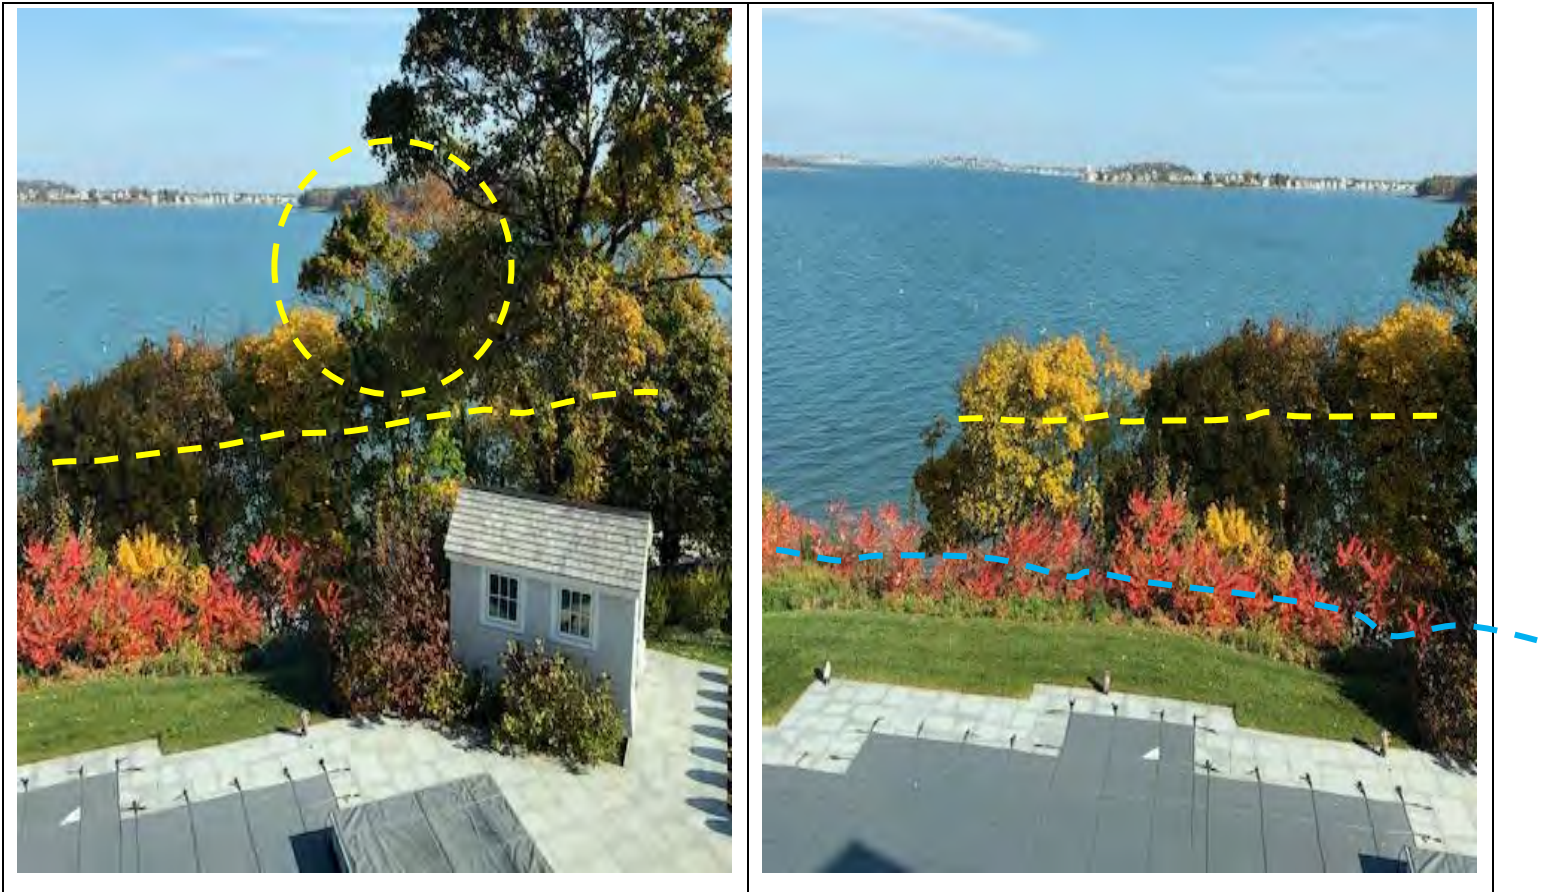
**North view towards Hingham Bay from the second story window with the estimated pruning heights highlighted. The circled area can be thinned to expand the view east.**

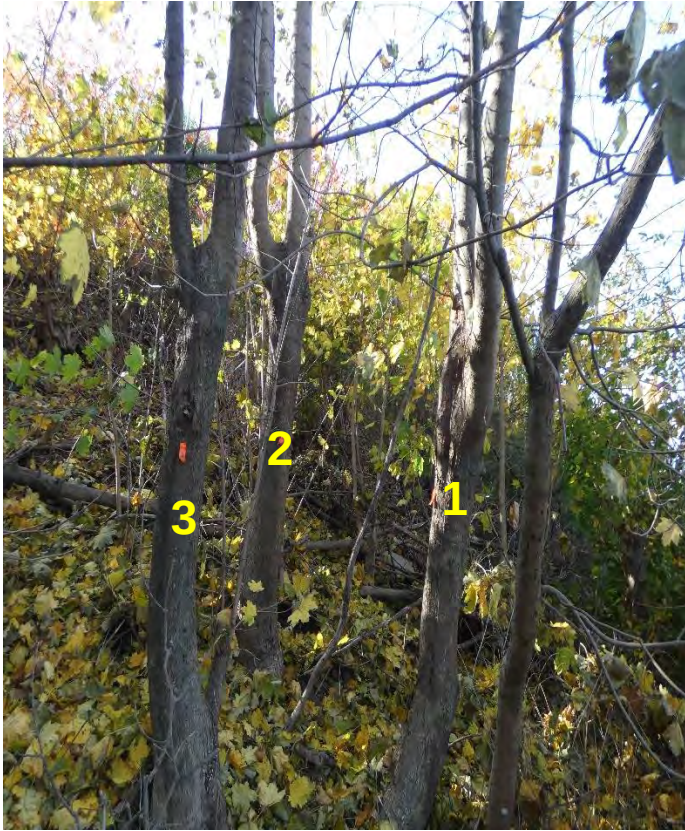
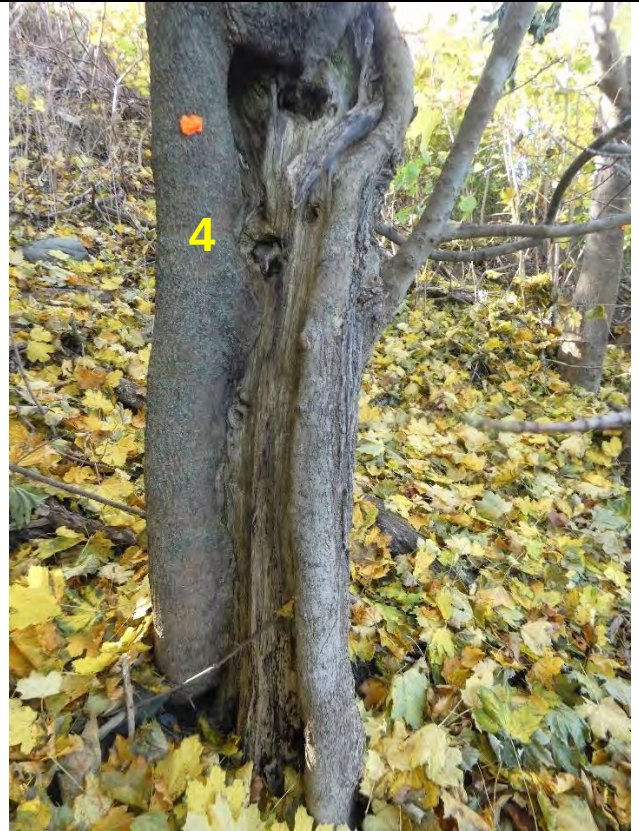
| No. | Species | DBH | Est. Ht. | Cond. | Invas. | Site Loc | Notes |
|---|---|---|---|---|---|---|---|
| 4 | Norway Maple | 16 | 45 | Fair | Yes | 10' SE of #3 | 3 leaders at 8 feet. Significant decay on lower trunk. Failure likely. Remove or prune |

**Significant decay. Recommend removal**

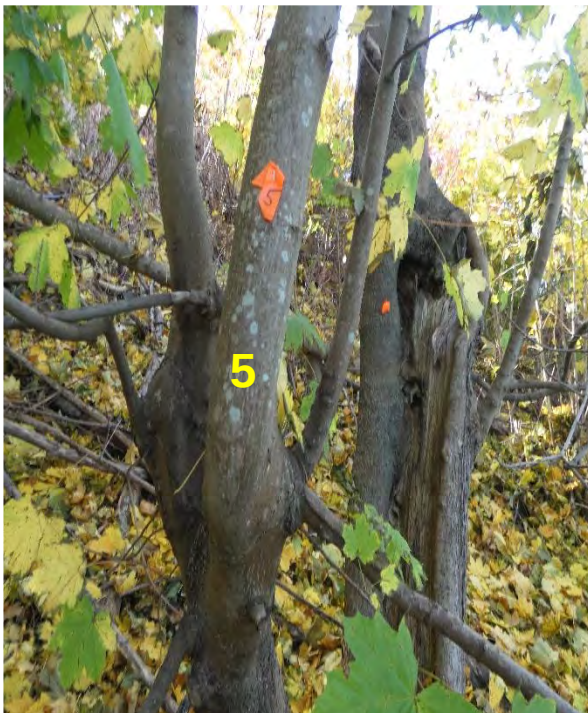
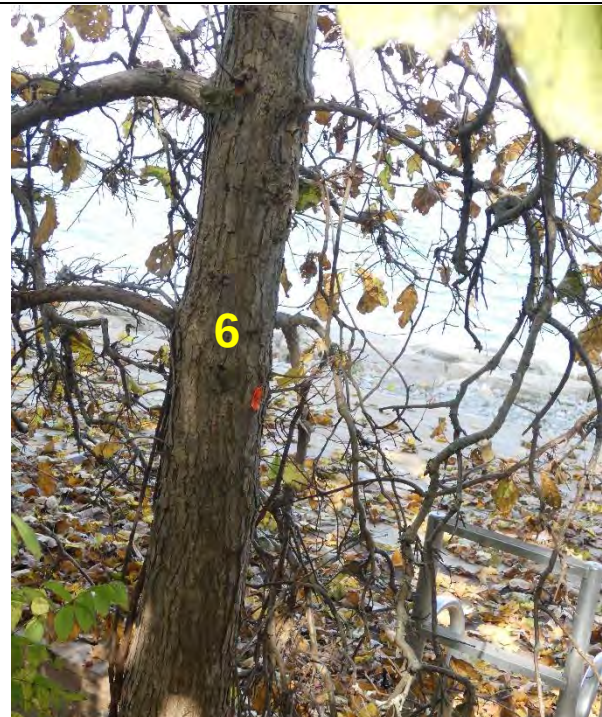
**Swamp white oak**

| No. | Species | DBH | Est. Ht. | Cond. | Invas. | Site Loc | Notes |
|---|---|---|---|---|---|---|---|
| 6 | Swamp White Oak ( <i>Quercus bicolor</i> ) | 9 | 40 | Good | No | Mid site. Bottom of slope next to dock. 8' E of #7 | Lean and weight over docks. Minor pruning needed. |

Twenty-two trees were tallied on the wooded bank that are obstructing the view to the north and Hingham Bay. Twenty are Norway maple trees, one is a swamp white oak, and one is a black cherry. Both the oak and cherry are located at the base of the slope and next to and over the dock area and existing barn. The oak needs minimal pruning to enhance the view. The cherry does not need pruning but should be removed as it is at risk of falling onto the barn due to an excessive lean.
