HINGHAM AFFORDABLE HOUSING TRUST FY 2027 CPA FUNDS REQUEST

In late June of 2023, BEA performed a Building Envelope Inspection at Lincoln School Apartments in Hingham, Massachusetts. The purpose of this Condition Survey was to assess the condition of the building envelope components and identify exterior deficiencies. The report summarizes our findings, conclusions, recommendations, and associated repair/restoration cost budget estimates.

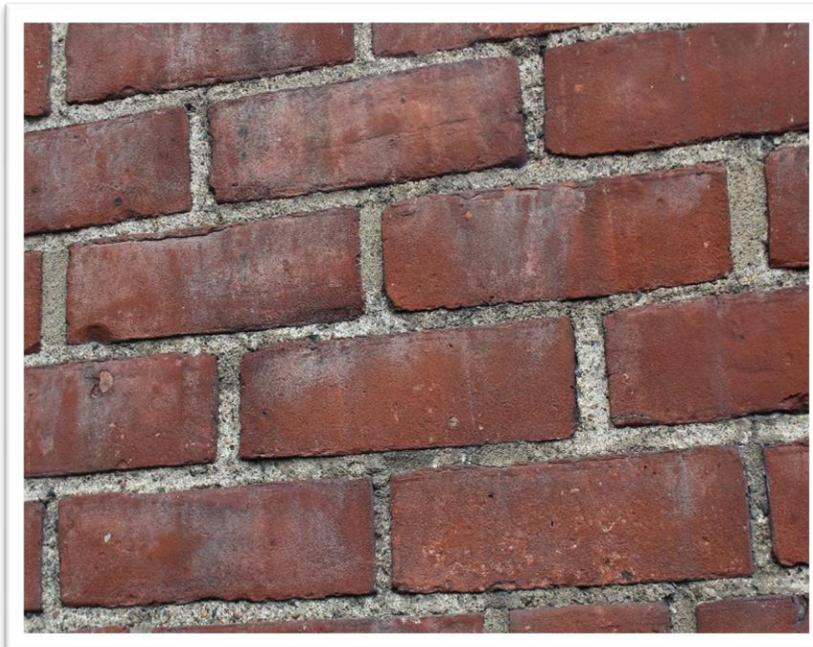
Photo 6: Close-up photo shows typical condition of aging and weathered brick mortar joints.

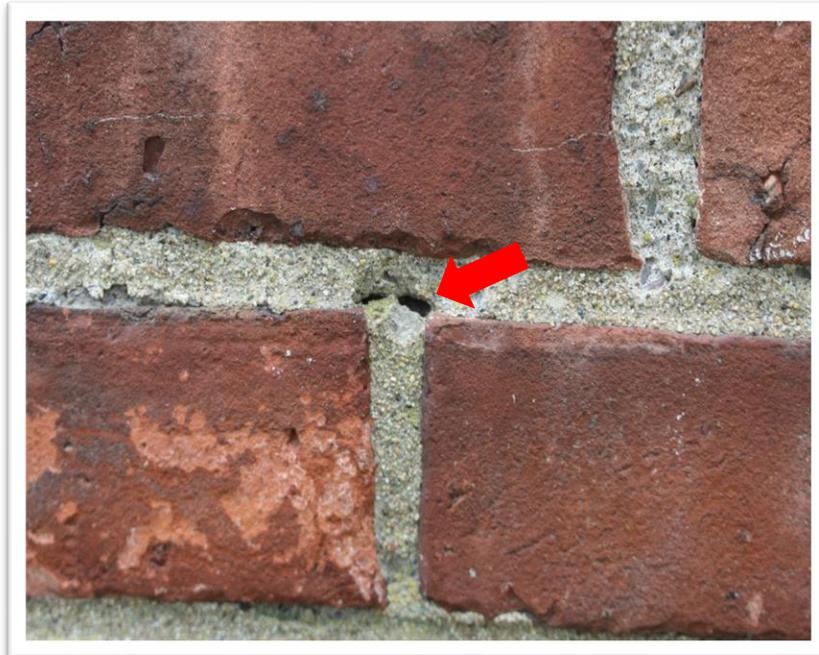
Photo 7: Small holes and voids in brick mortar observed throughout historic facade.

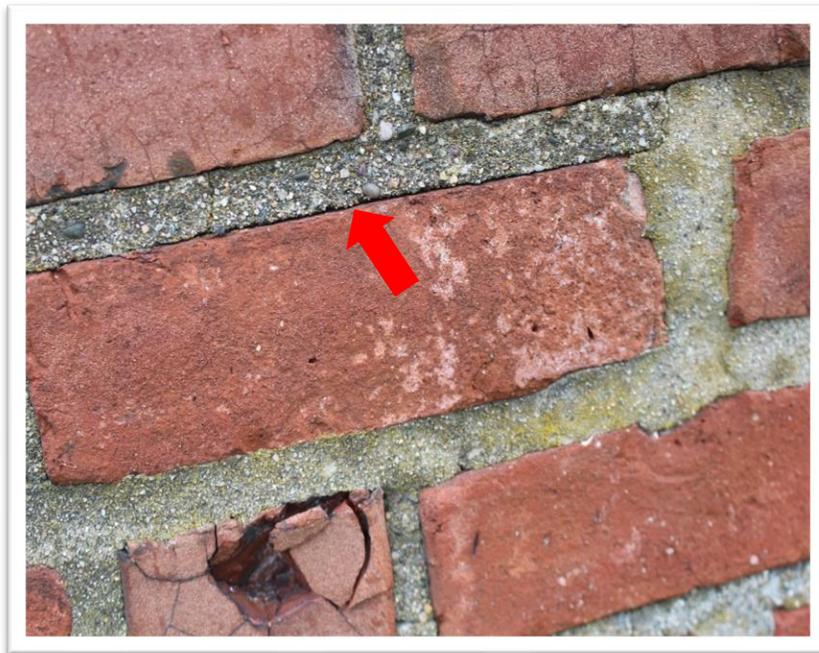
Photo 8: Moderate mortar deterioration and subsequent separation/damage along brick joint observed.

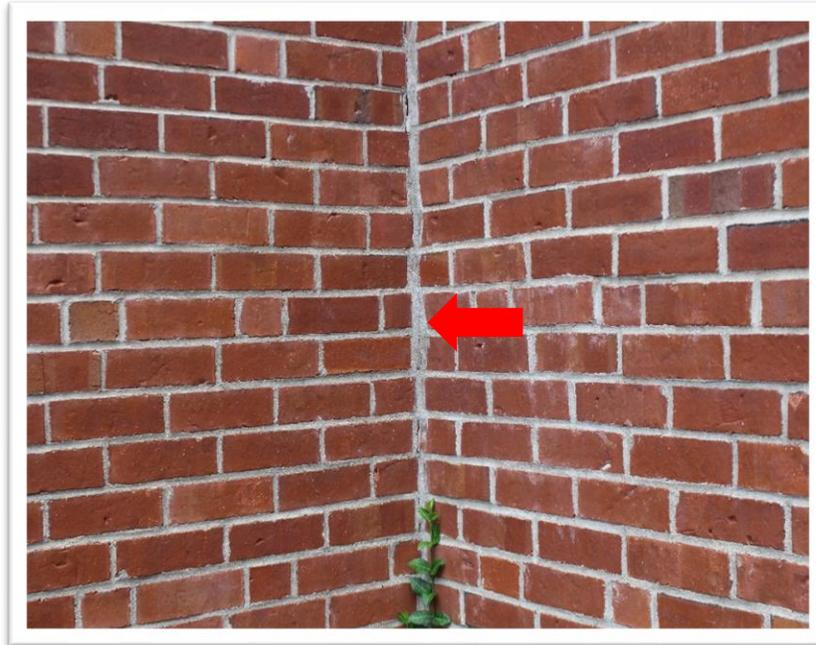
Photo 10: Mortar deterioration and subsequent separation along vertical wall joint.

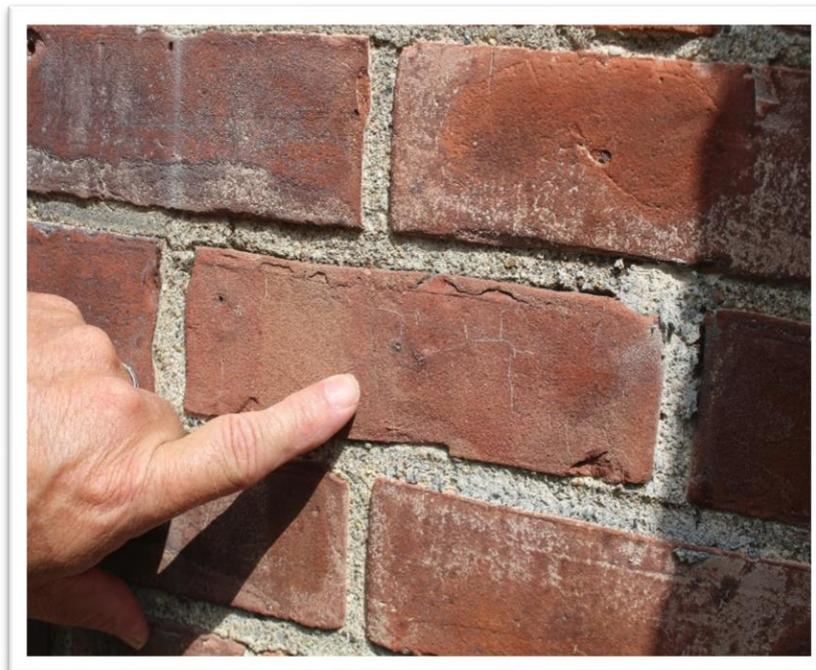
Photo 11: The majority of old brick was observed in fair condition.

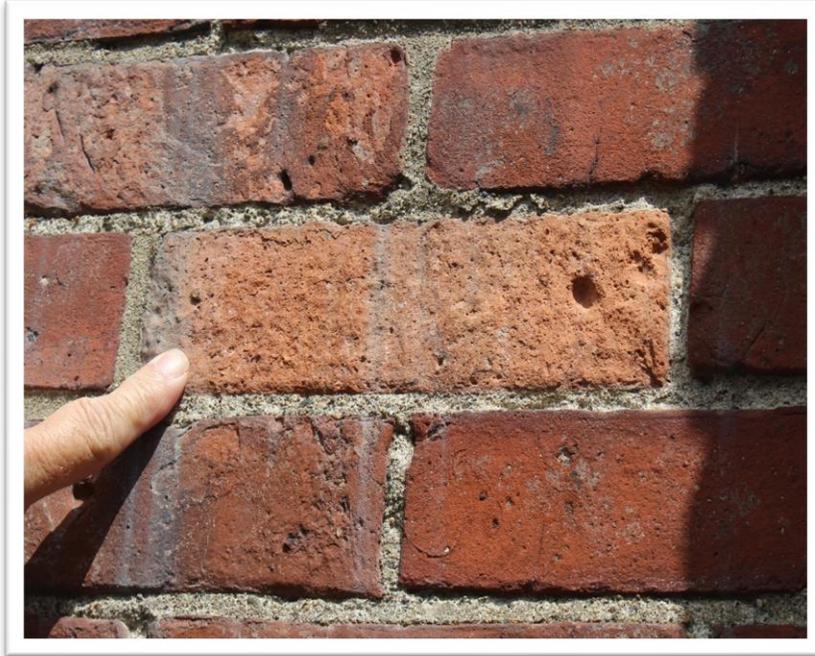
Photo 12: Random brick deterioration was observed at certain building elevations.

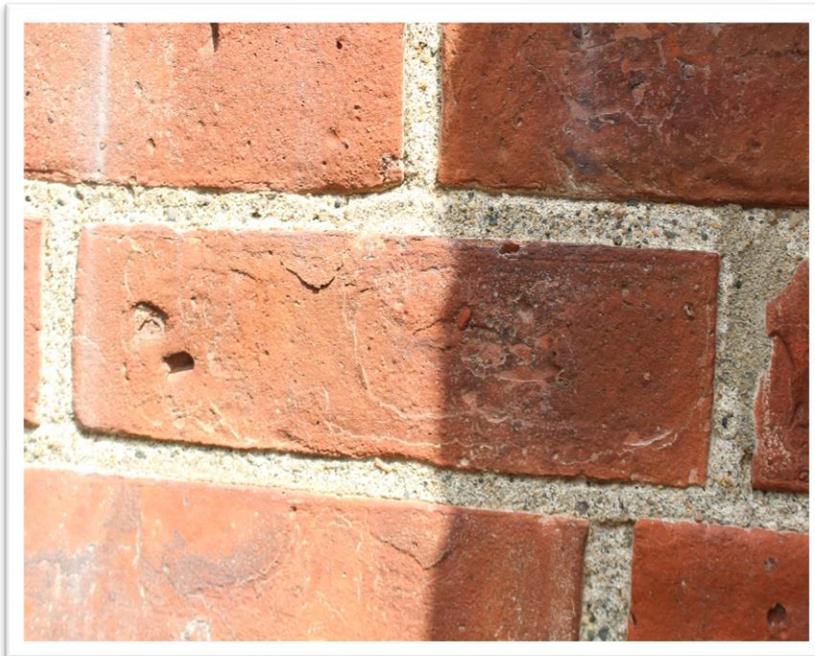
Photo 13: The historic bricks is in various stages of surface deterioration.

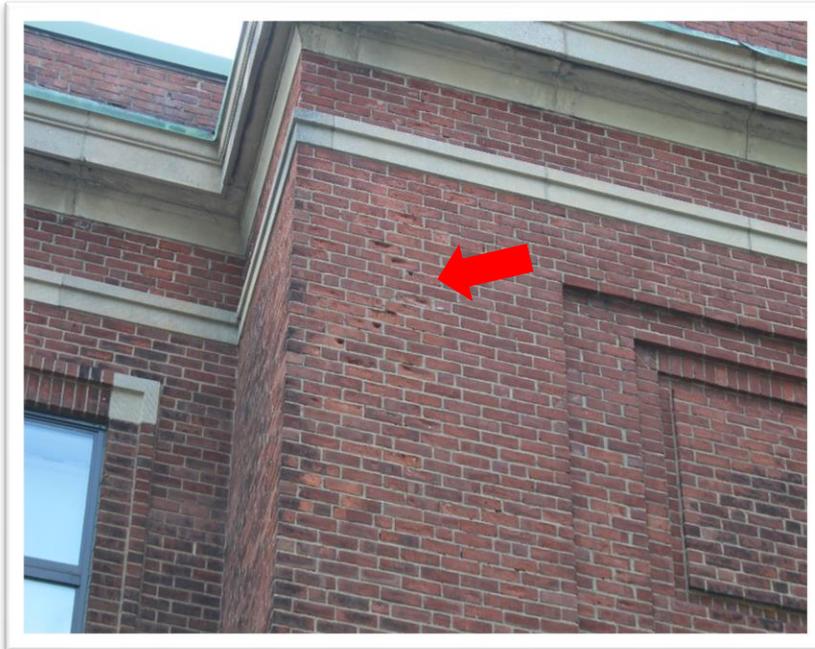
Photo 14: One of several locations of spalling brick observed along the building's south elevation.

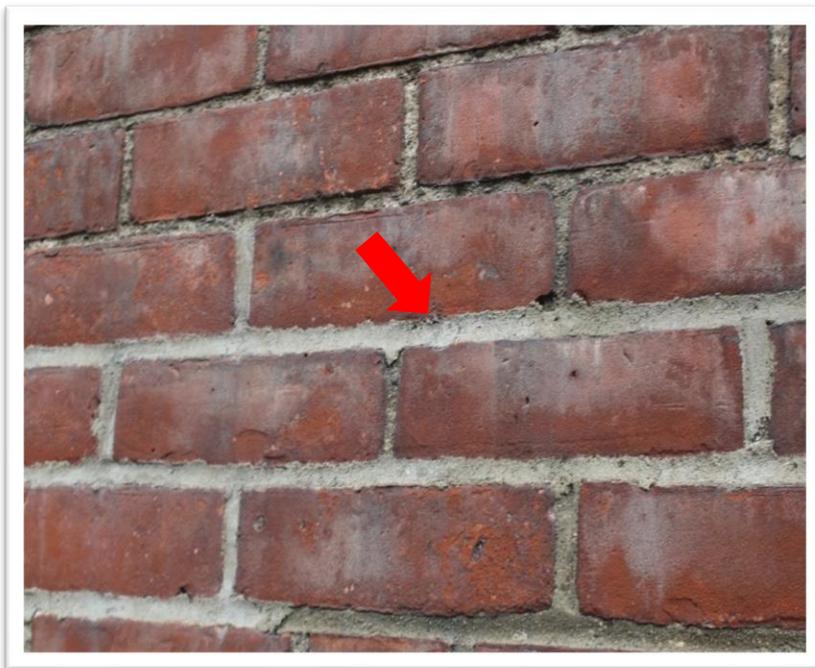
Photo 15: Locations of improper mortar joint repairs were observed, where deteriorated mortar joints were overlaid with new mortar, in lieu of proper cutting and repointing techniques.

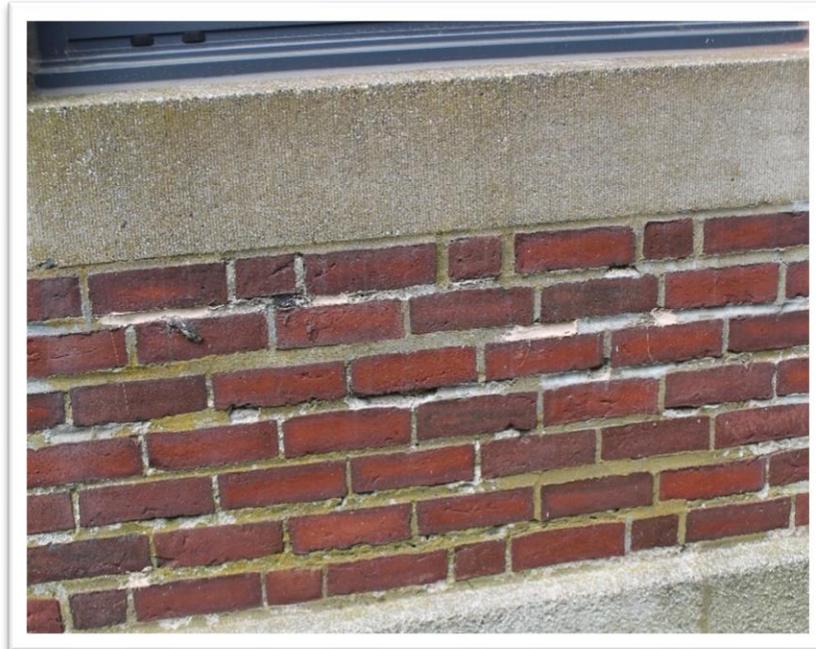
Photo 16: Typical condition observed at locations where improper masonry repairs were performed.

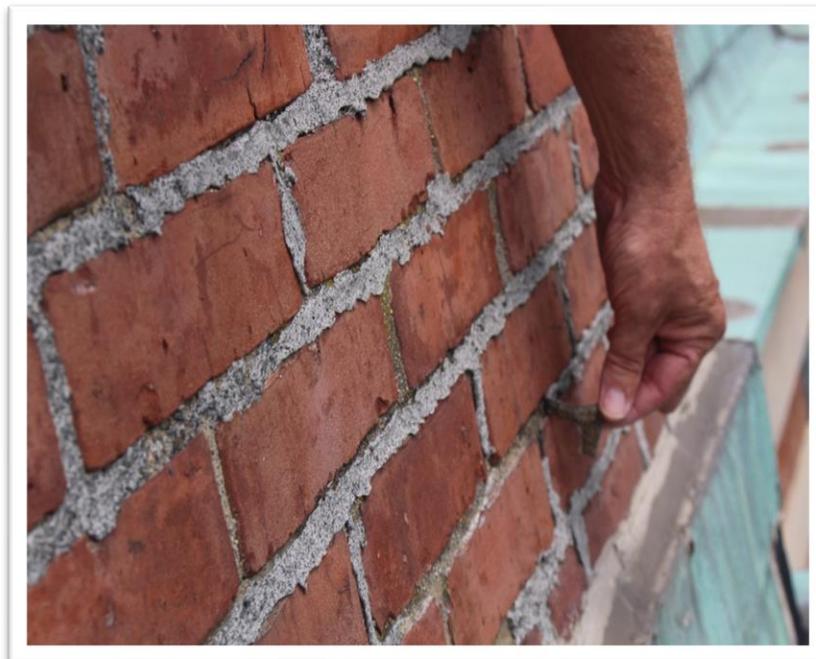
Photo 17: Improper repair material used at numerous locations.

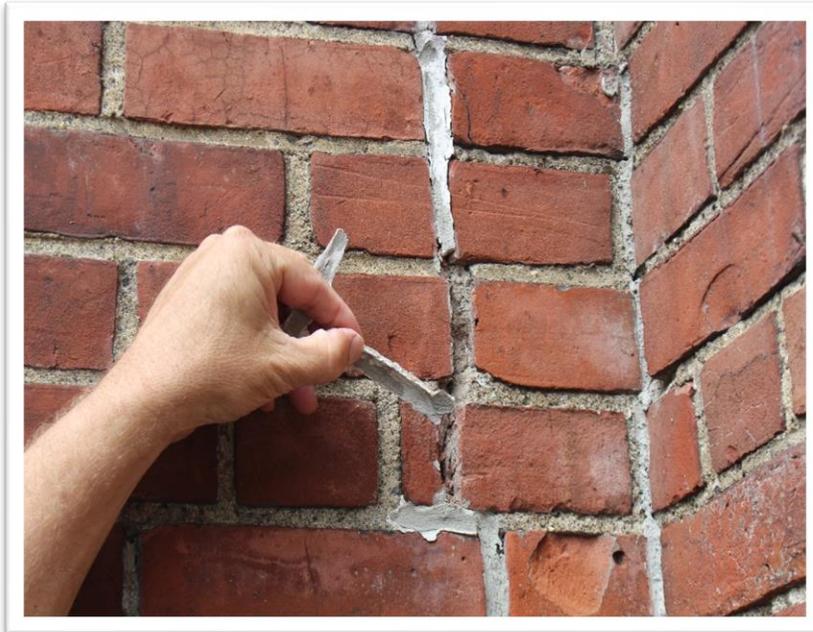
Photo 18: At most locations, the repair material easily peels away from the repair area.

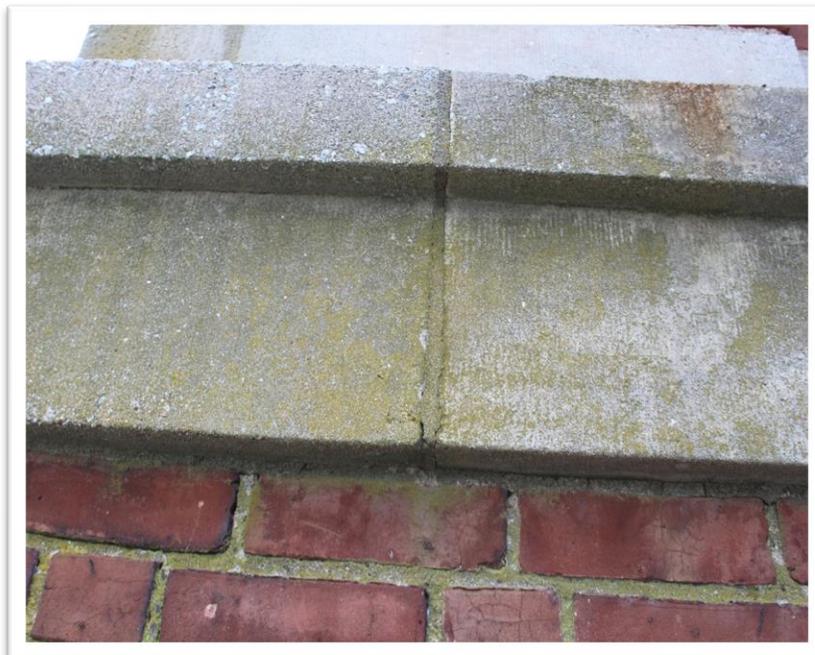
Photo 21: This photo shows precast concrete mortar joint observed in fair condition.

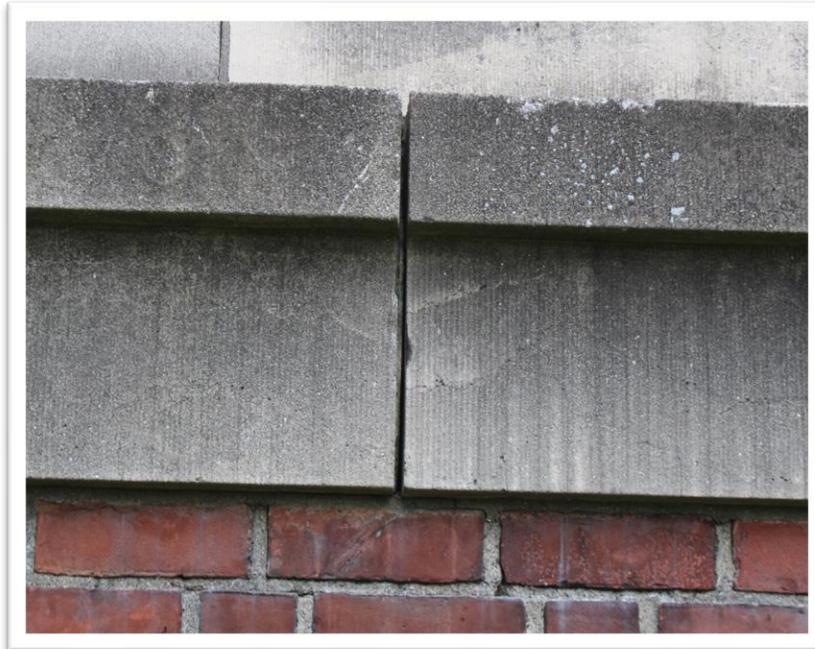
Photo 22: A large percentage of existing mortar joints along the precast cornice and bands were noted in poor condition, exposing underlying masonry to water infiltration.

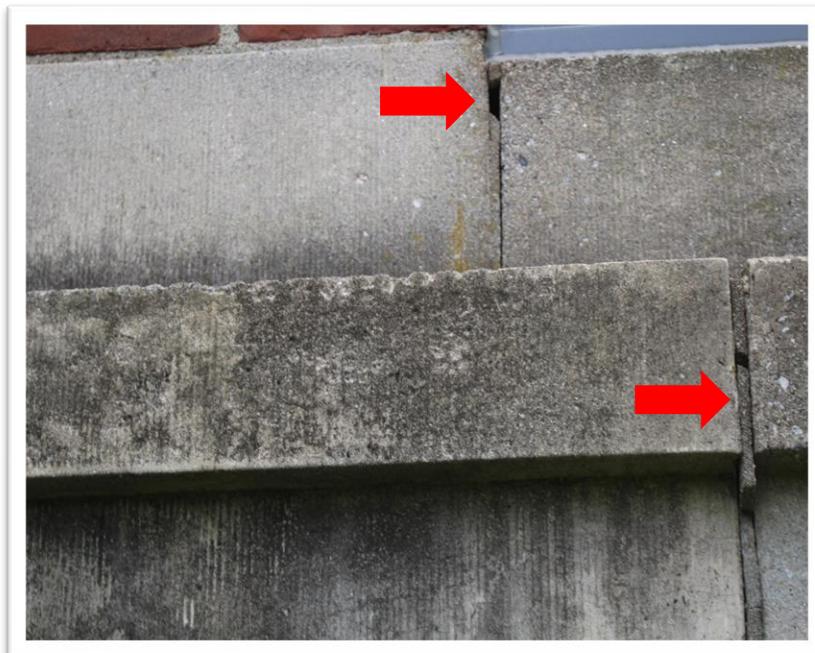
Photo 23: Numerous hole and voids observed in precast concrete mortar joints.

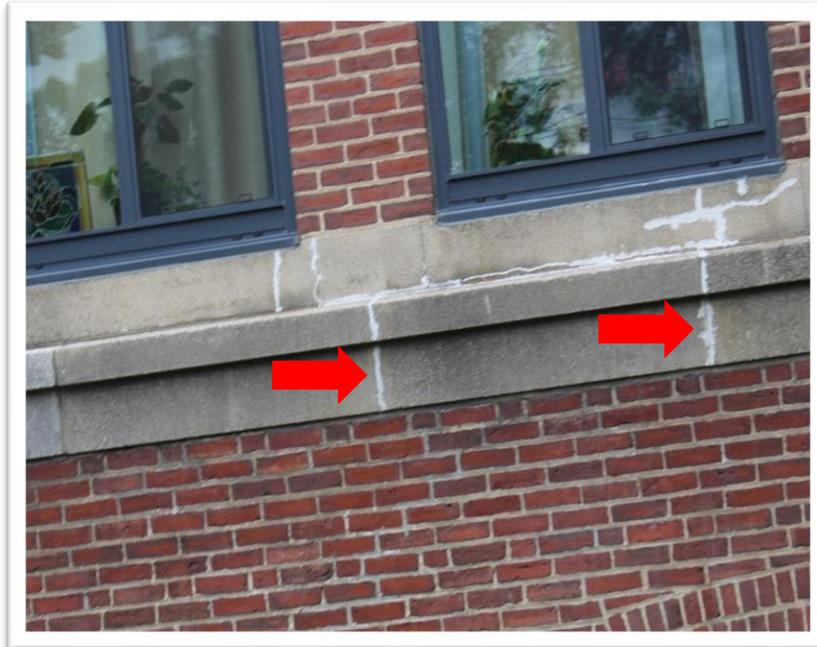
Photo 24: Improper precast concrete mortar joint repairs.

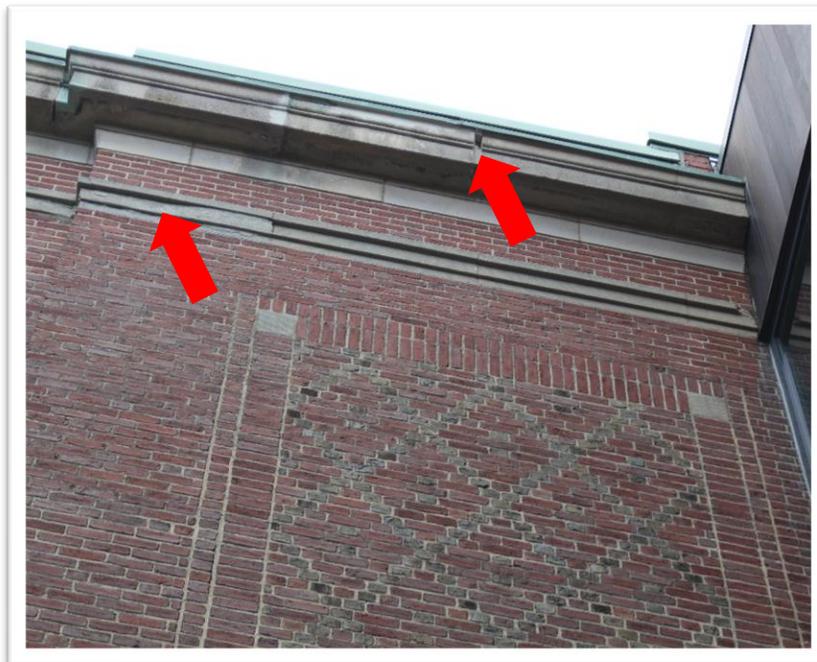
Photo 25: Random locations of deteriorated/defective precast observed along cornice/upper band.

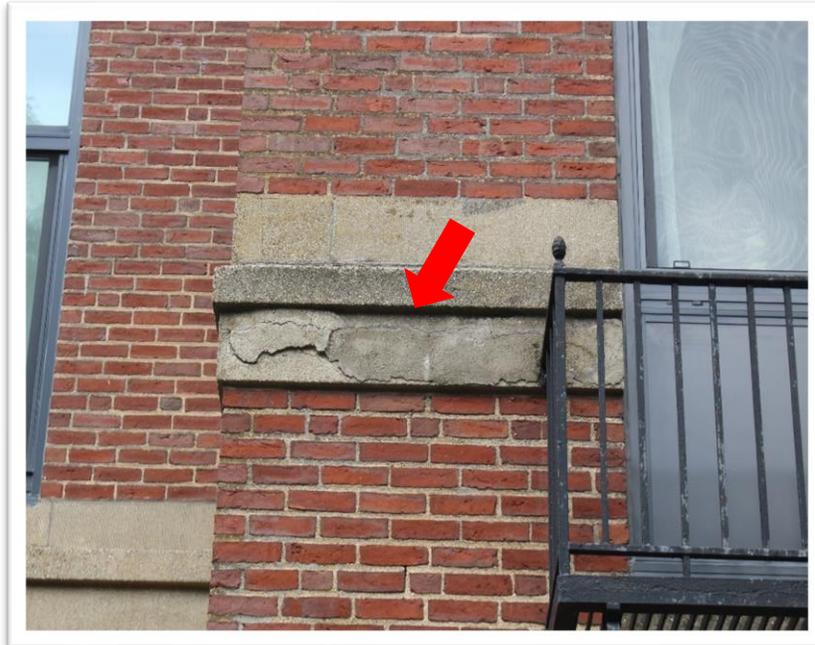
Photo 26: Deterioration and spalling sections/portion of precast concrete randomly observed.

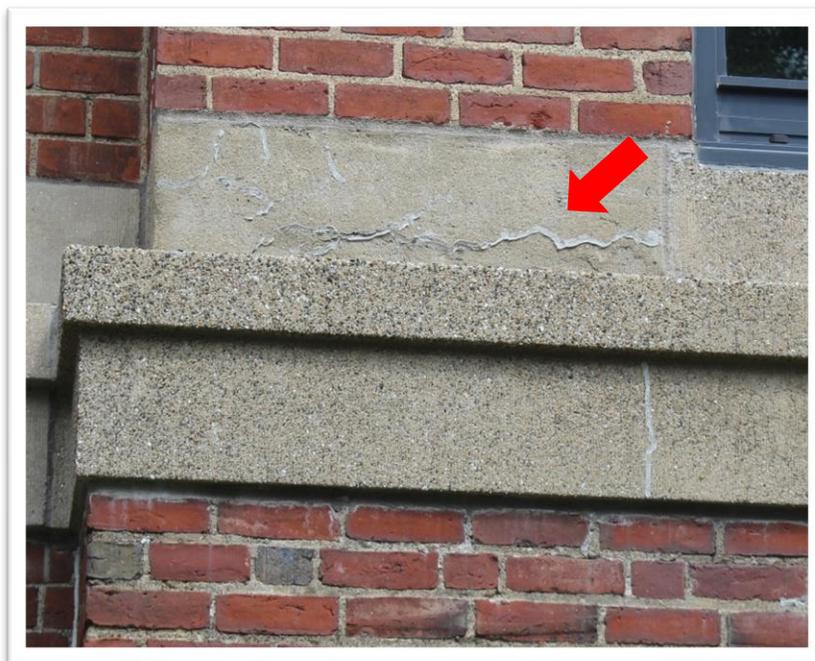
Photo 27: Many sections of defective precast have been improperly repaired with caulking.

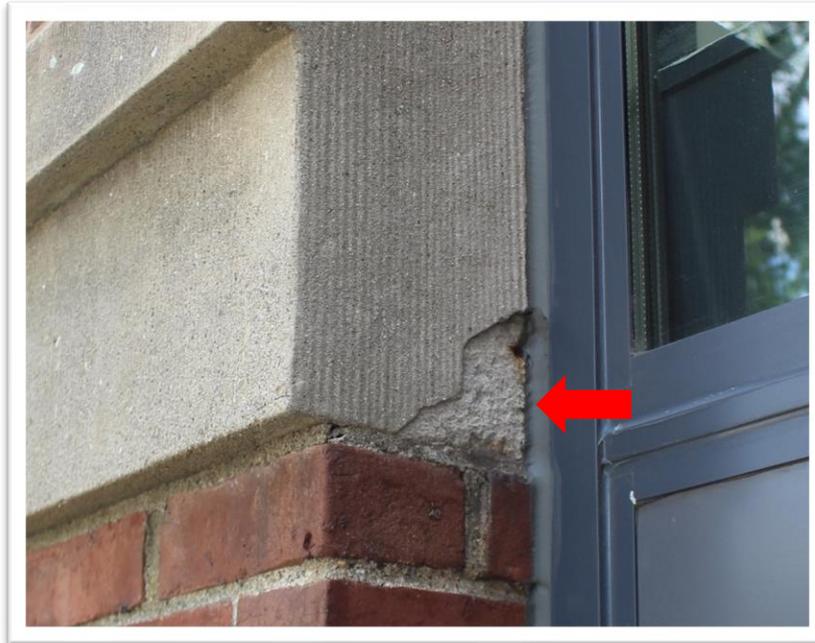
Photo 28: Cracked and chipped precast concrete randomly observed.

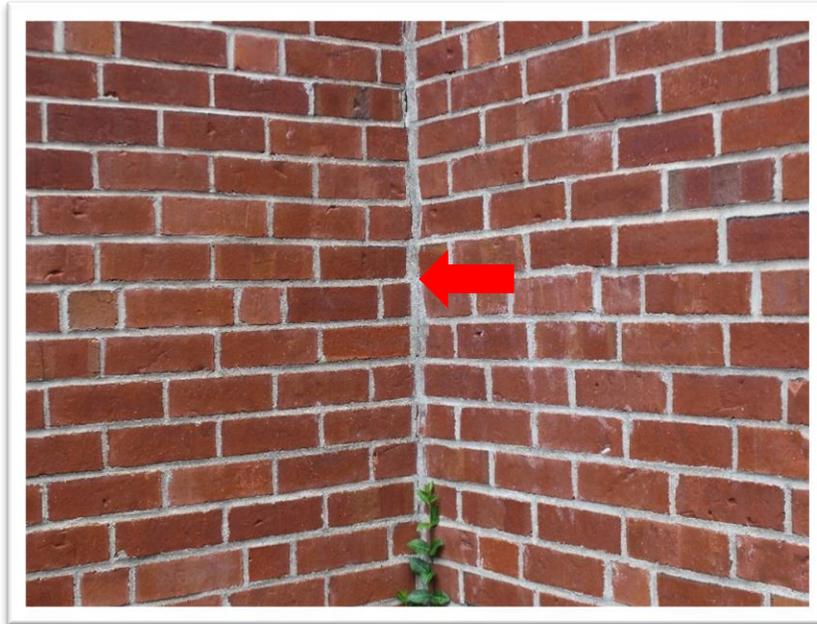
Photo 32: Photo shows one a several defective vertical brick mortar joints.

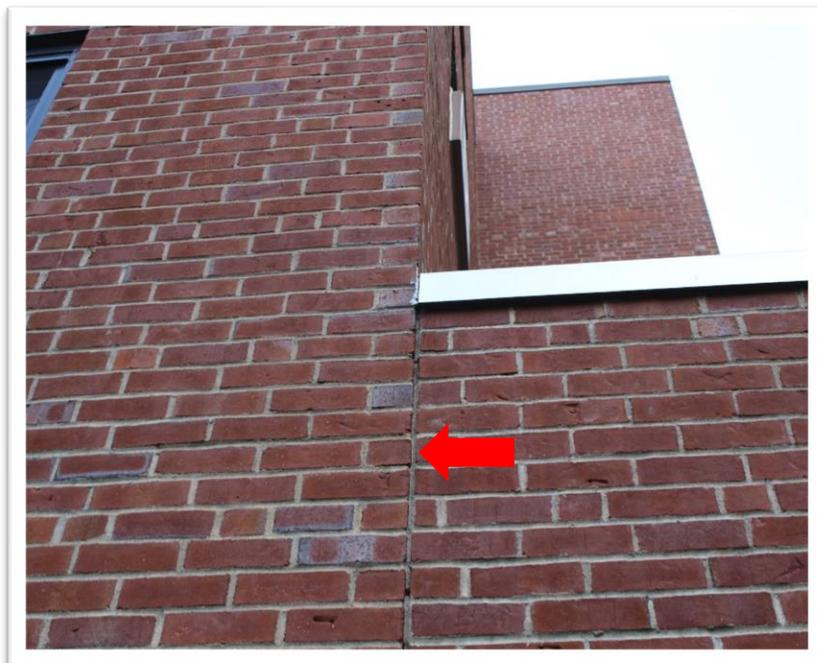
Photo 33: Photo shows defective brick mortar joint at roof parapet wall.

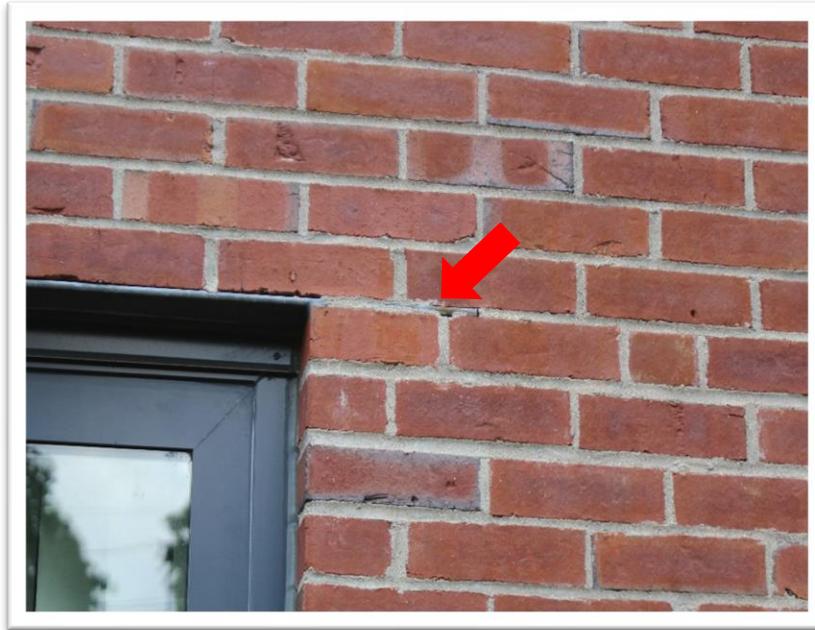
Photo 34: Photo shows exposed steel lintel at brick mortar joint.

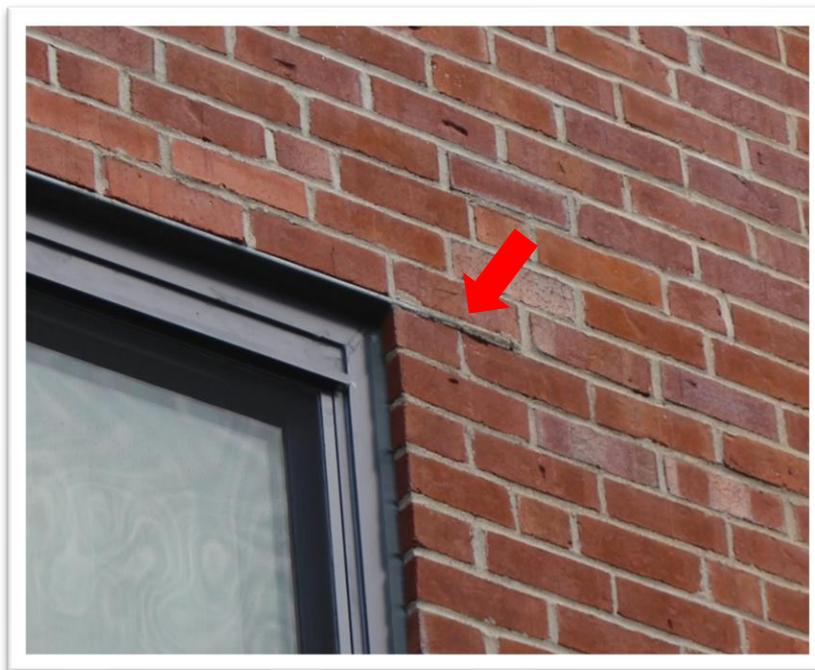
Photo 35: Photo shows portion of loose mortar at steel lintel (randomly observed).

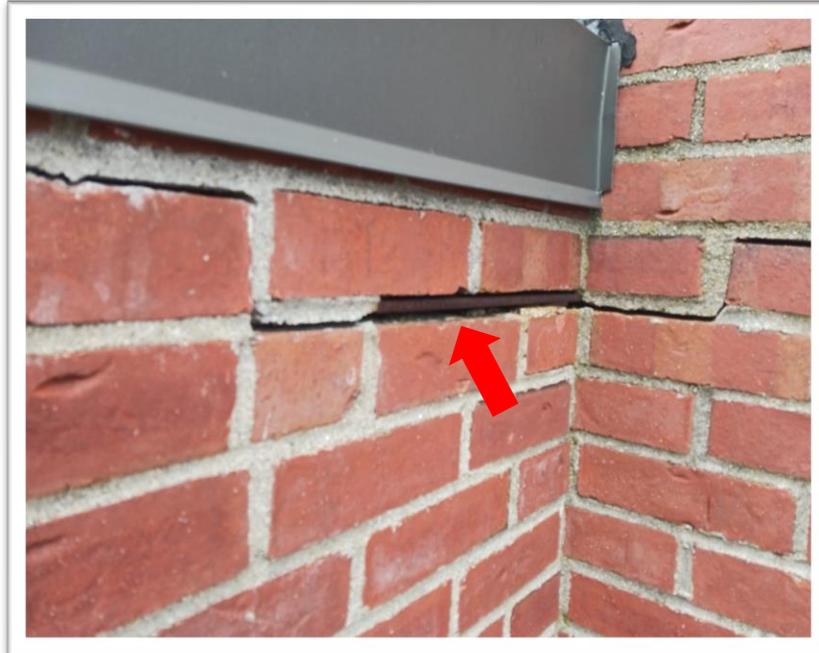
Photo 36: Embedded rusting steel beam in brick masonry wall.

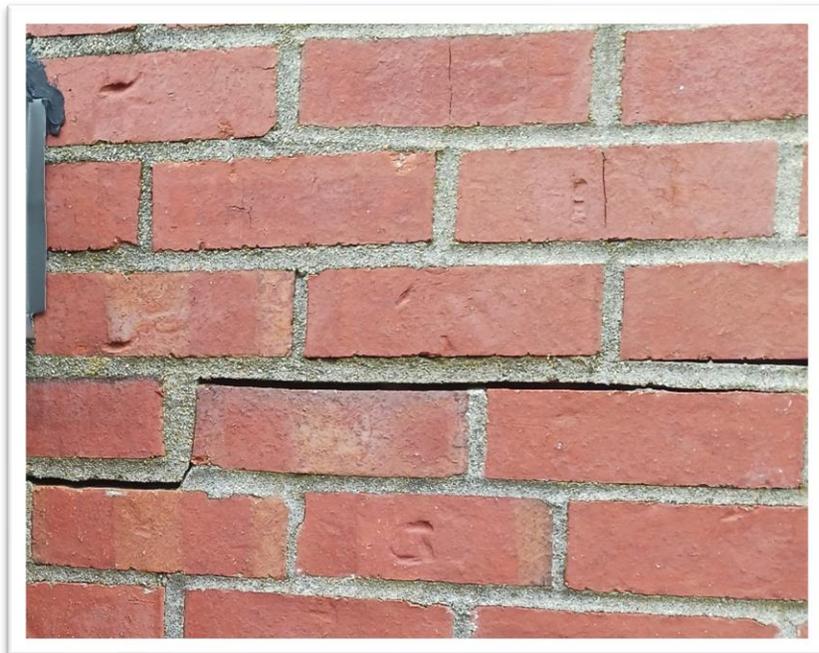
Photo 37: Known as “jacking” when steel forms rust and expands up to six times it’s volume, it can cause subsequent and damage to surrounding brick masonry.

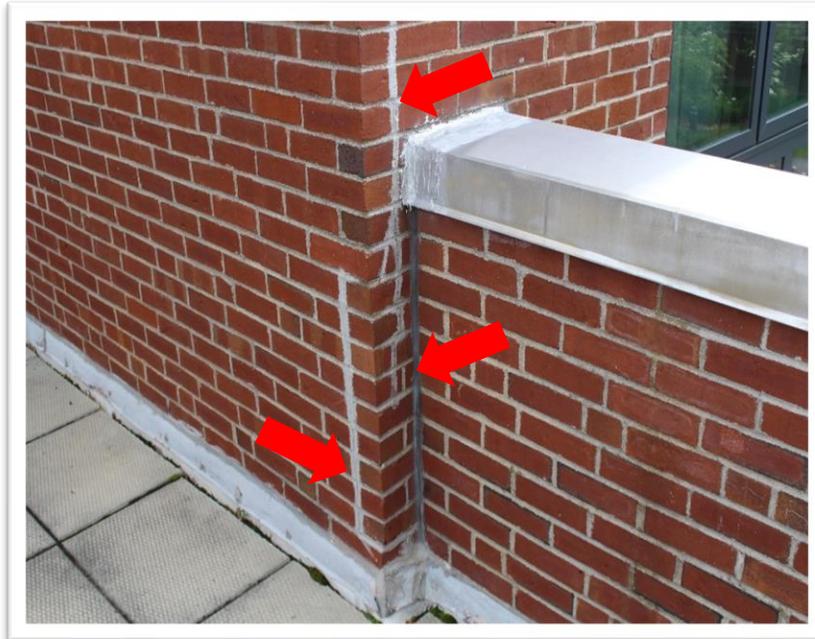
Photo 38: Random brick masonry repairs using caulking observed.

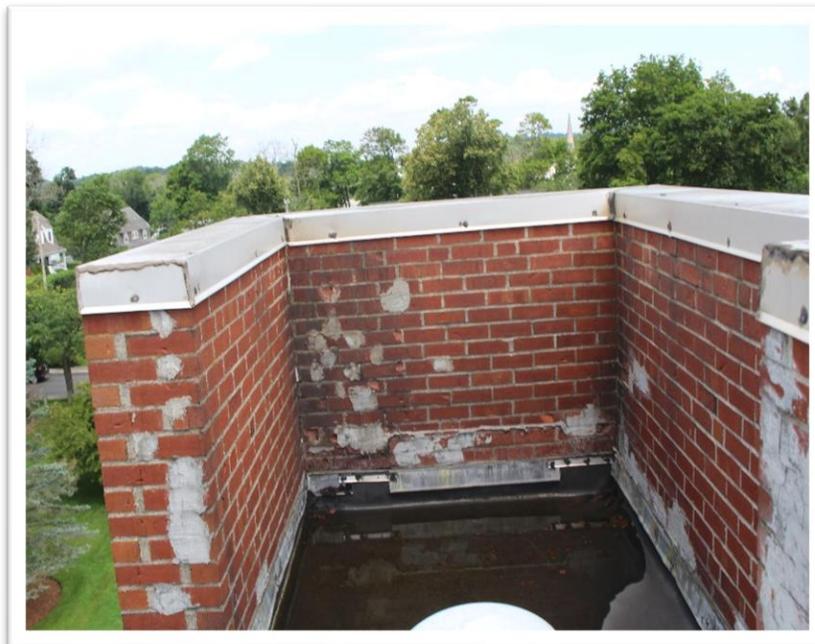
Photo 39: This photo shows back side of roof parapet wall with improper brick masonry repairs.

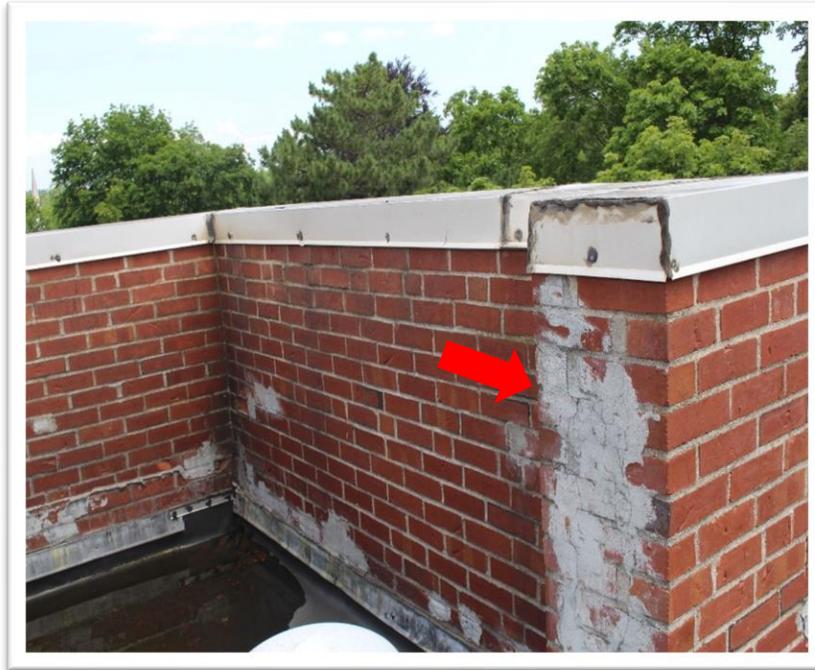
Photo 40: Defective brick patched with slurry coat of cement.

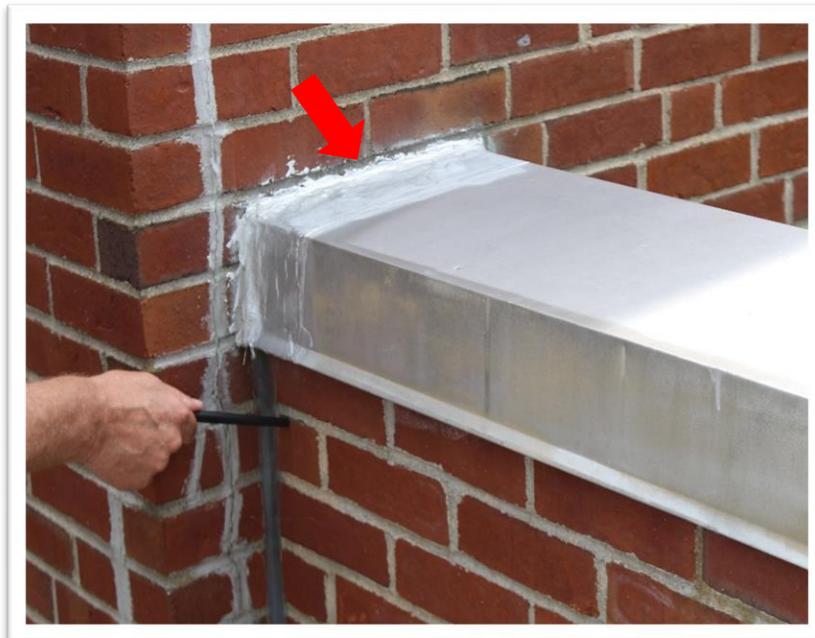
Photo 41: Improper waterproofing termination at parapet wall coping cap.

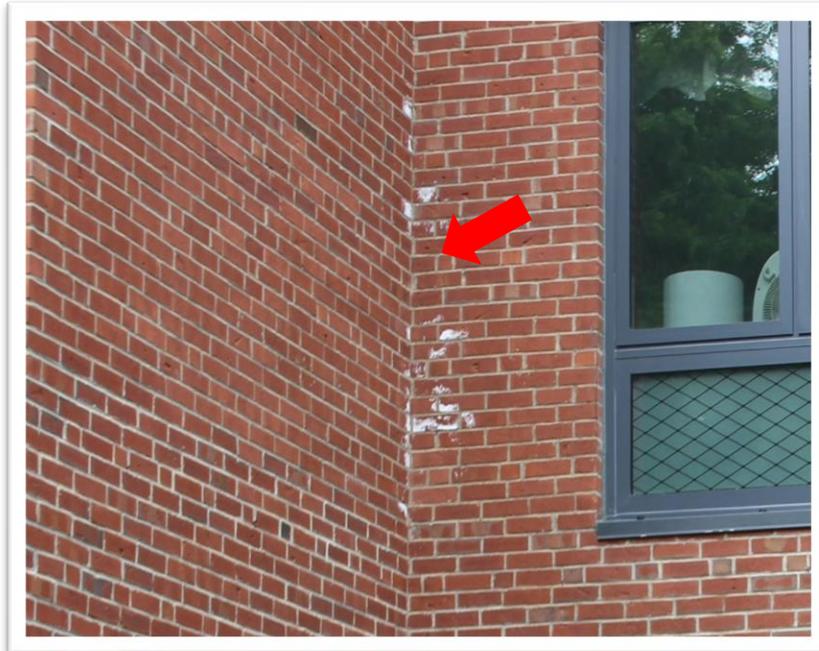
Photo 42: Presents of efflorescence on surface of brick at possible leak location.

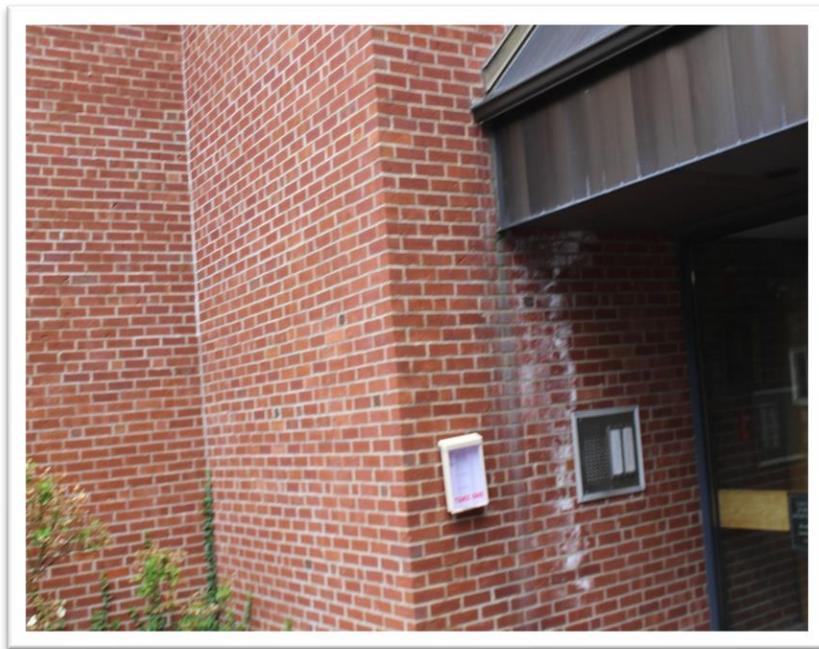
Photo 43: Presents of efflorescence on surface of brick at possible leak location.

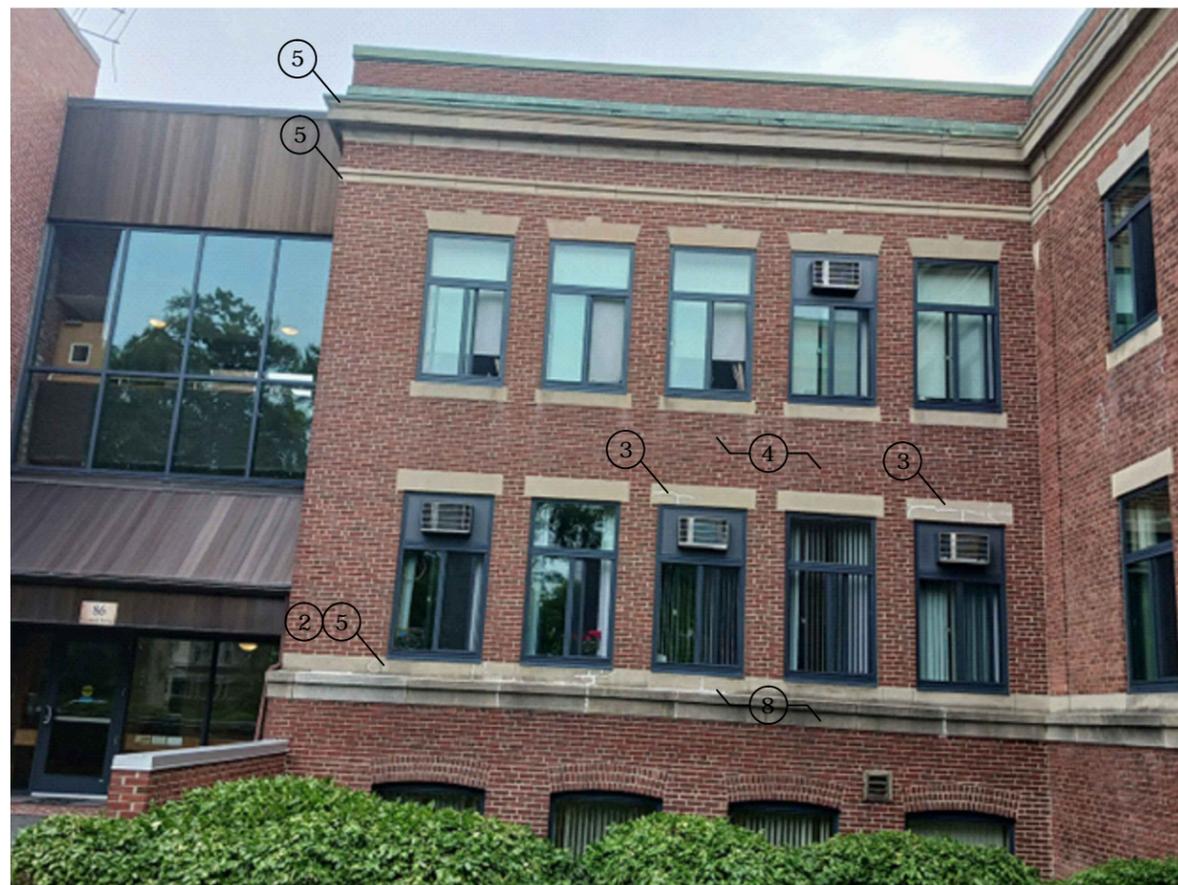
E1 - East Elevation

Deficiency Noted:	Approximate Percentage:
(2)	35%
(3)	20%
(4)	50%
(5)	65%
(8)	30% (Stained Precast)

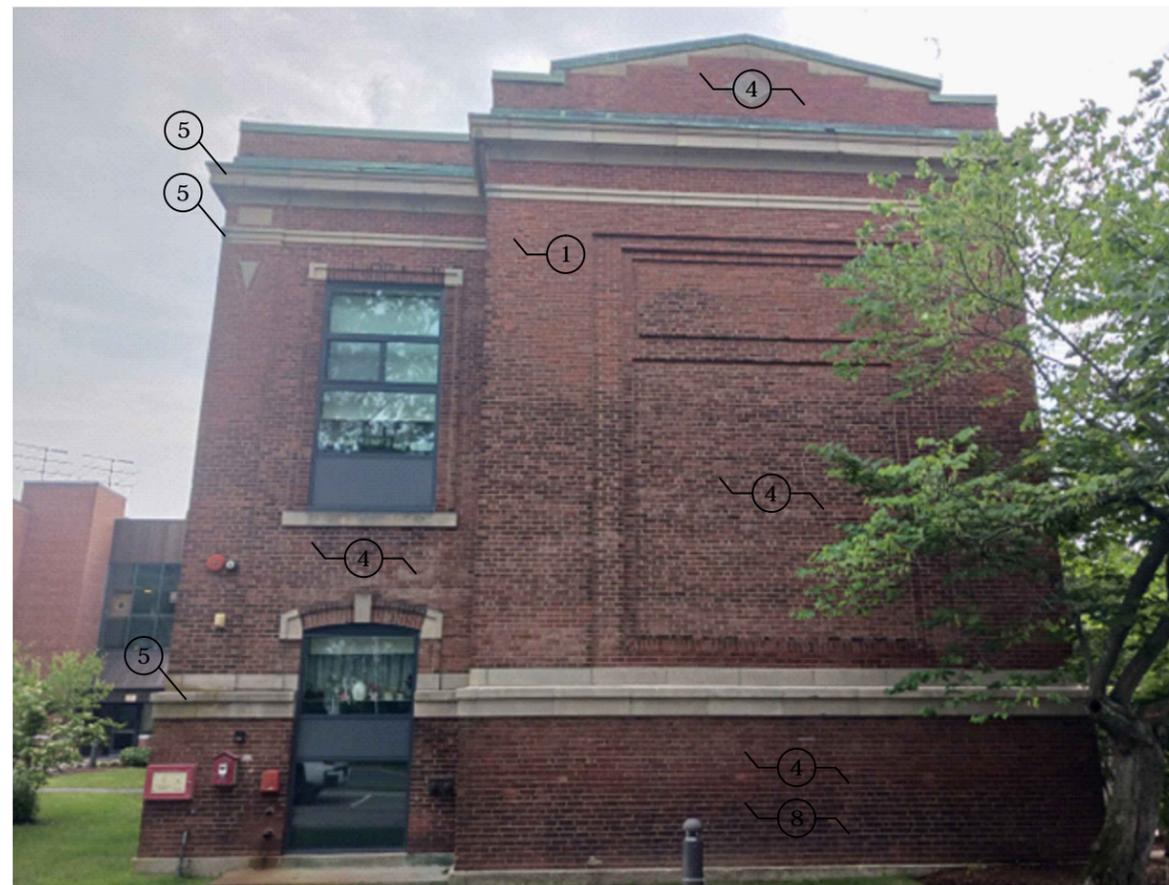
E2 - East Elevation

Deficiency Noted:	Approximate Percentage:
(1)	10%
(4)	50%
(5)	60%
(8)	40% (Stained Precast/Brick)

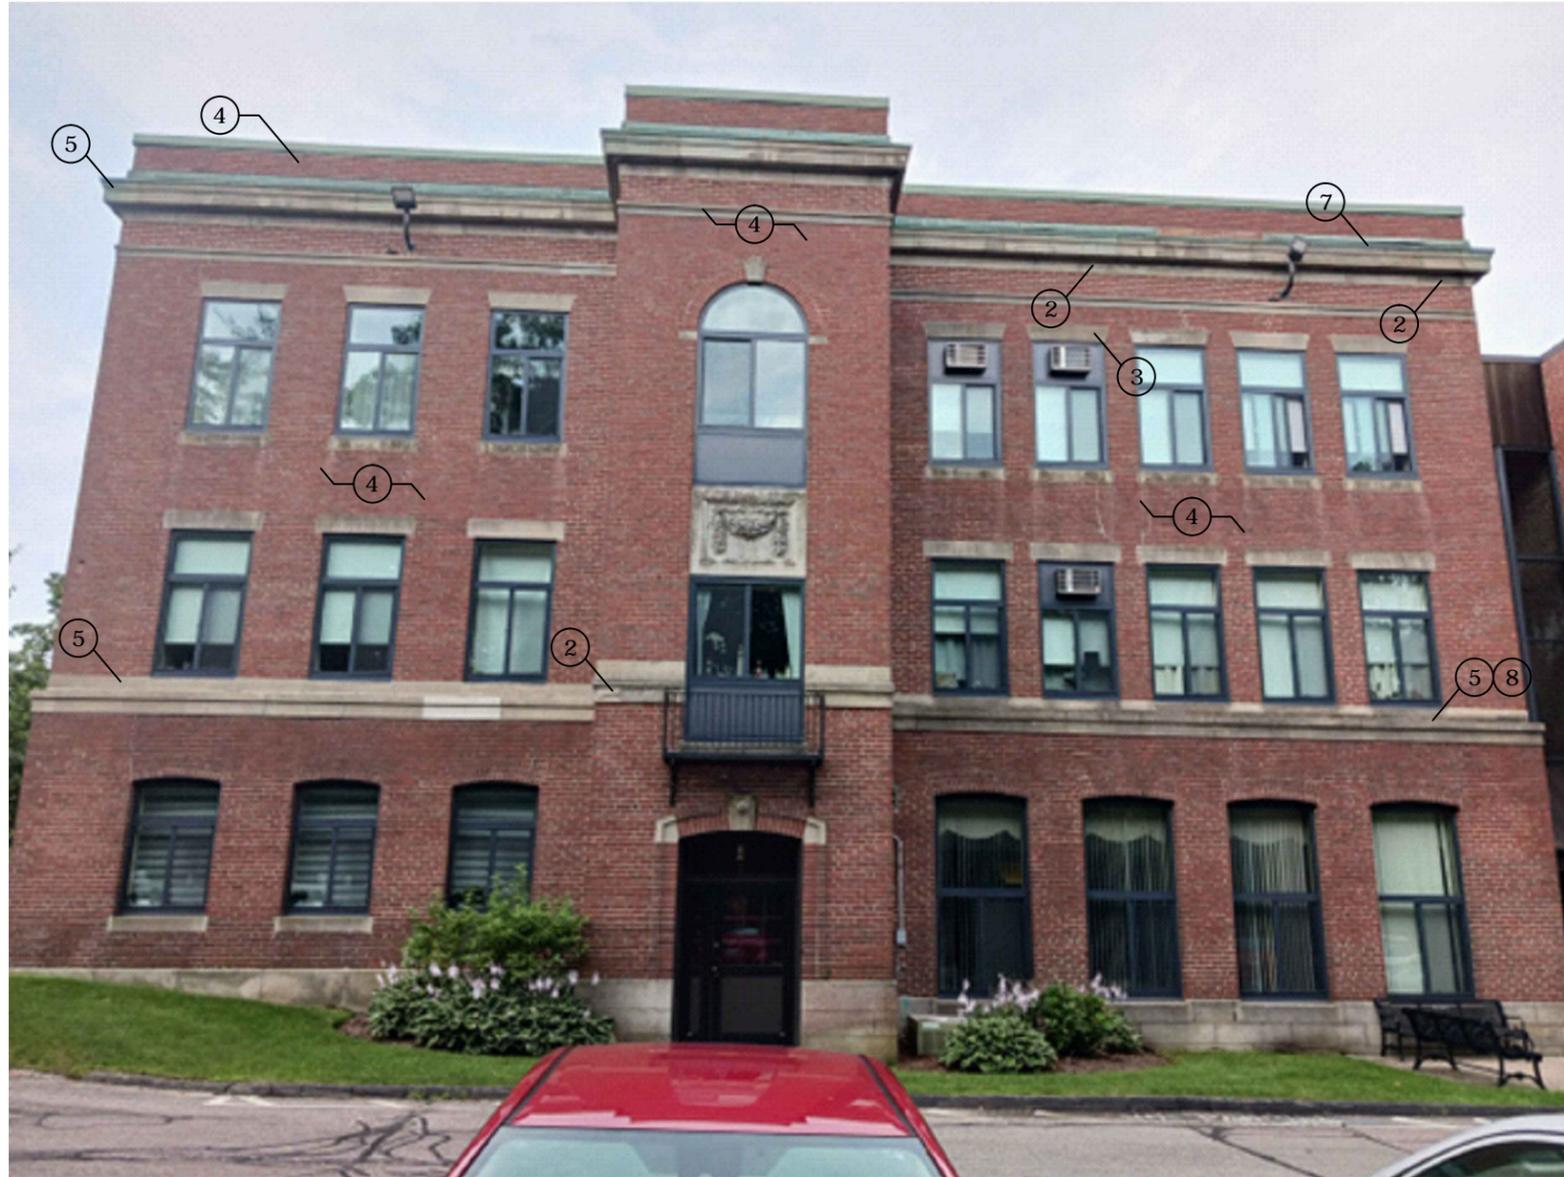
W1 - West Elevation

Deficiency Noted:	Approximate Percentage:
②	30%
③	15%
④	40%
⑤	60%
⑧	60% (Stained Precast)

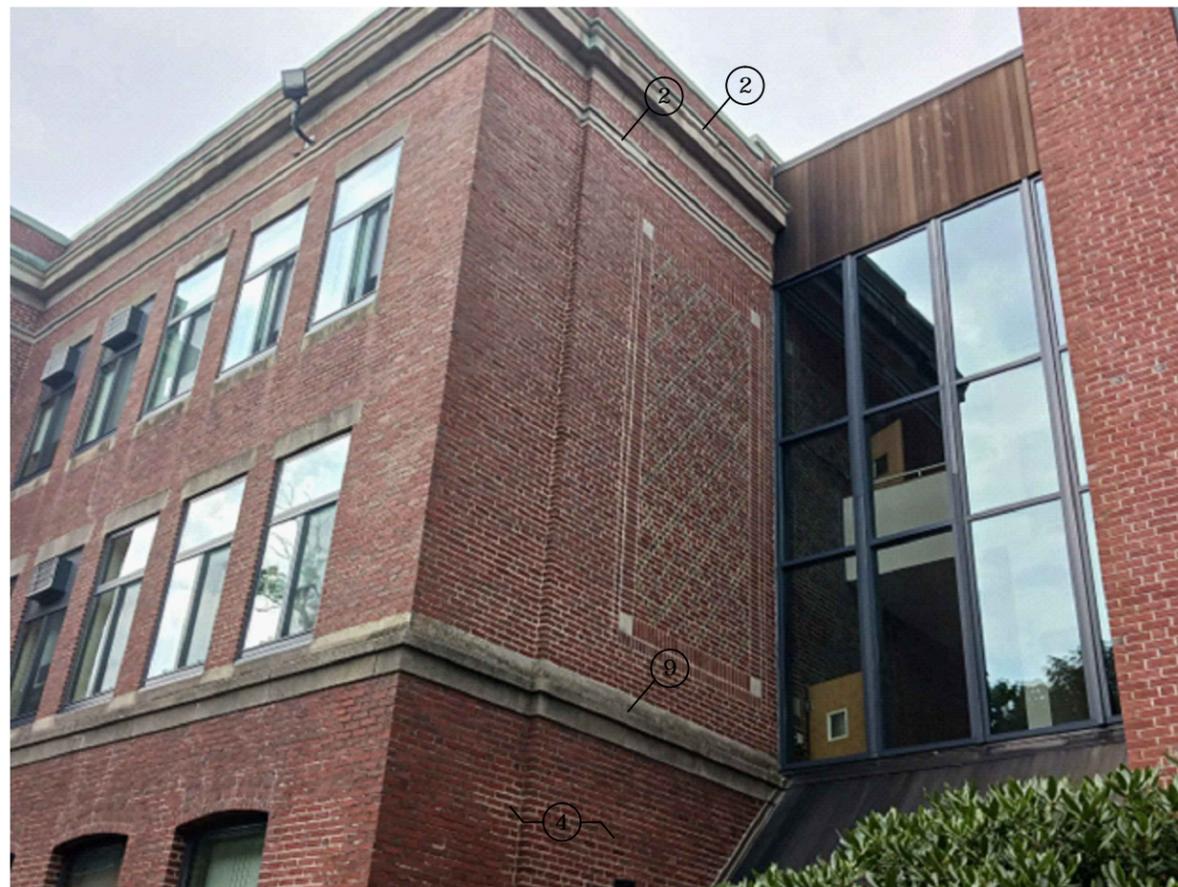
N1 - East Elevation

Deficiency Noted:	Approximate Percentage:
(2)	40%
(4)	50%
(9)	80% (Stained Precast)
