HINGHAM AFFORDABLE HOUSING TRUST FY 2027 CPA FUNDS REQUEST

In late June of 2023, BEA performed a Building Envelope Inspection at Lincoln School Apartments in Hingham, Massachusetts. The purpose of this Condition Survey was to assess the condition of the building envelope components and identify exterior deficiencies. The report summarizes our findings, conclusions, recommendations, and associated repair/restoration cost budget estimates.

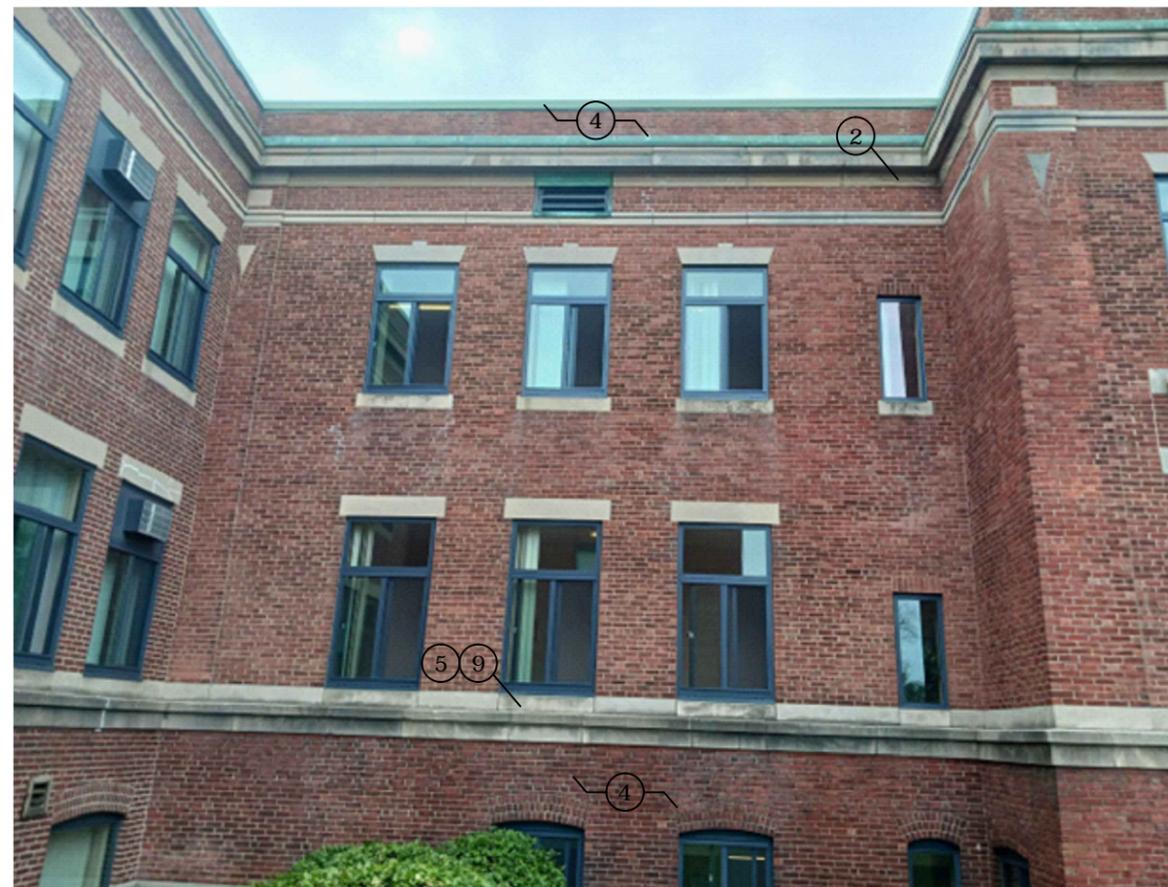
N2 - East Elevation

Deficiency Noted:	Approximate Percentage:
(2)	20%
(4)	50%
(5)	50%
(8)	50% (Stained Precast/Brick)

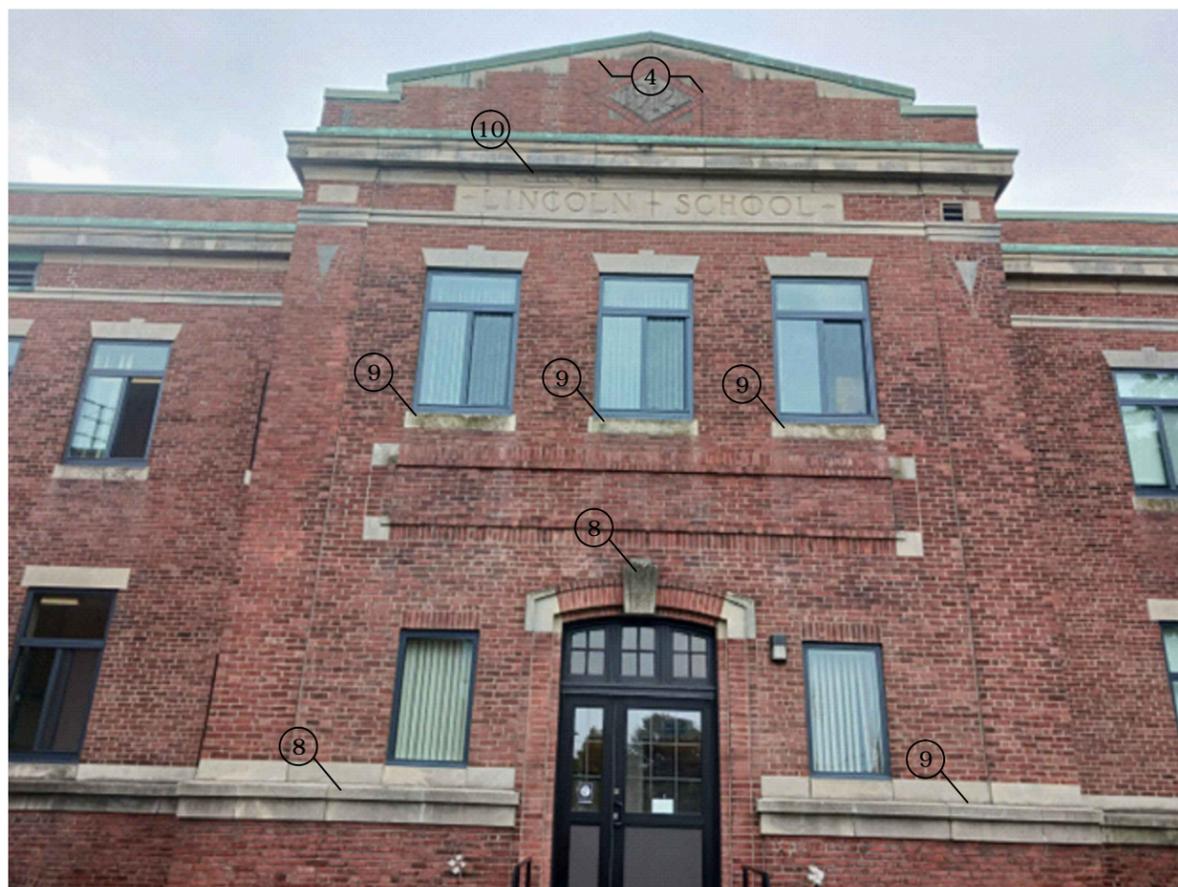
N3 - East Elevation

Deficiency Noted:	Approximate Percentage:
(4)	50%
(9)	30% (Stained Precast)
(10)	Plant Growth (Vines)

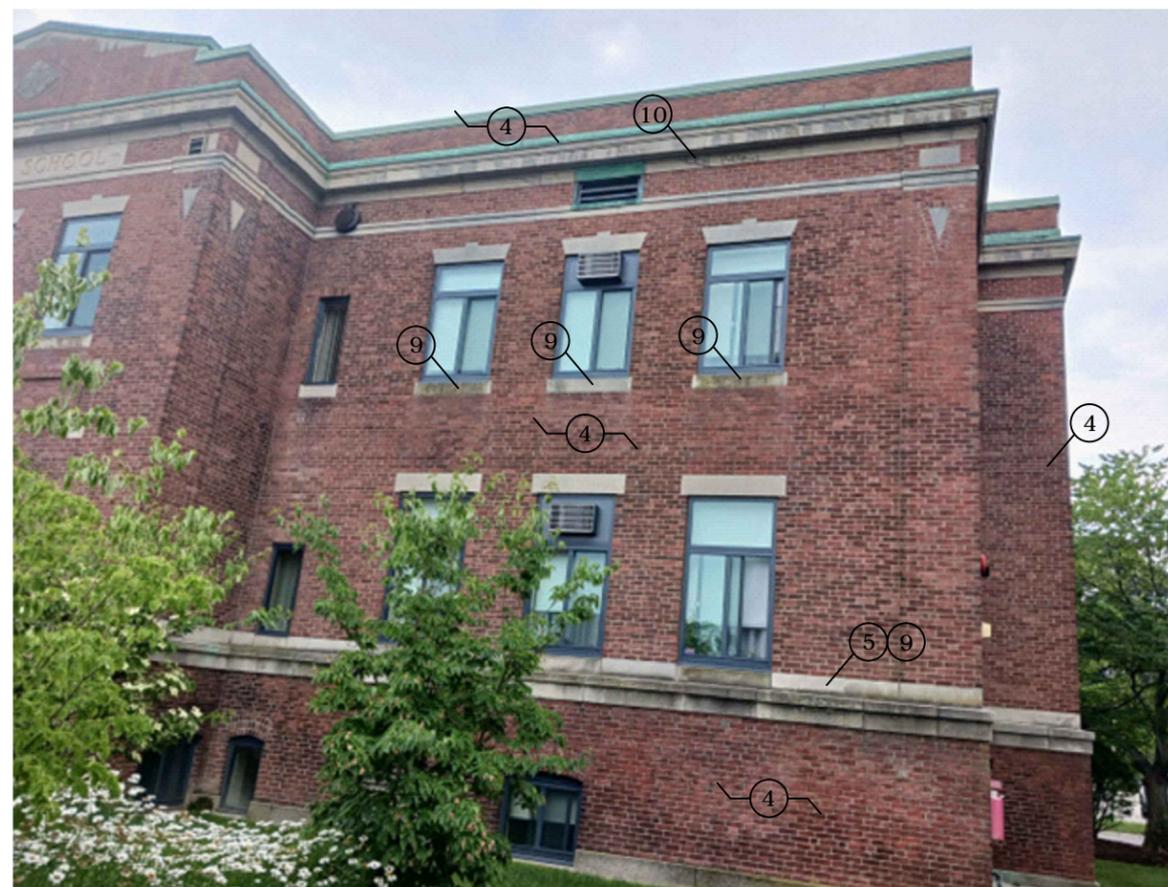
N4 - East Elevation

Deficiency Noted:	Approximate Percentage:
(4)	40%
(5)	50%
(9)	50% (Stained Precast)
(10)	Plant Growth (Vines)

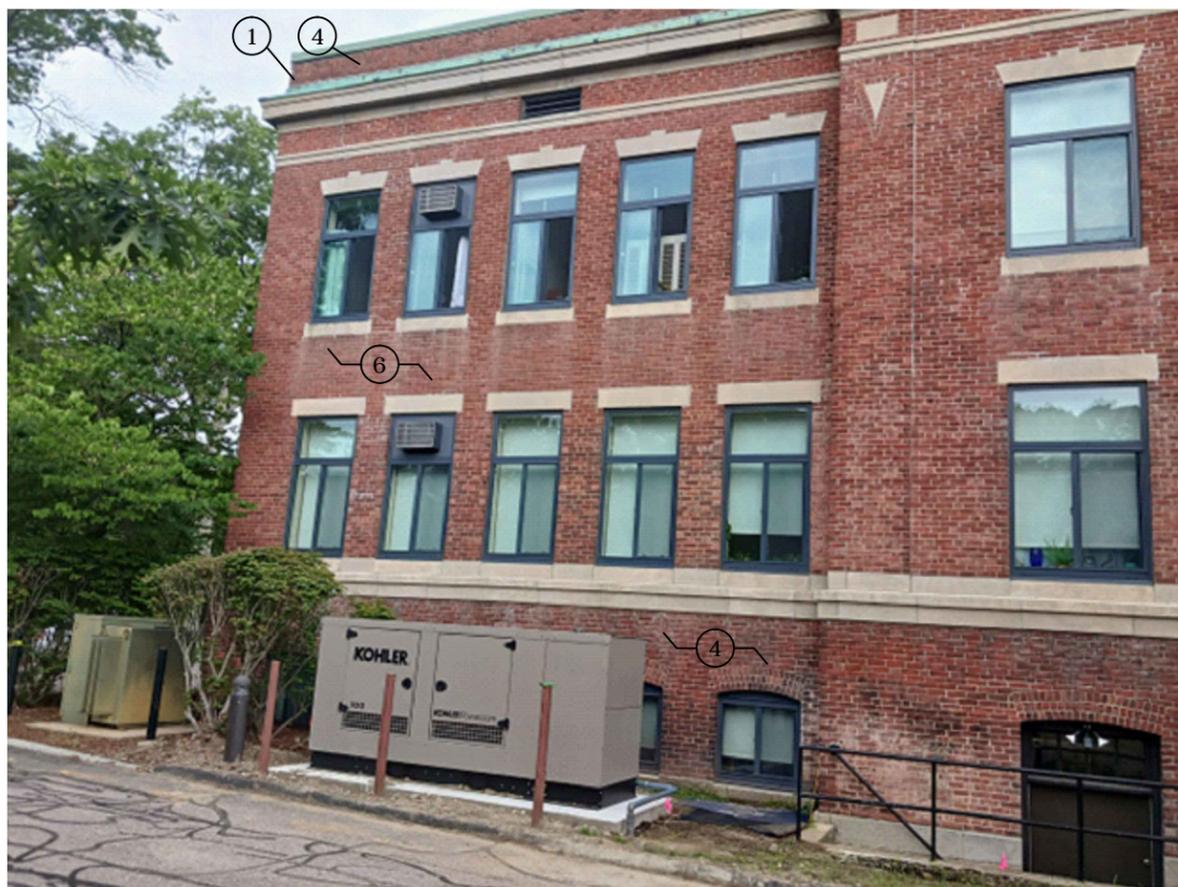
S1 - East Elevation

Deficiency Noted:	Approximate Percentage:
①	10%
④	80%
⑥	Random

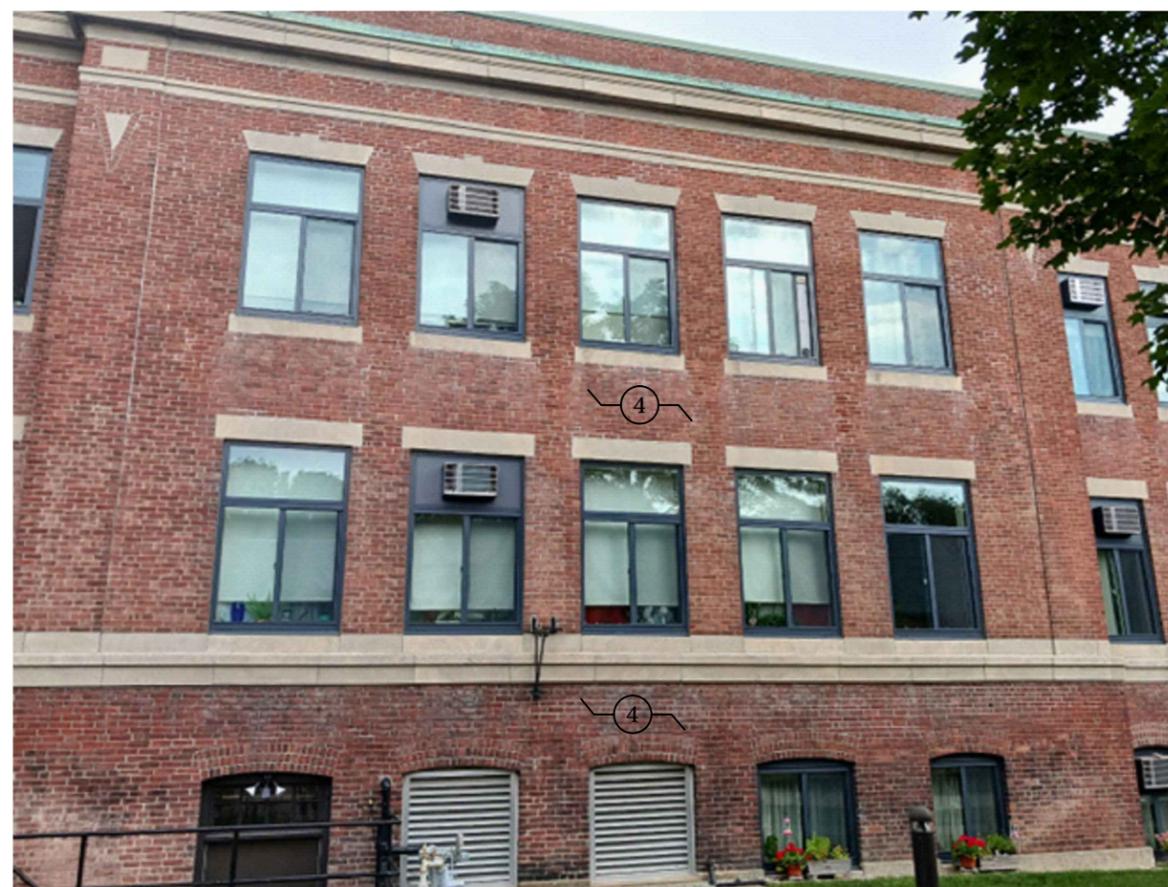
S2 - East Elevation

Deficiency Noted:	Approximate Percentage:
④	70%
⑨	30% (Stained Brick)

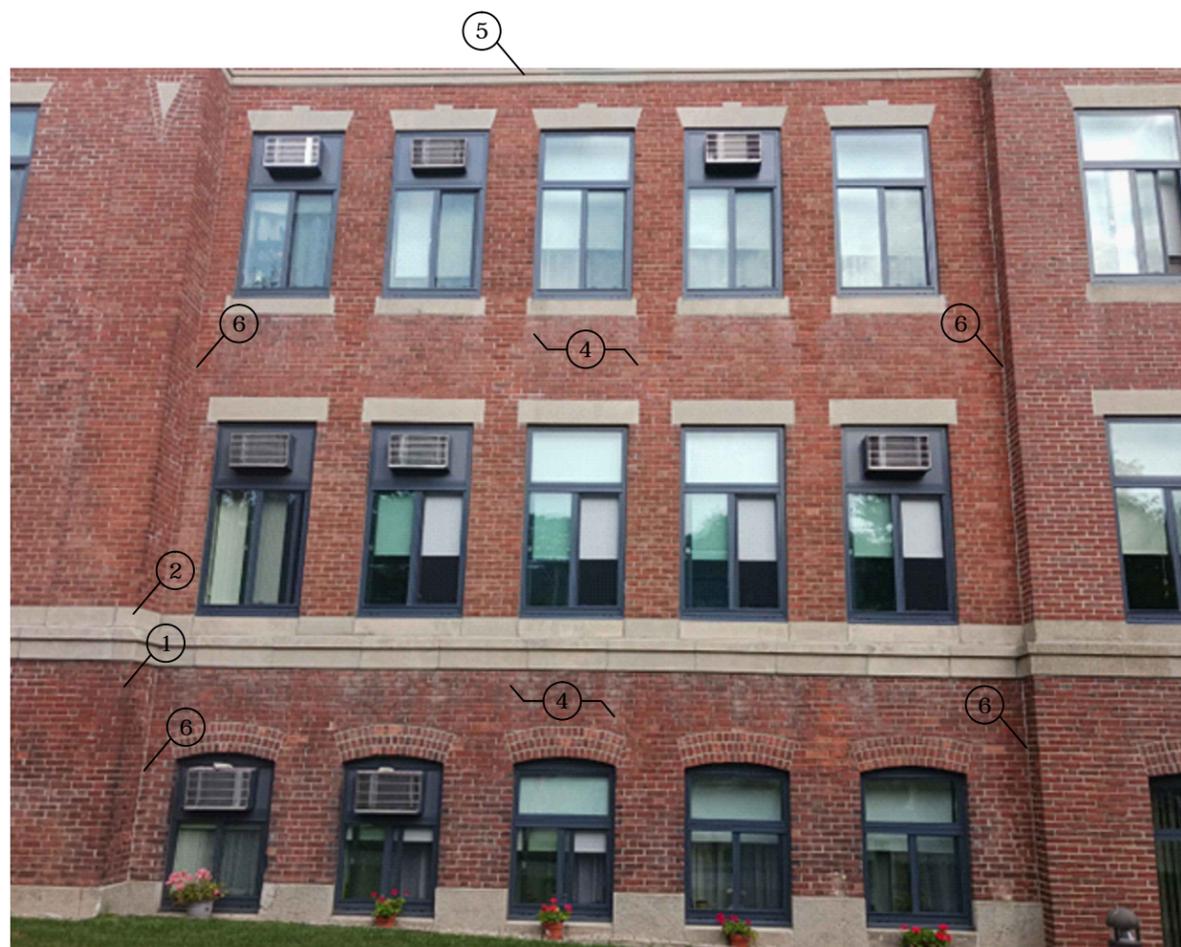
S3 - East Elevation

Deficiency Noted:	Approximate Percentage:
(1)	Isolated
(2)	Isolated
(4)	60%
(5)	50%
(6)	Vertical Masonry Joint

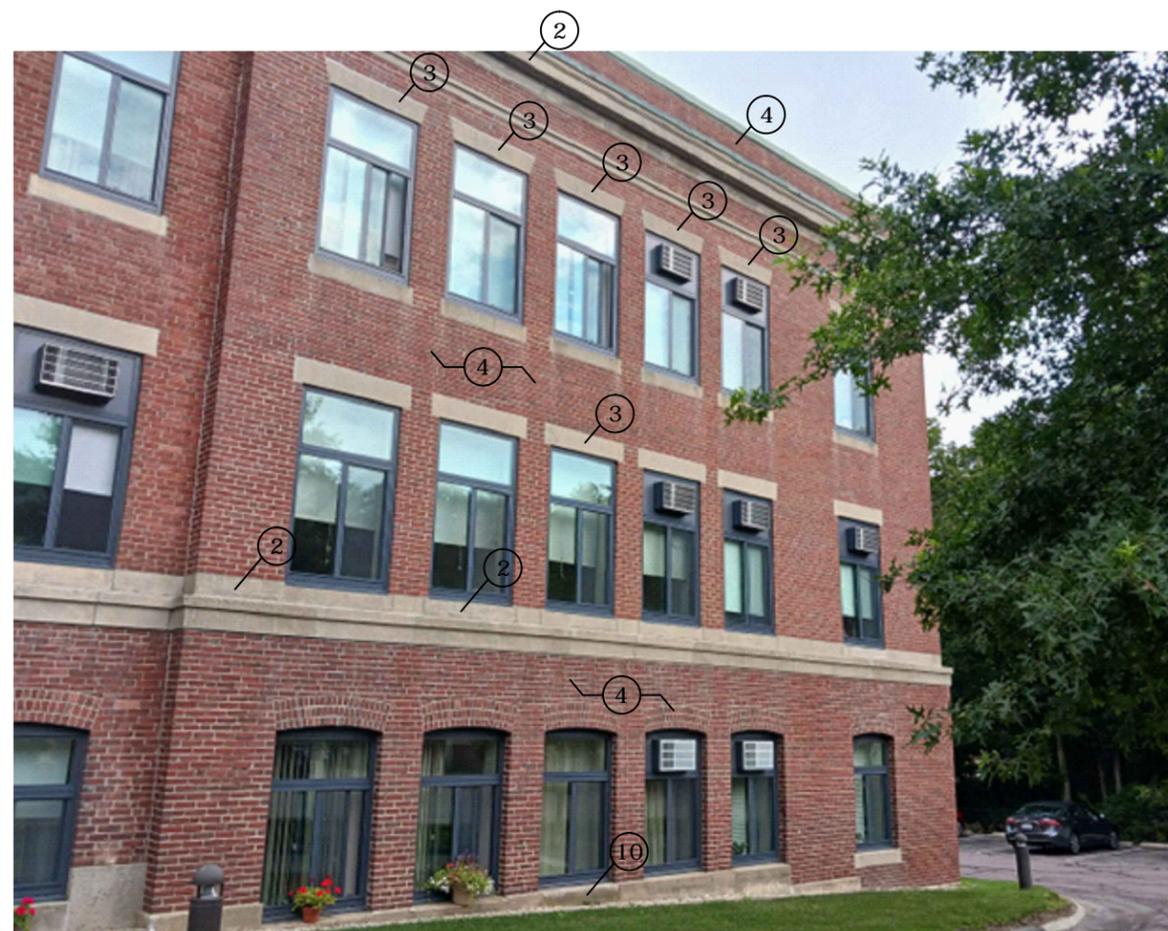
S4 - East Elevation

Deficiency Noted:	Approximate Percentage:
(2)	10% (Random)
(3)	50%
(4)	60%
(10)	70% (Along Foundation)

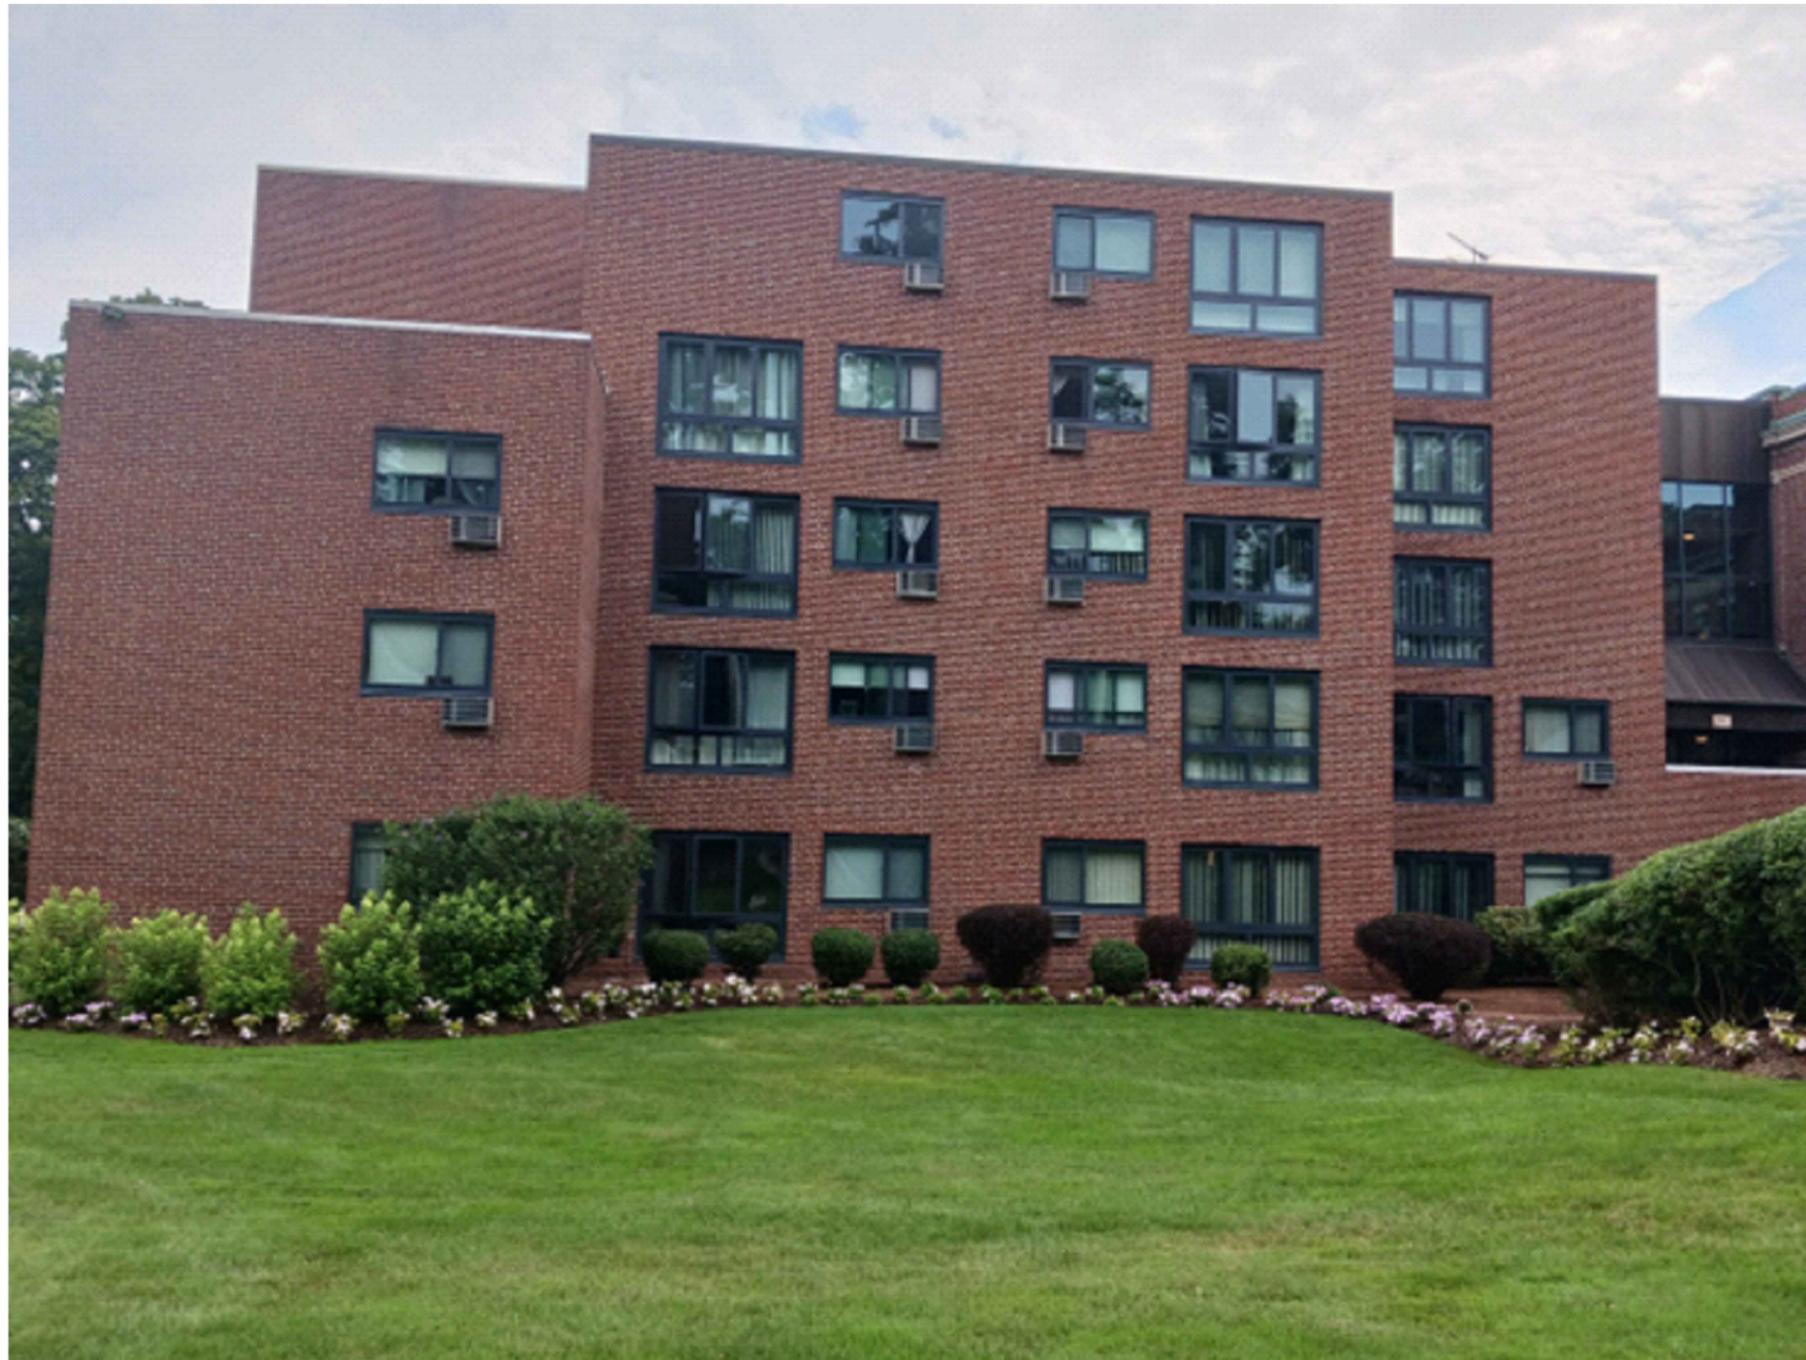
E1 - East Elevations

Deficiency Type:	Approximate Percentage:
④	05% (At Steel Lintels)
⑦	100% (Parapet Wall Coping)
⑧	10% (Vert. Wall Control Joint)
⑨	10% (Efflorescence)

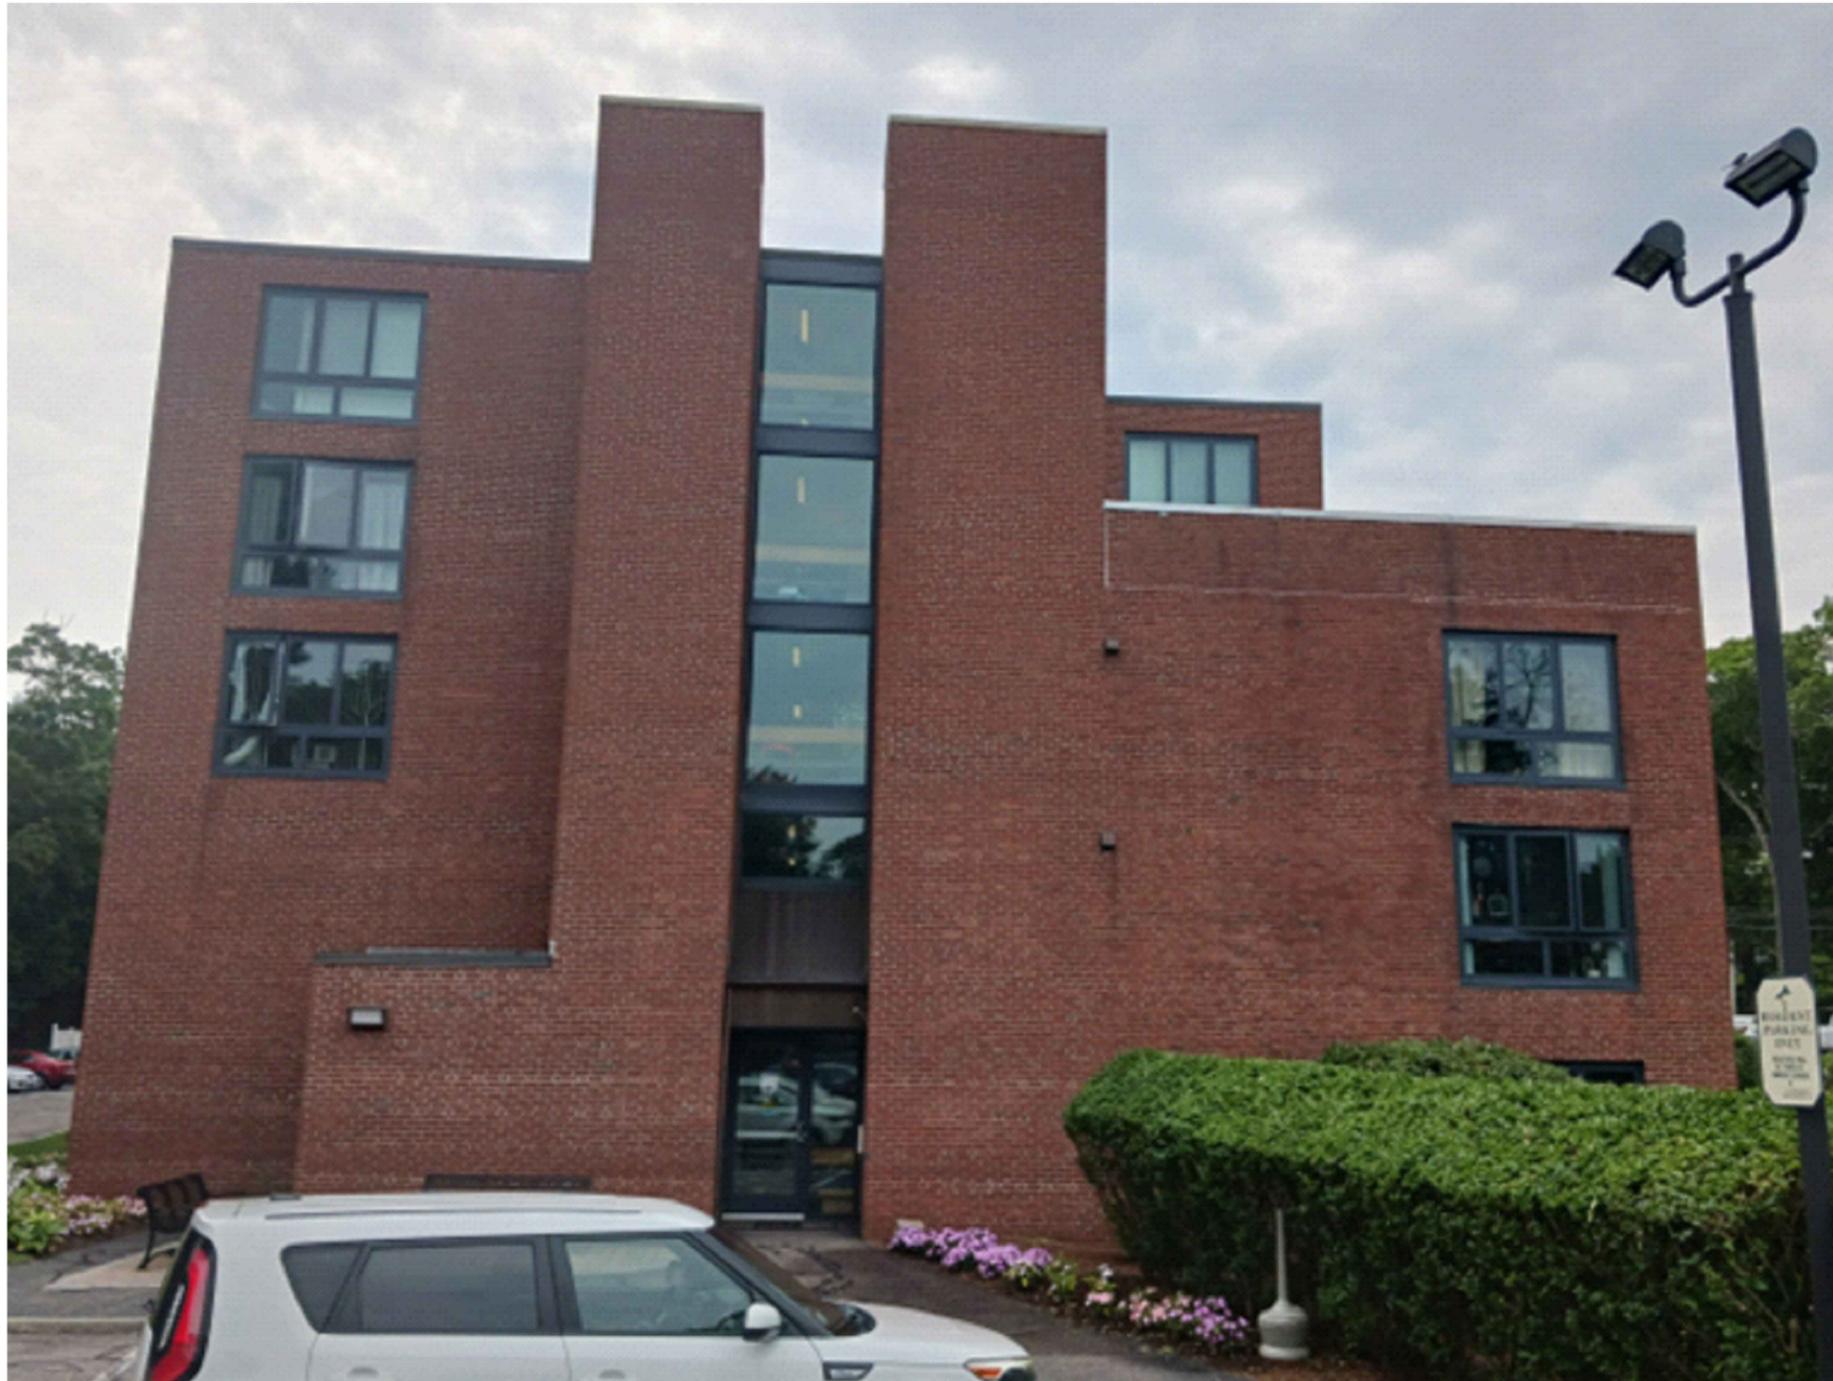
N1 - East Elevation

Deficiency Noted:	Approximate Percentage:
①	05% (At Embedded Steel)
④	10% (Random)
⑦	100% (At Parapet Wall)

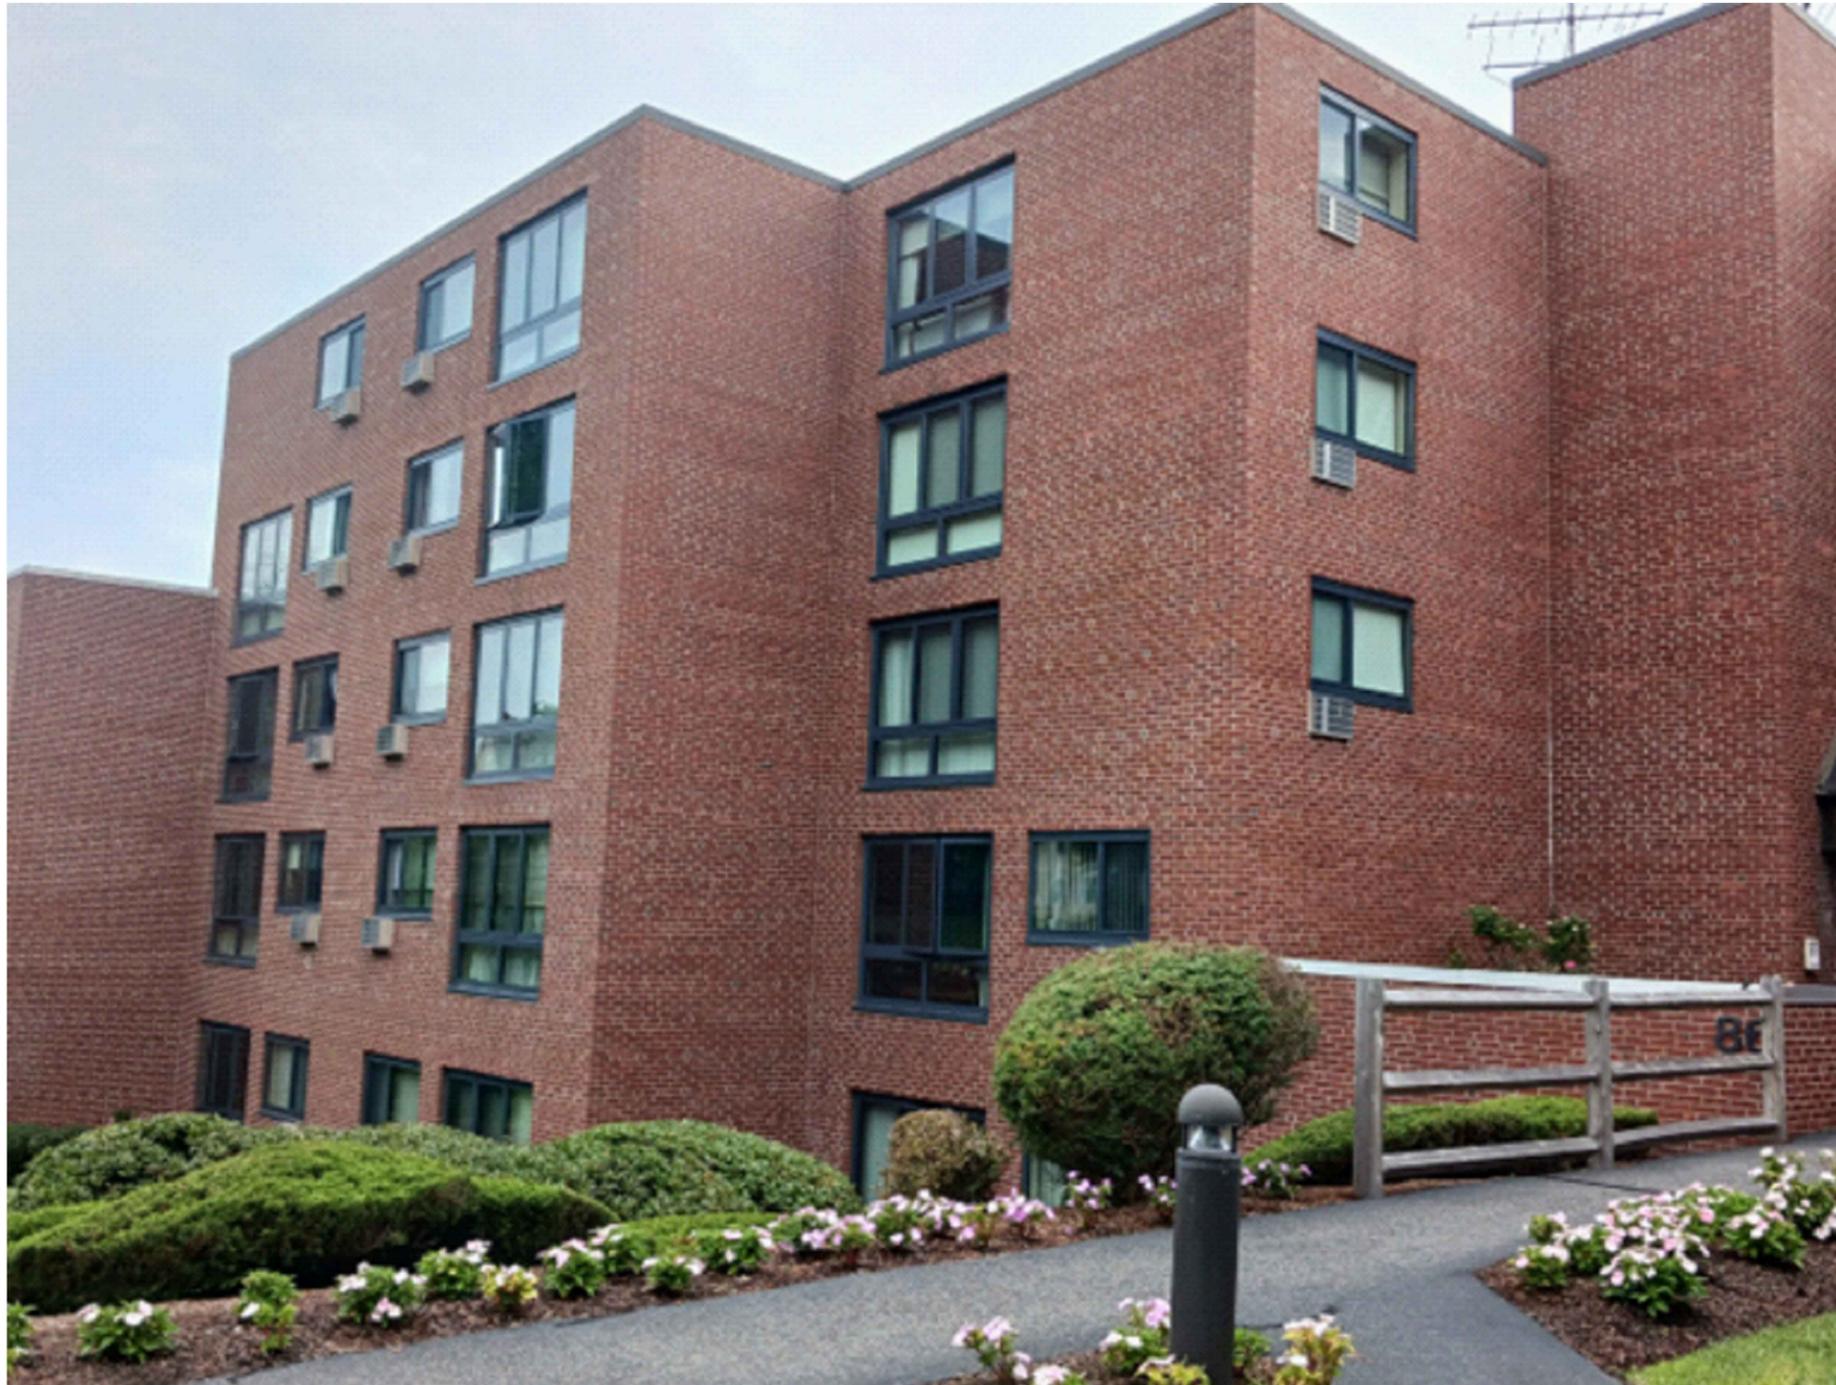
S1 - East Elevations

Deficiency Type:	Approximate Percentage:
④	05% (At Steel Lintels)
⑧	10% (Vert. Wall Control Joint)
⑨	20% (Efflorescence)

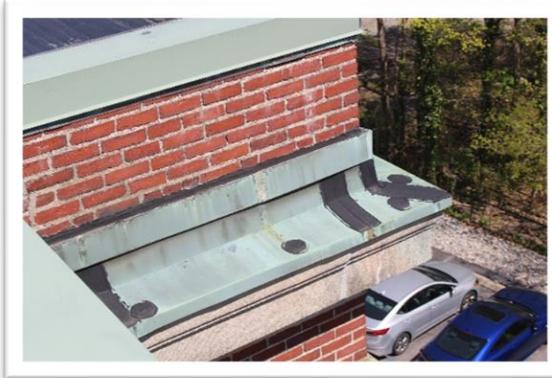
Typical repairs to copper ledge (widespread)

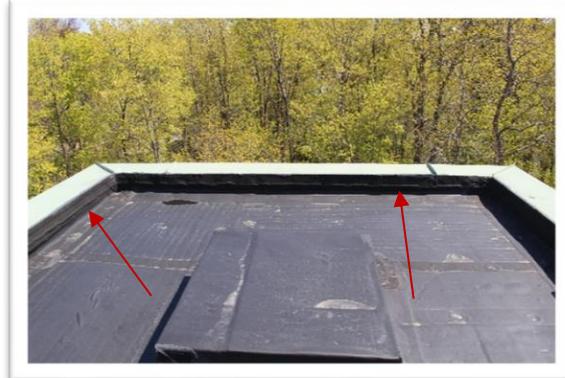
Repair flashing on coping cap

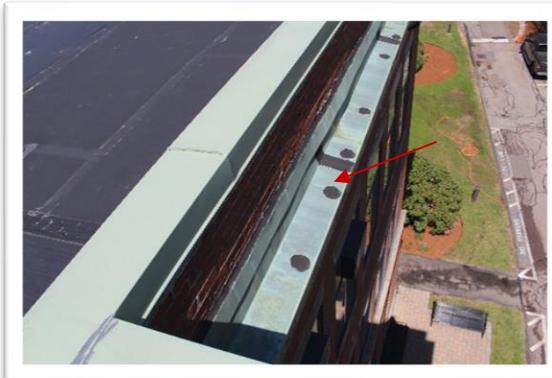
Typical repairs to copper ledge (widespread)

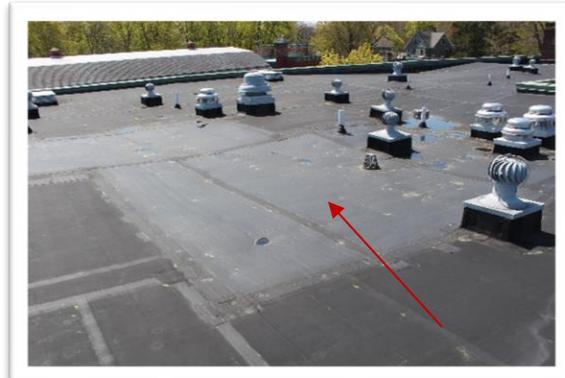
Field patch to membrane

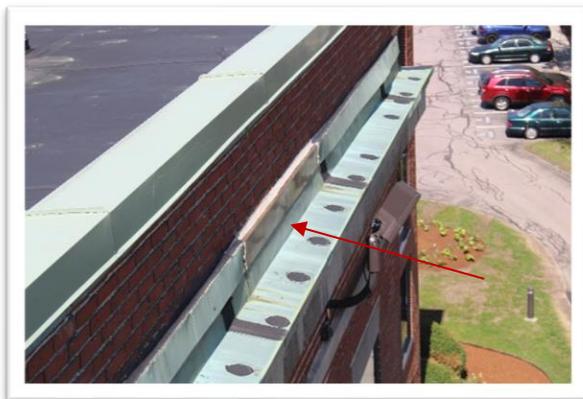
Typical repairs to copper ledge (widespread)

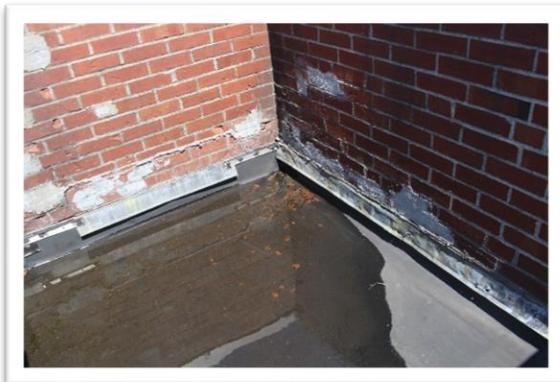
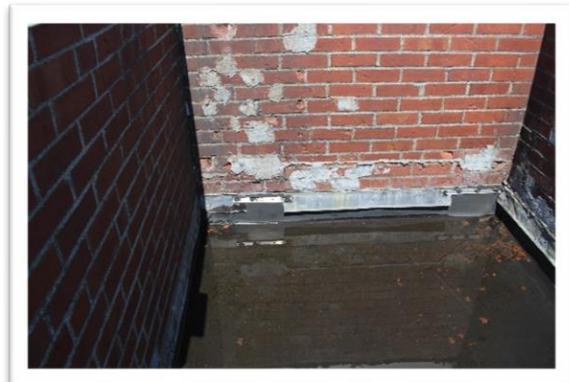
Masonry wall deficiencies – Typical

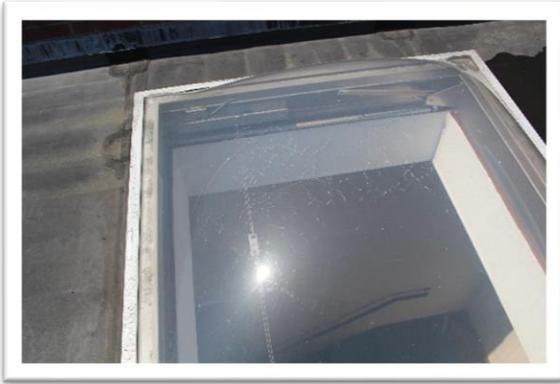
Degraded skylight dome

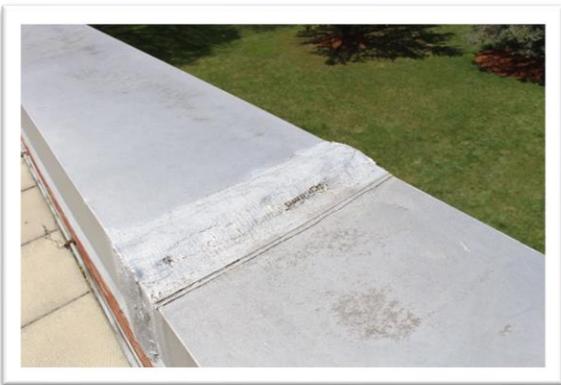
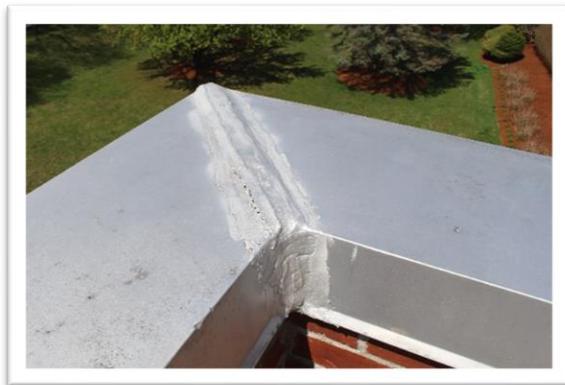
Typical poor repair attempts on the coping cap

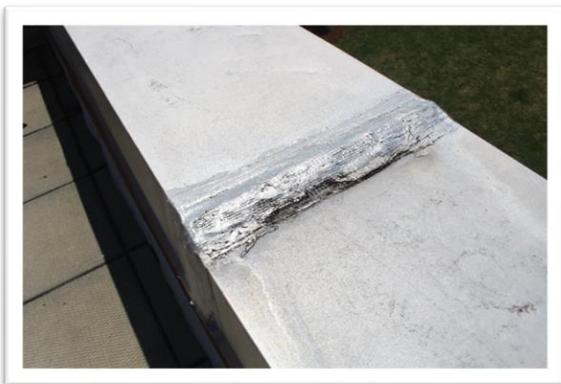
Typical degrading coping cap flashings

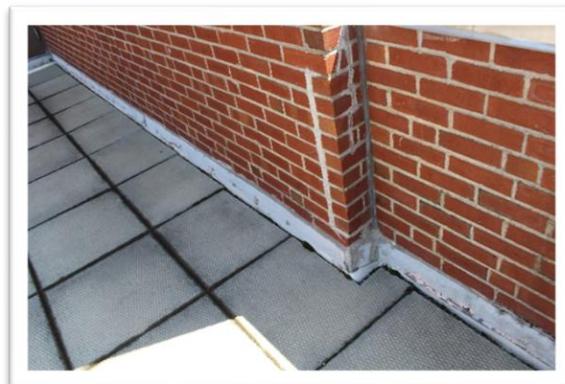
Overview showing minor masonry issues
