# Hingham Recreation: Play Barn at the Plymouth River School

# Play Barn: Exterior

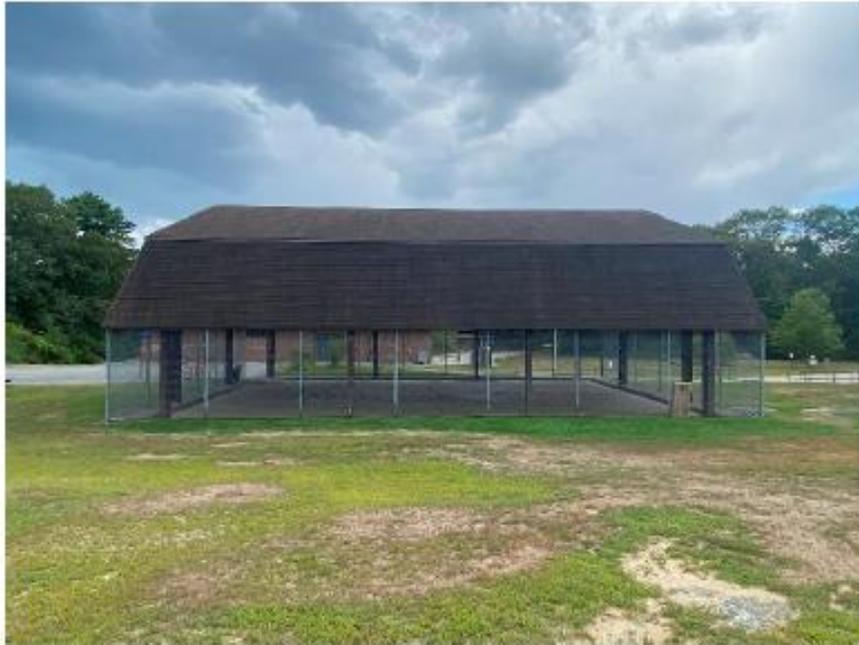
1. North Exterior Façade.

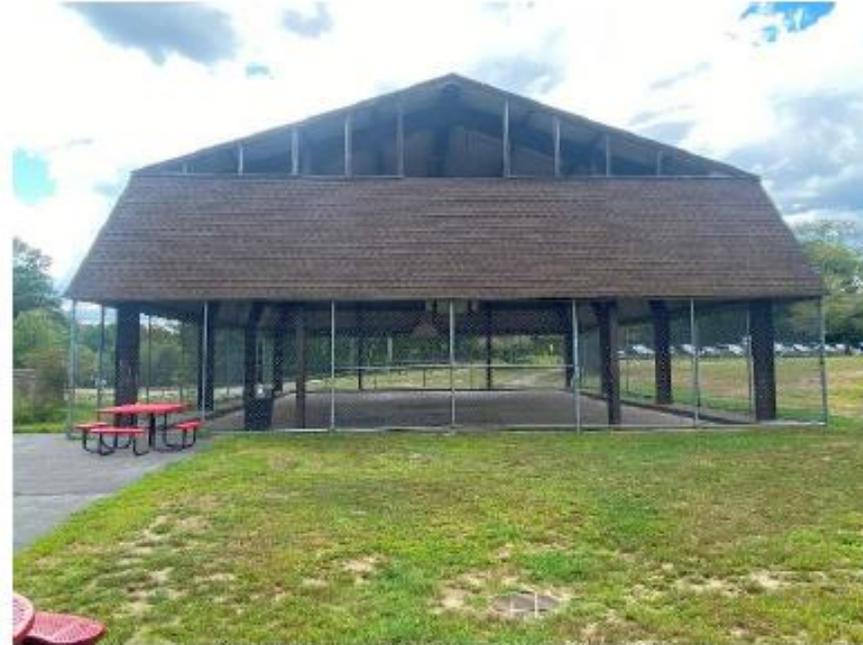
2. East Exterior Façade.

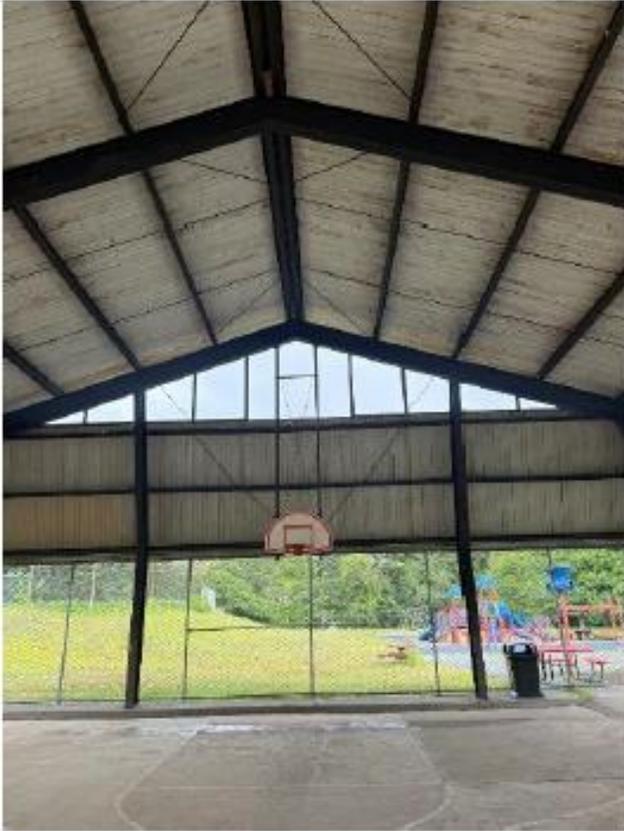
5. East Façade – All but 2 corner polycarbonate window panels missing.

Column repairs		\$100,000.
Asphalt Removal and replacement		\$ 90,000.
Replacement of windows on gable ends		<u>\$ 20,000.</u>
Construction Cost subtotal		\$210,000.
Design and pricing contingency (20%)		\$ 42,000.
Escalation (4%)		\$ 8,400.
General conditions (6%)		\$ 12,600.
Permit (1%)		\$ 2,100.
Overhead and Fee (4%)		<u>\$ 8,400.</u>
Total Construction Cost		\$283,500.
Design and permitting fee*		\$ 60,000.
Total Project Cost		\$343,500.

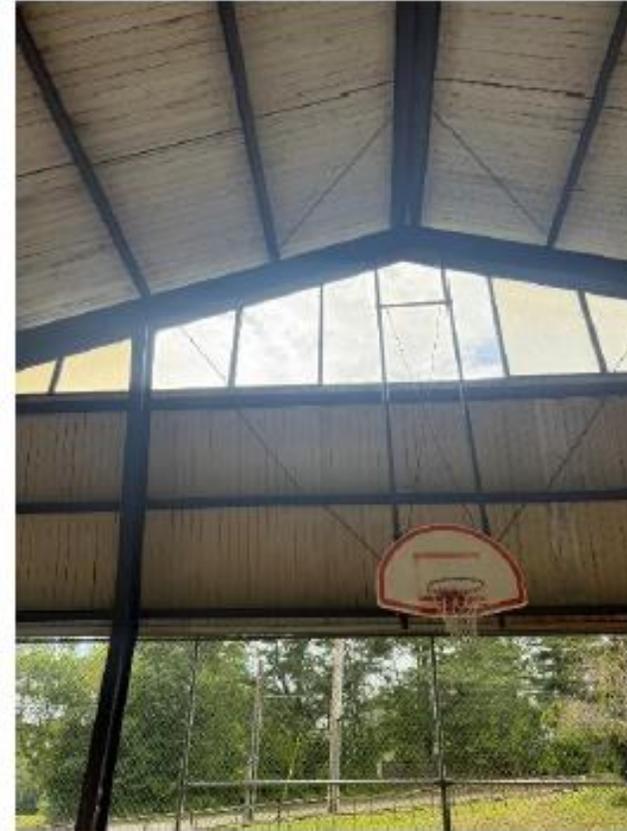
6. West Façade - 3 polycarbonate window panels missing.

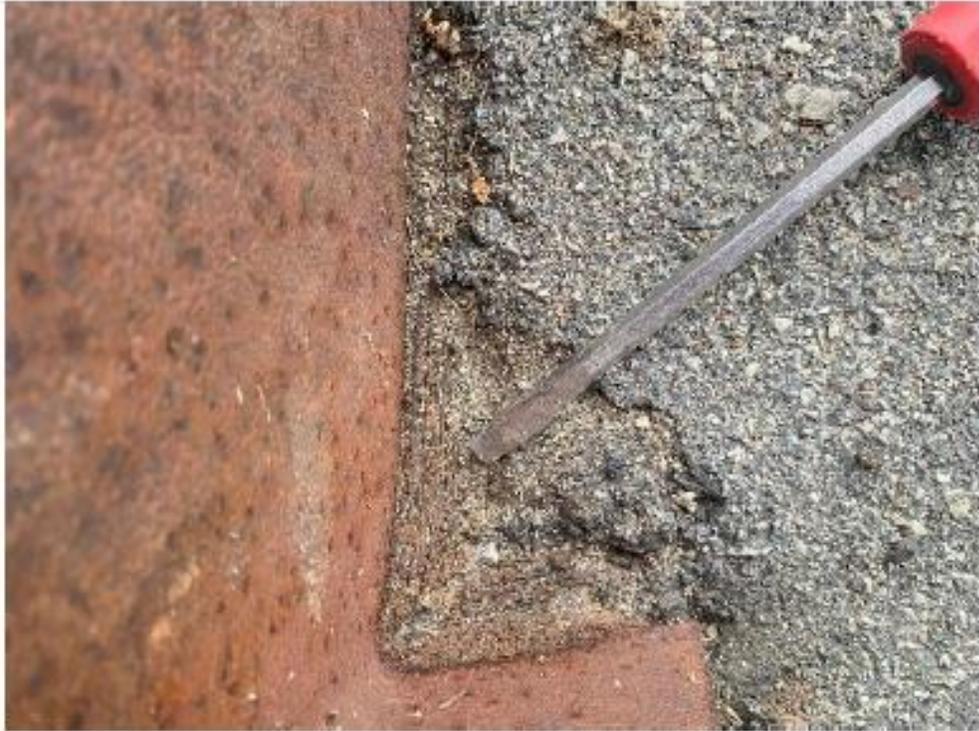
7. Column A2 - exfoliated rust at inside flange.

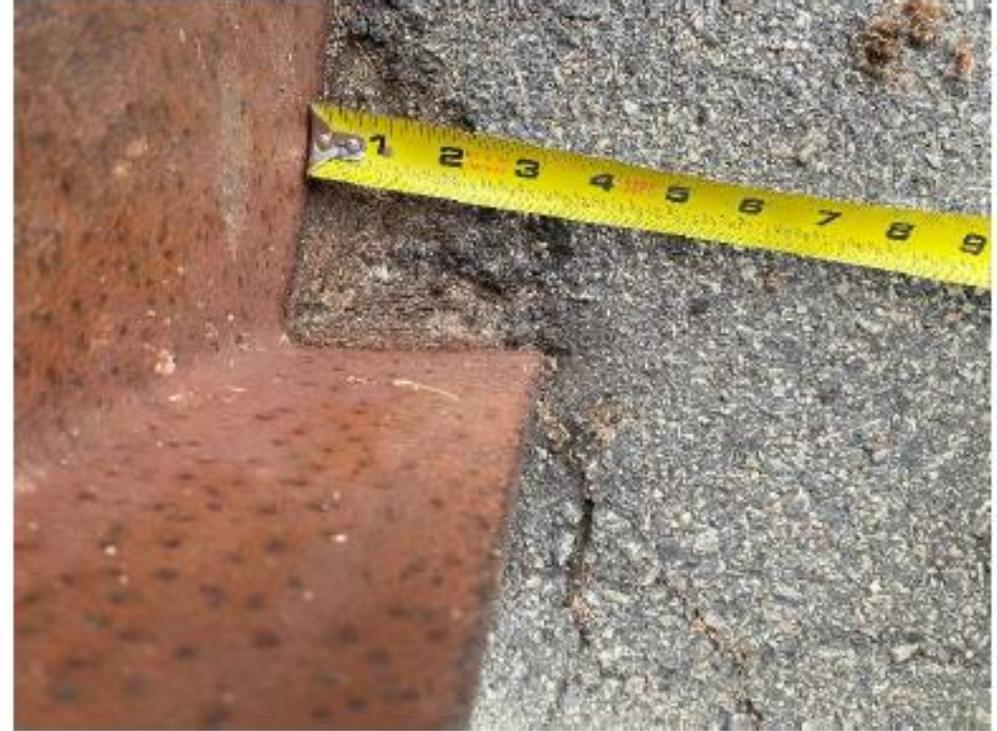
8. Column A2 - exfoliated rust at inside flange.

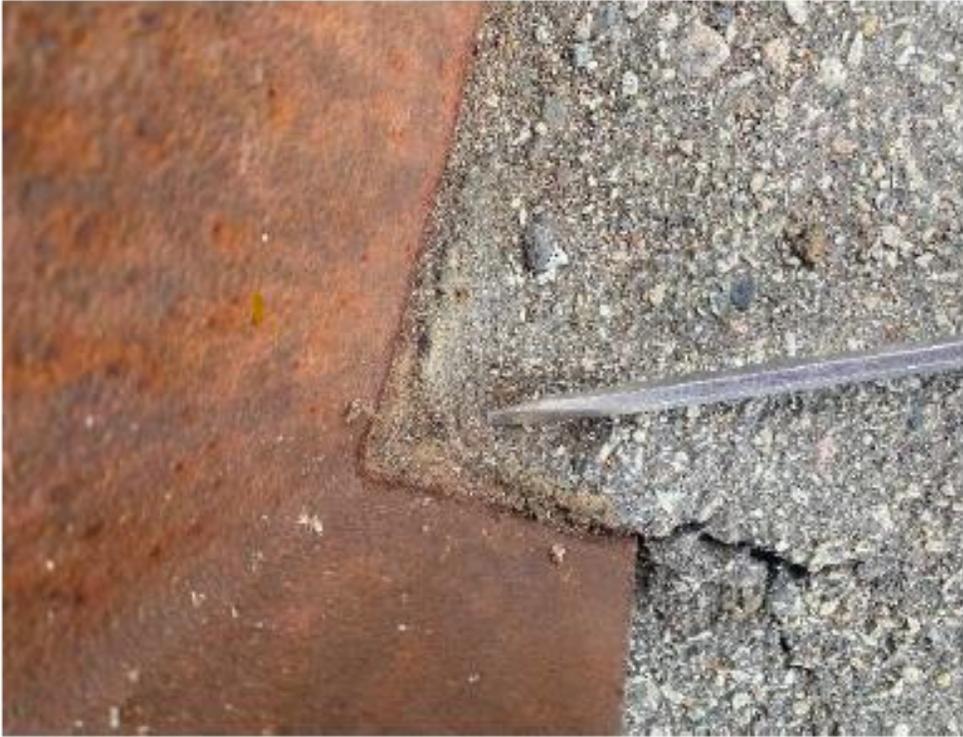
13. Column B1 - exfoliated rust at inside flange.

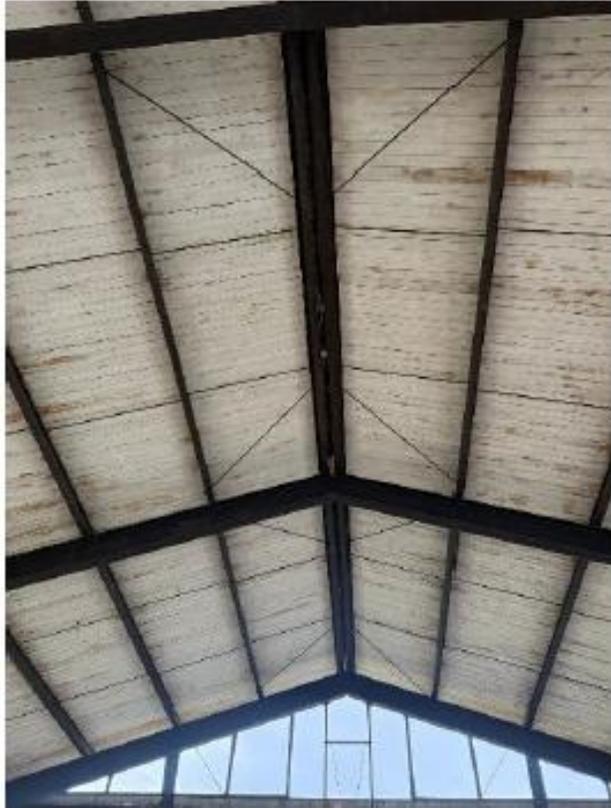
30. Wood Deck – Overall.

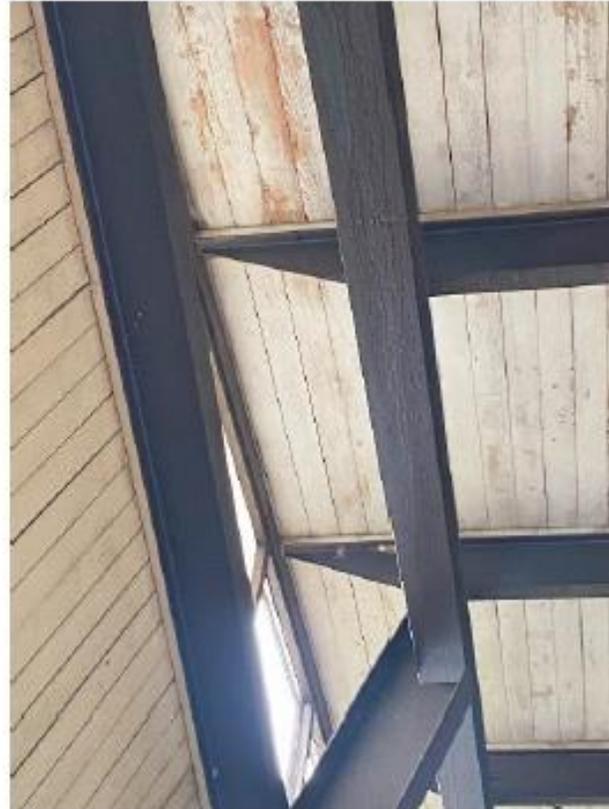
31. Wood Deck – Overall.

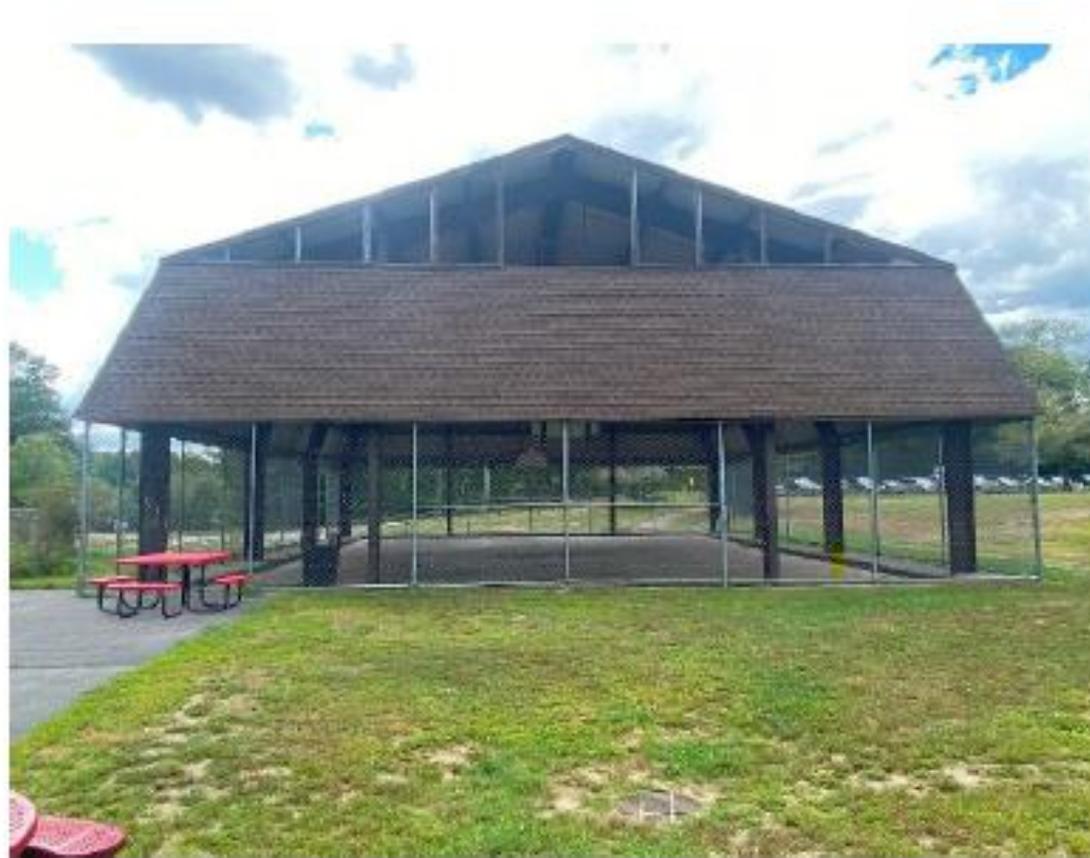
2. East Exterior Façade.
