HINGHAM AFFORDABLE
HOUSING TRUST FY 2027
CPA FUNDS REQUEST

Hingham Affordable Housing Trust

In late June of 2023, BEA performed a Building Envelope Inspection at Lincoln School Apartments in Hingham, Massachusetts. The purpose of this Condition Survey was to assess the condition of the building envelope components and identify exterior deficiencies. The report summarizes our findings, conclusions, recommendations, and associated repair/restoration cost budget estimates.

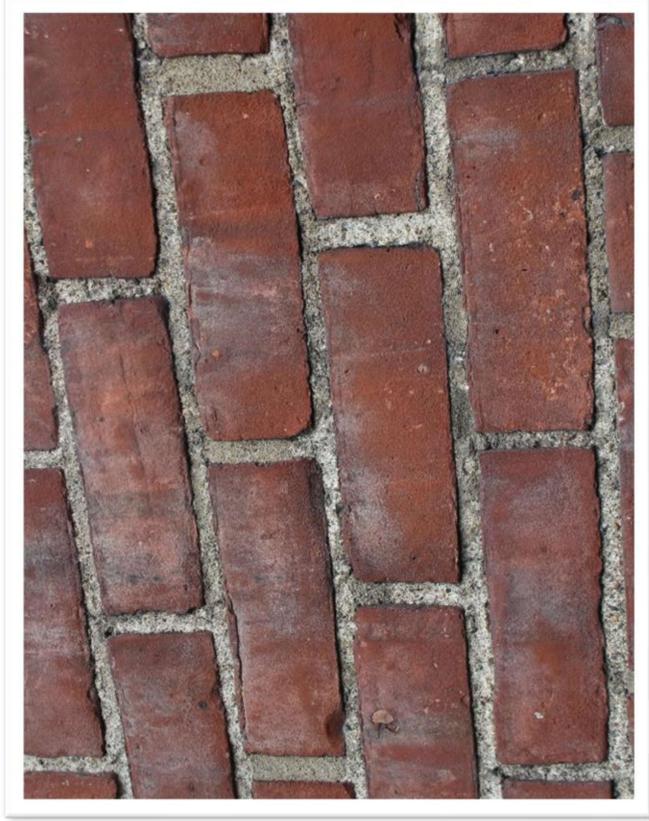
Photo 6: Close-up photo shows typical condition of aging and weathered brick mortar joints.

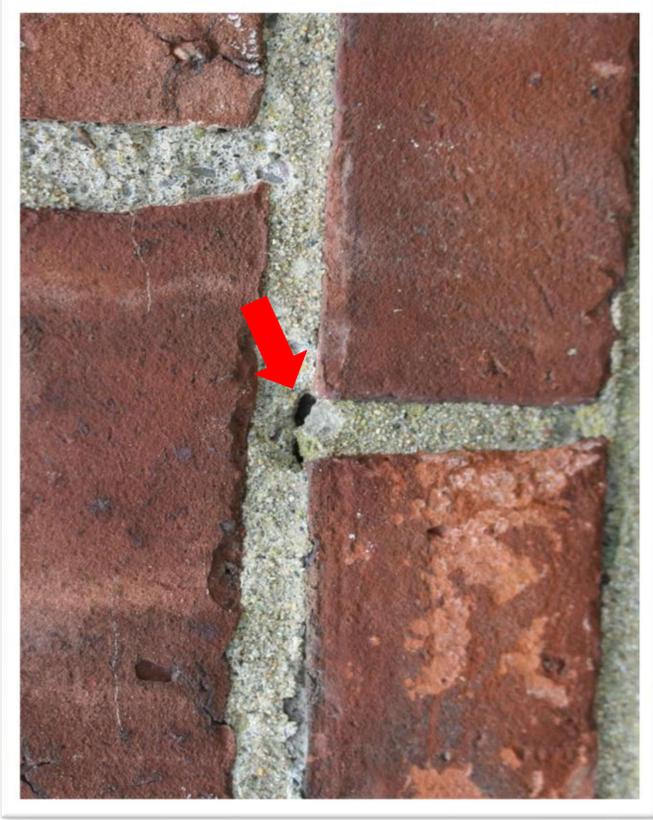
Photo 7: Small holes and voids in brick mortar observed throughout historic facade.

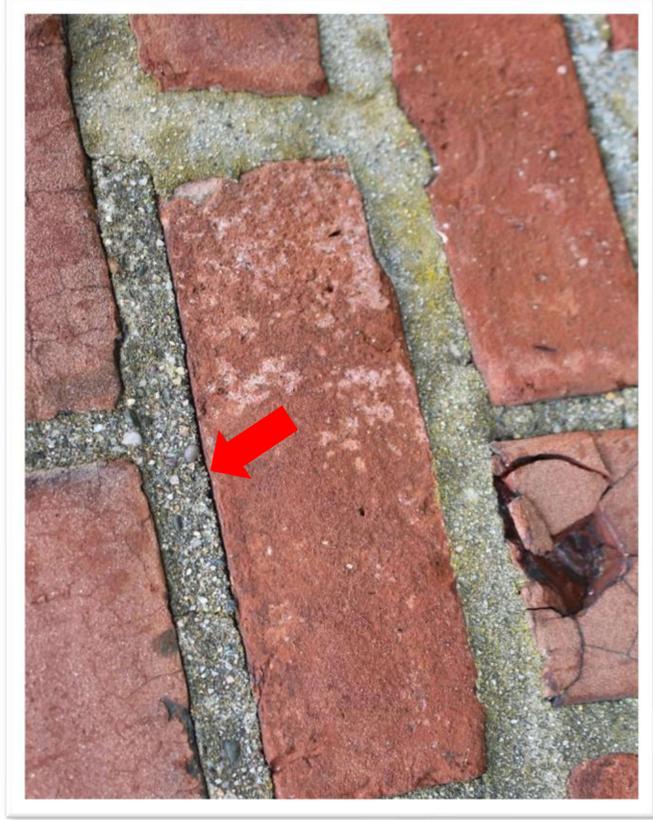
Photo 8: Moderate mortar deterioration and subsequent separation/damage along brick joint observed.

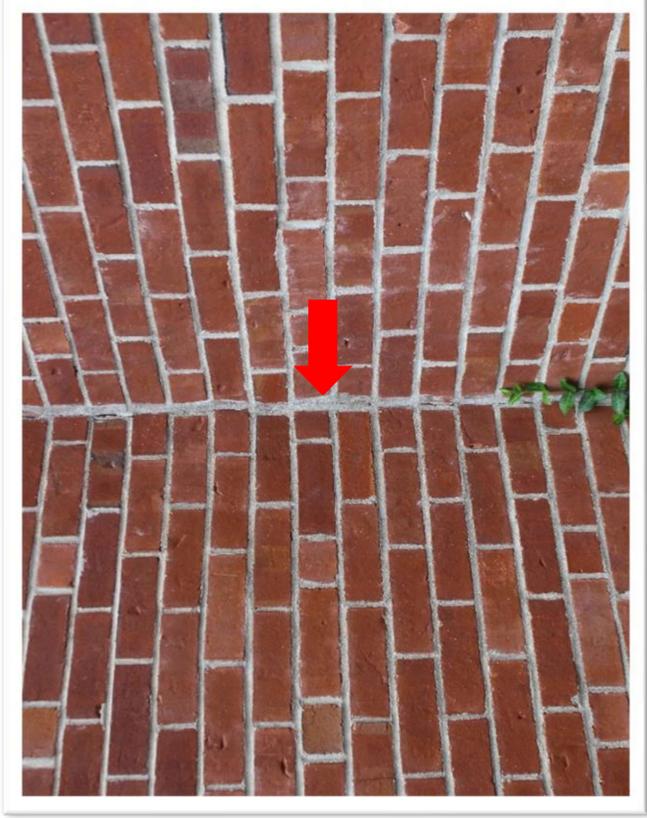
Photo 10: Mortar deterioration and subsequent separation along vertical wall joint.

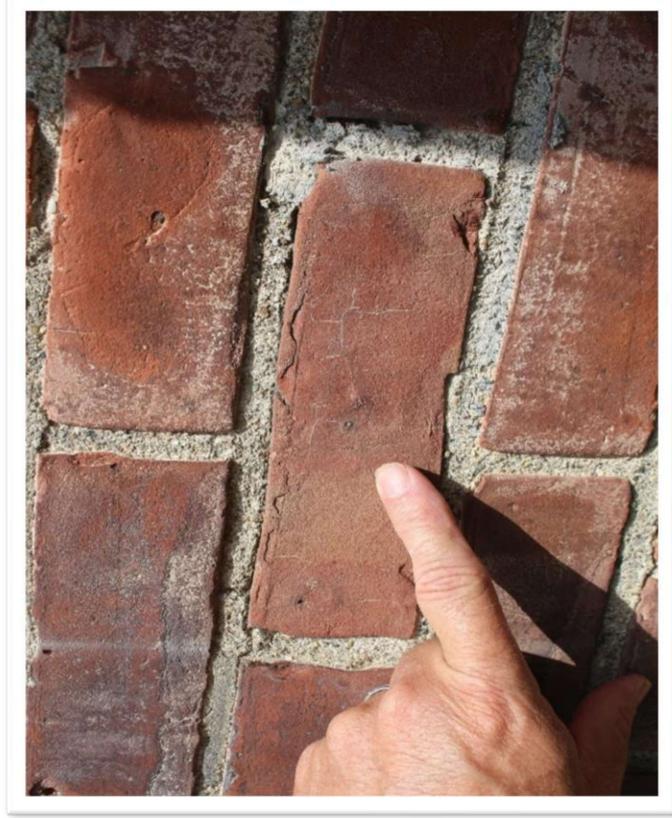
Photo 11: The majority of old brick was observed in fair condition.

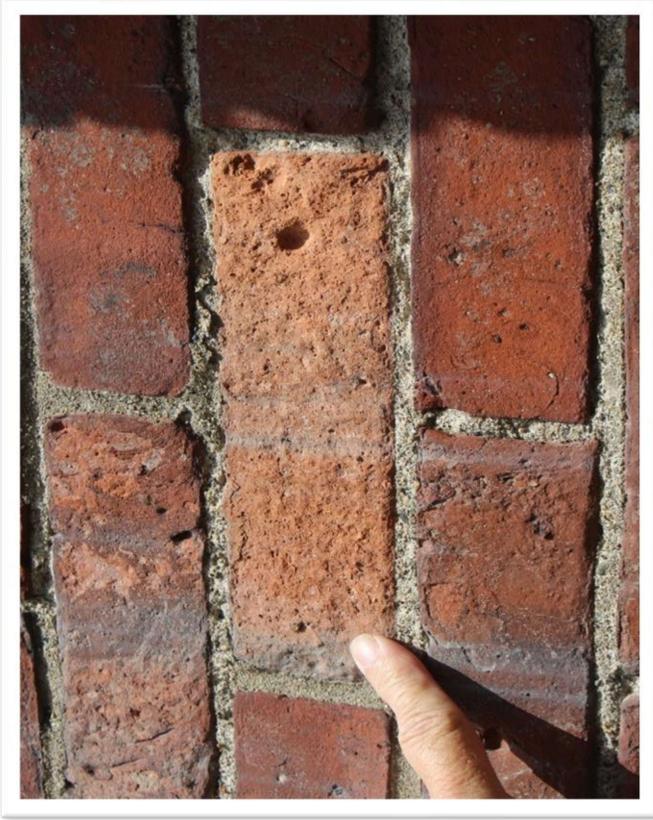
Photo 12: Random brick deterioration was observed at certain building elevations.

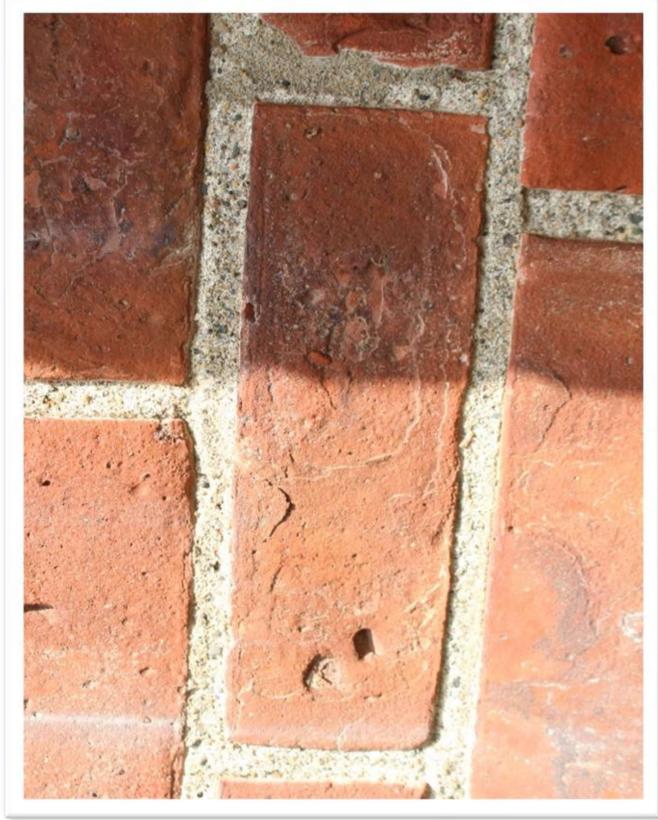
Photo 13: The historic bricks is in various stages of surface deterioration.

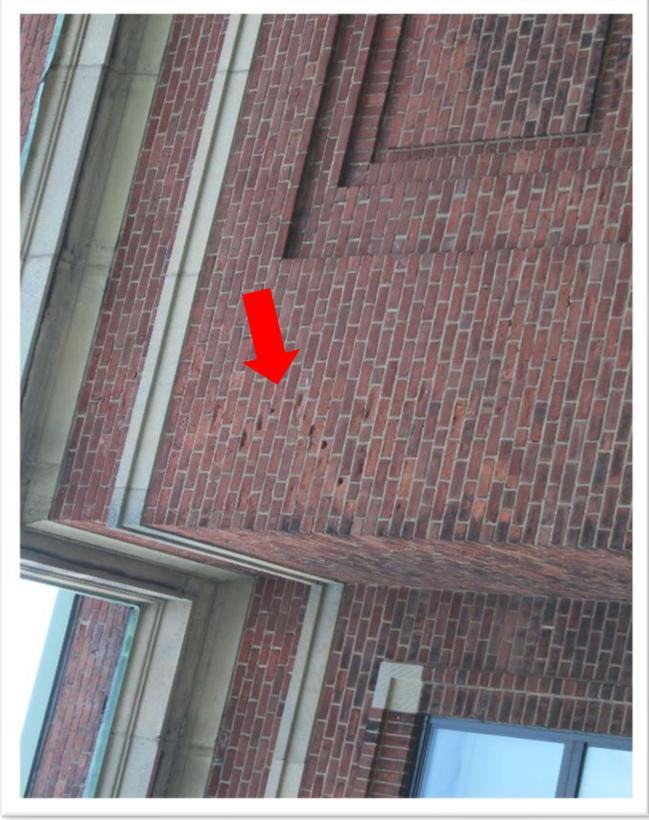
Photo 14: One of several locations of spalling brick observed along the building's south elevation.

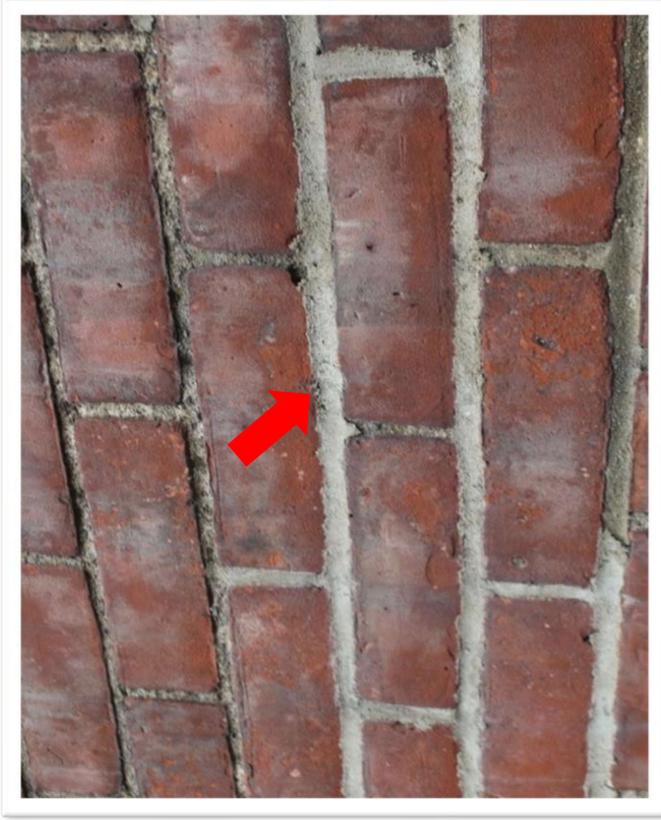
Photo 15: Locations of improper mortar joint repairs were observed, where deteriorated mortar joints were overlaid with new mortar, in lieu of proper cutting and repointing techniques.

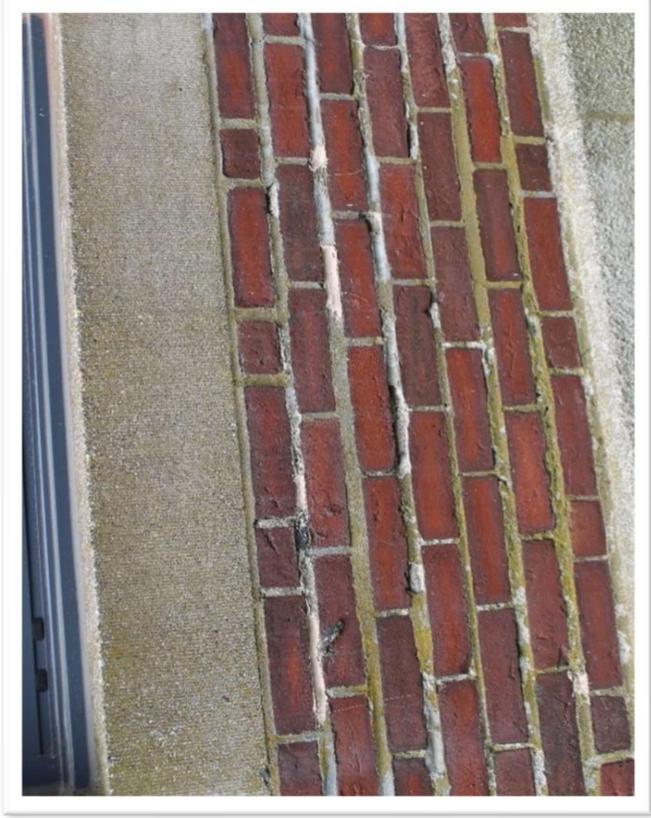
Photo 16: Typical condition observed at locations where improper masonry repairs were performed.

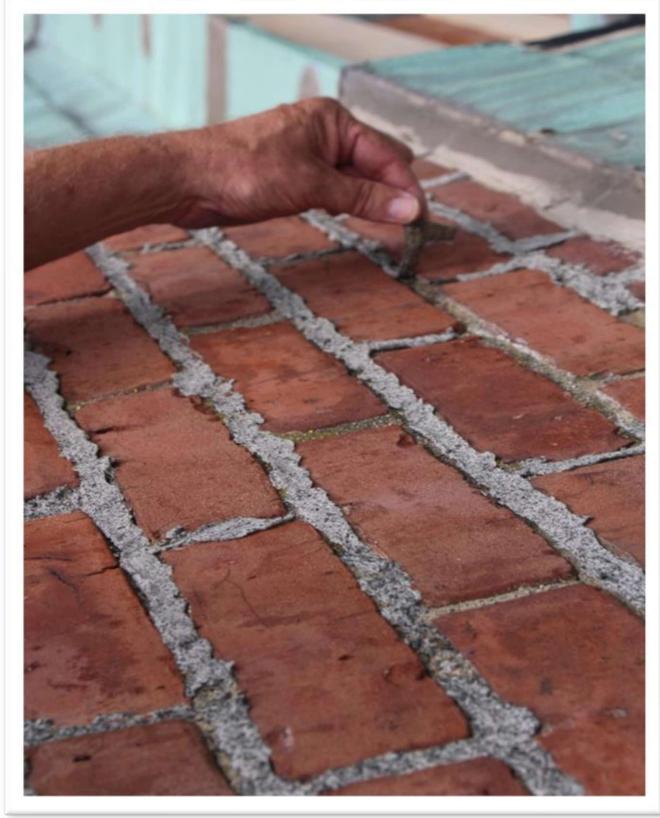
Photo 17: Improper repair material used at numerous locations.

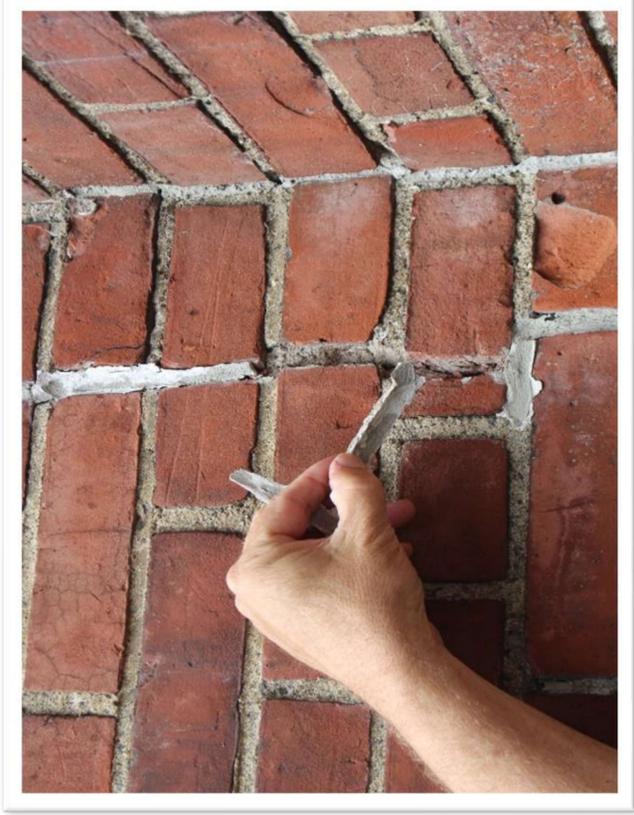
Photo 18: At most locations, the repair material easily peels away from the repair area.

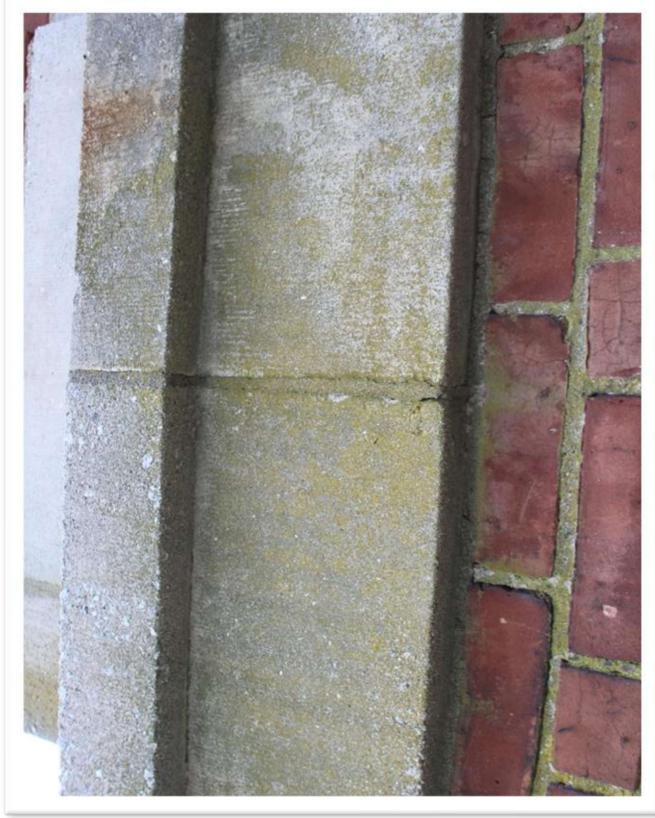
Photo 22: A large percentage of existing mortar joints along the precast cornice and bands were noted in poor condition, exposing underlying masonry to water infiltration.

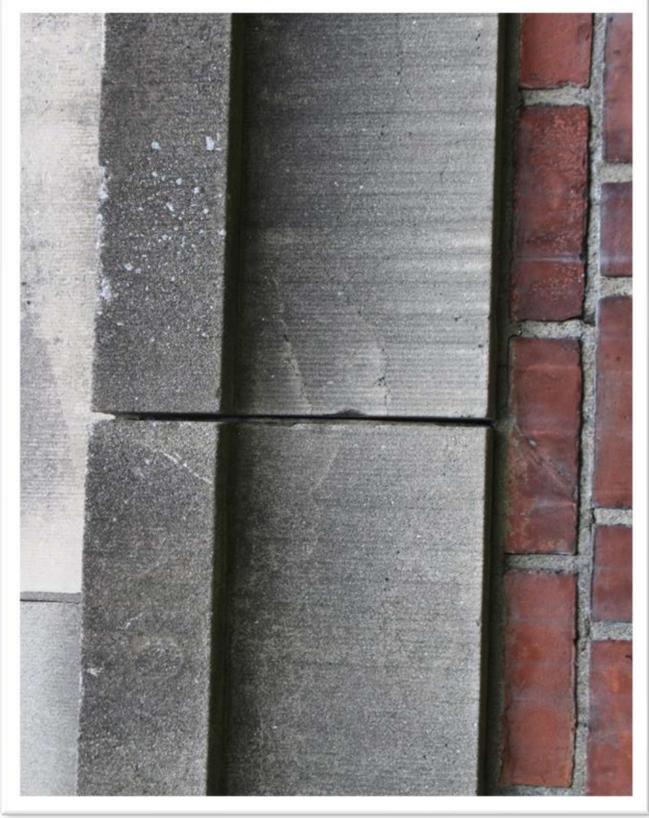
Photo 23: Numerous hole and voids observed in precast concrete mortar joints.

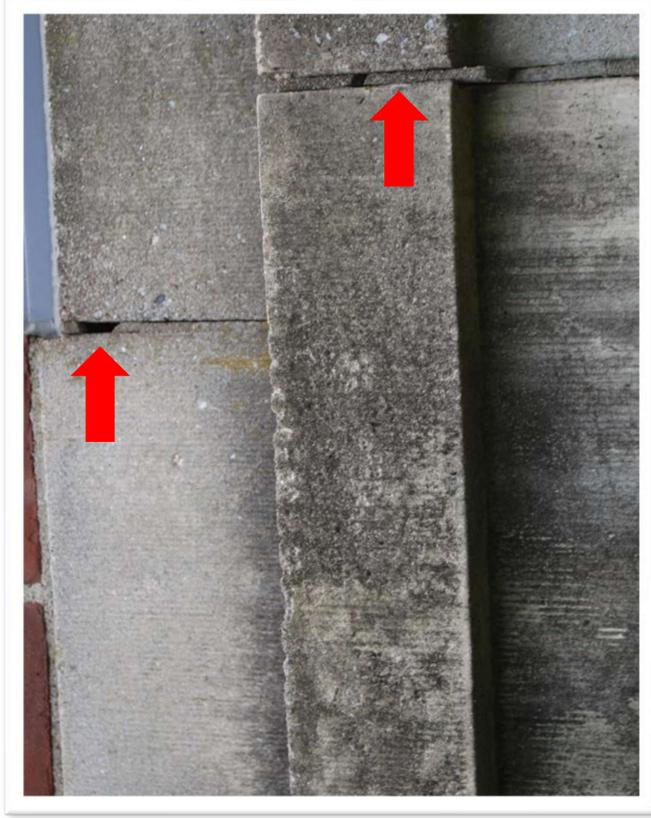
Photo 24: Improper precast concrete mortar joint repairs.

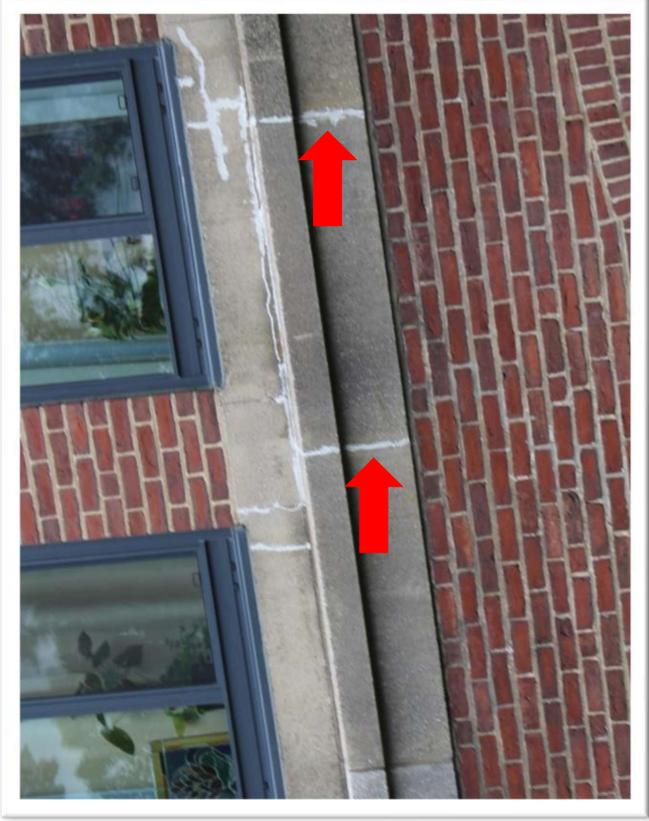
Photo 25: Random locations of deteriorated/defective precast observed along cornice/upper band.

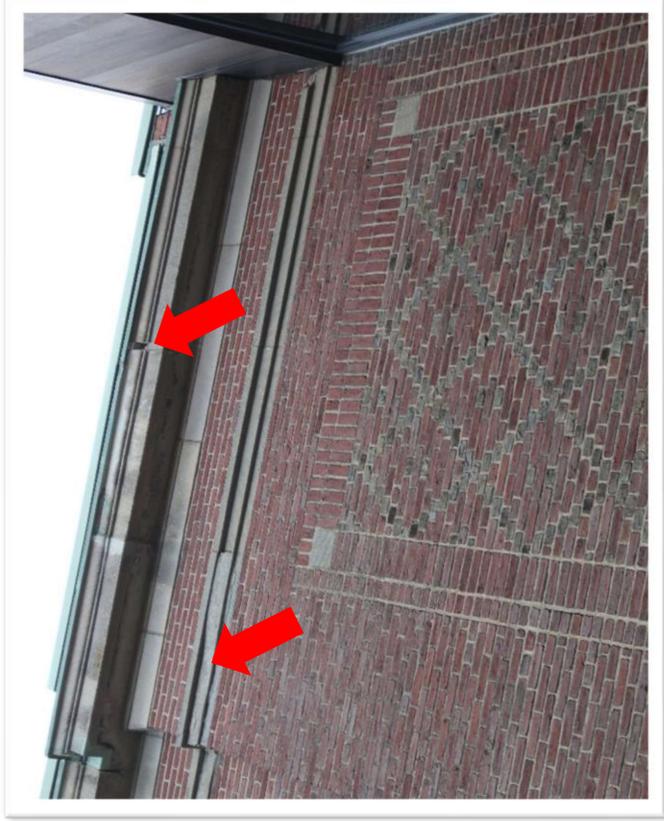
Photo 26: Deterioration and spalling sections/portion of precast concrete randomly observed.

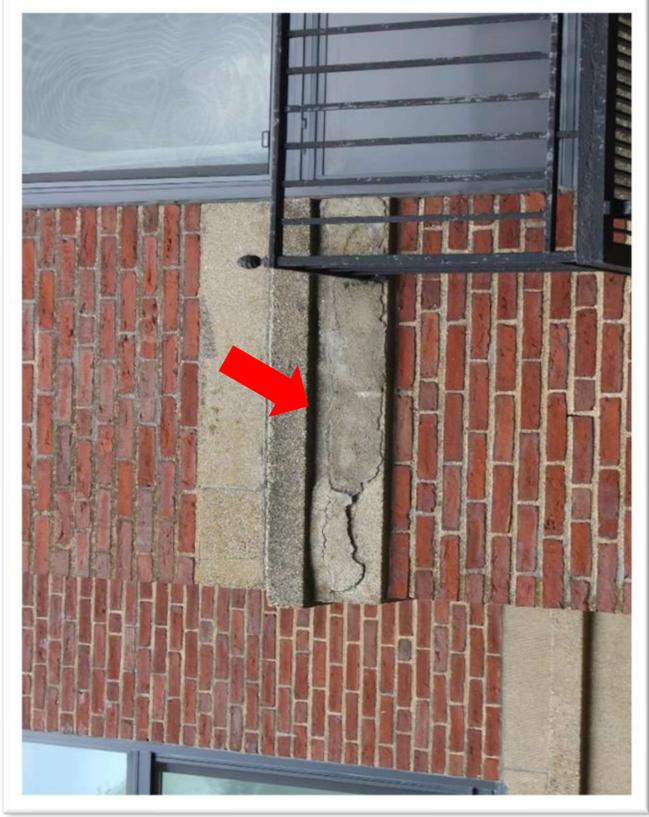
Photo 27: Many sections of defective precast have been improperly repaired with caulking.

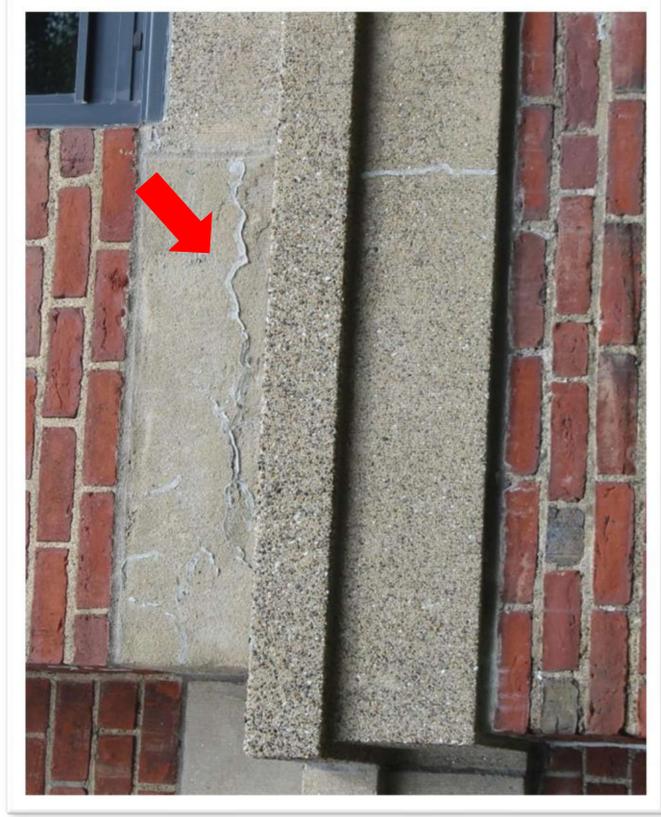
Photo 28: Cracked and chipped precast concrete randomly observed.

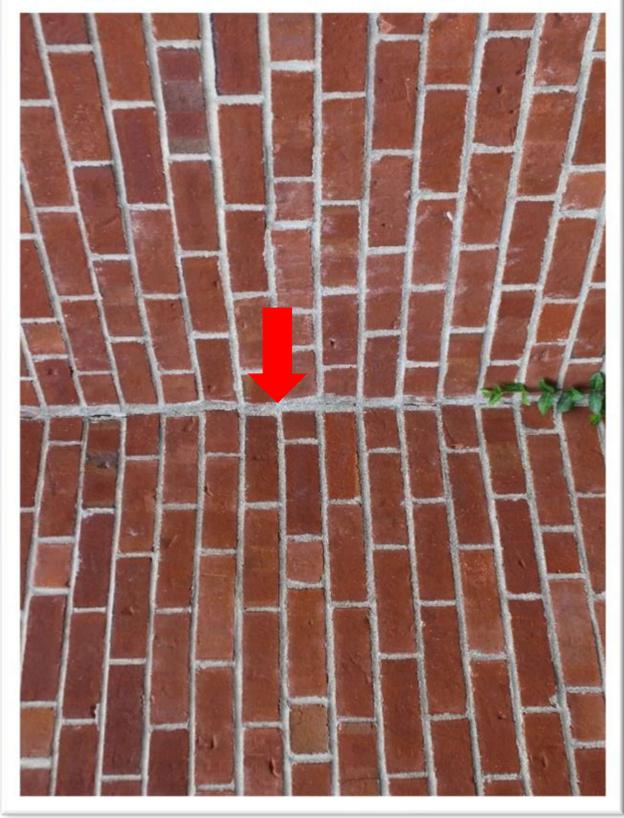
Photo 32: Photo shows one a several defective vertical brick mortar joints.

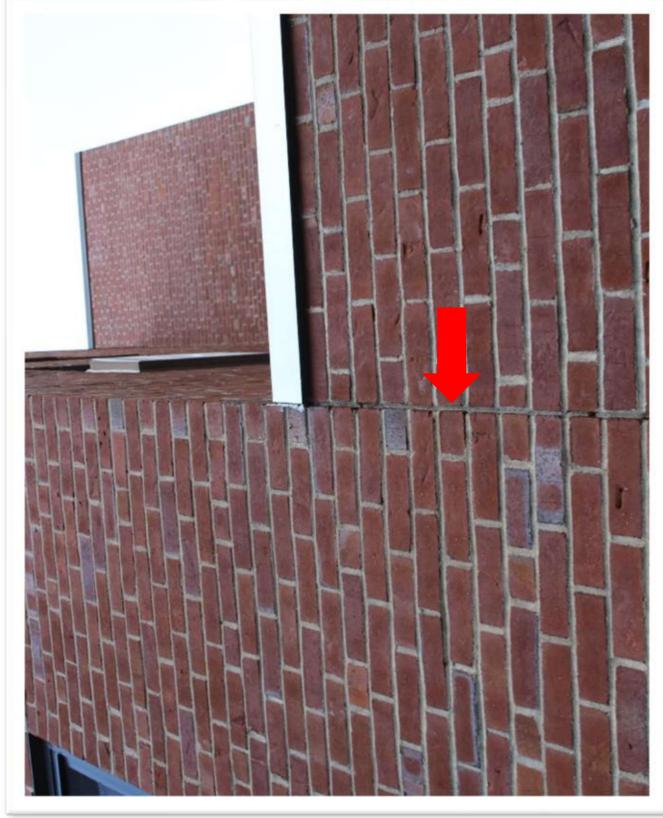
Photo 33: Photo shows defective brick mortar joint at roof parapet wall.

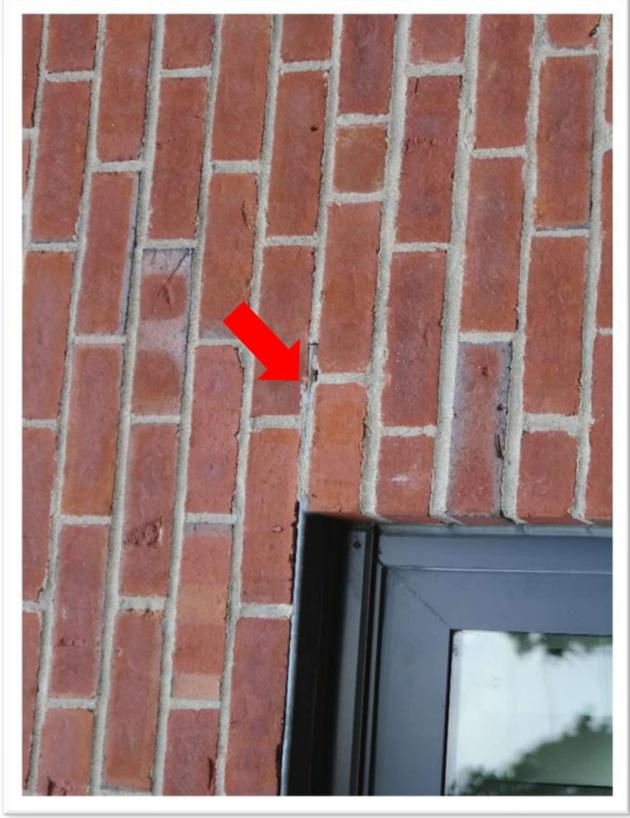
Photo 34: Photo shows exposed steel lintel at brick mortar joint.

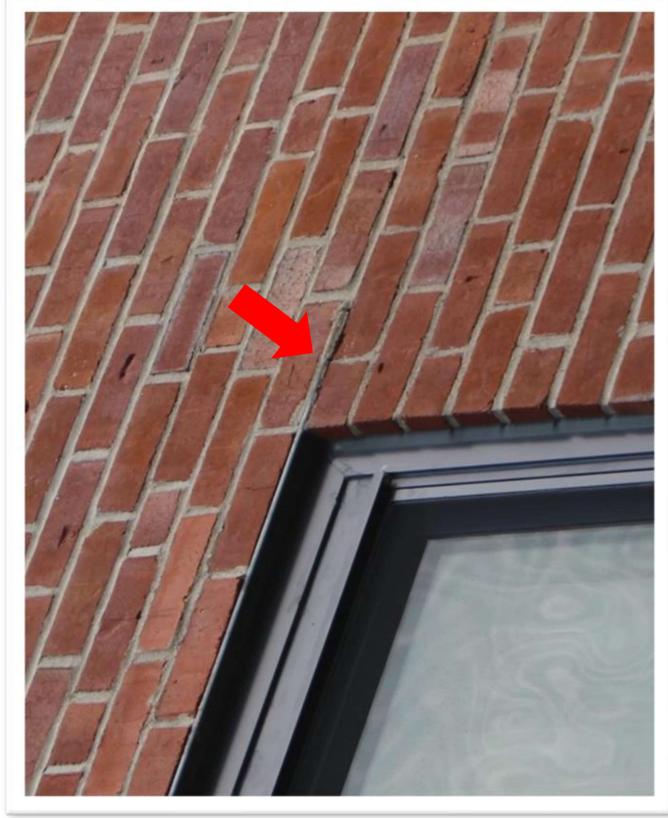
Photo 35: Photo shows portion of loose mortar at steel lintel (randomly observed).

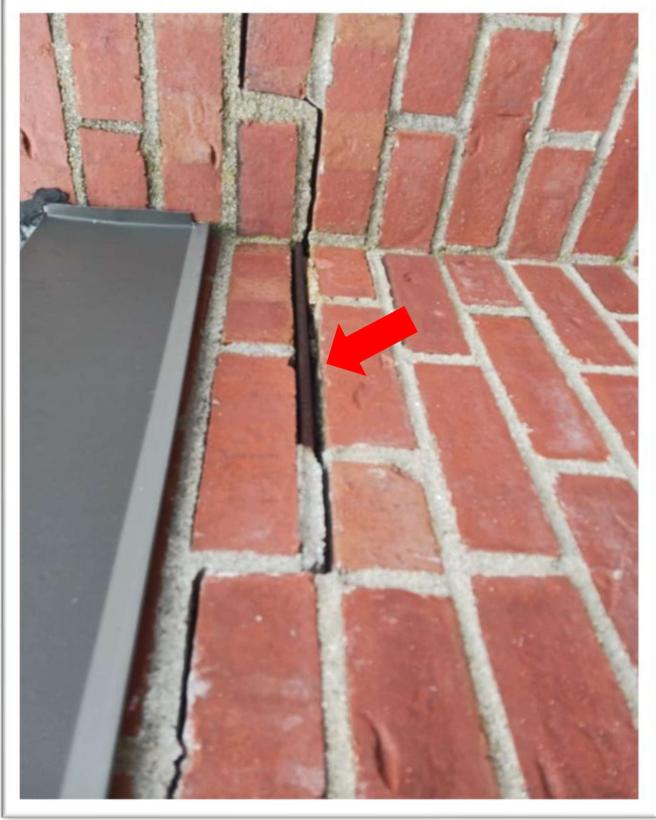
Photo 36: Embedded rusting steel beam in brick masonry wall.

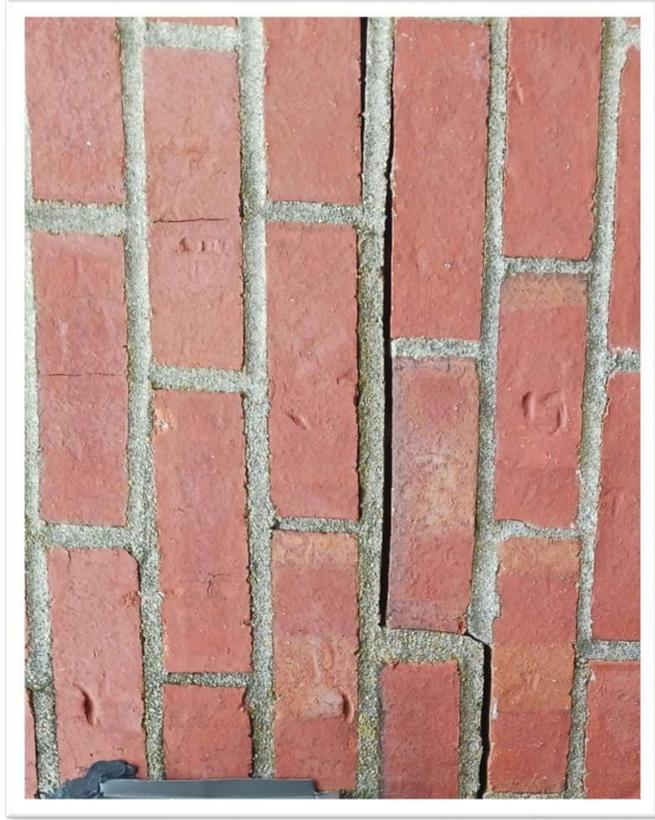
Photo 37: Known as "jaxing" when steel forms rust and expands up to six times its volume, it can cause subsequent and damage to surrounding brick masonry.

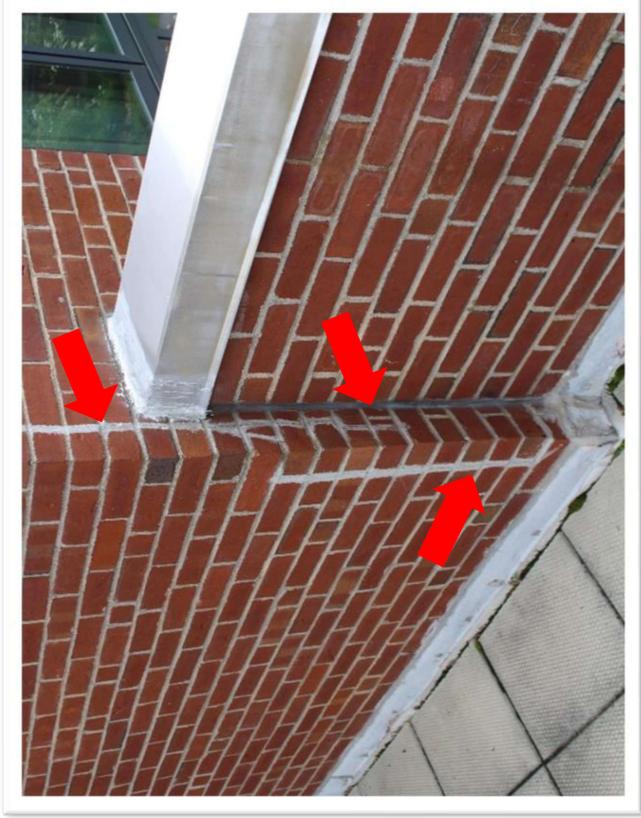
Photo 38: Random brick masonry repairs using caulking observed.

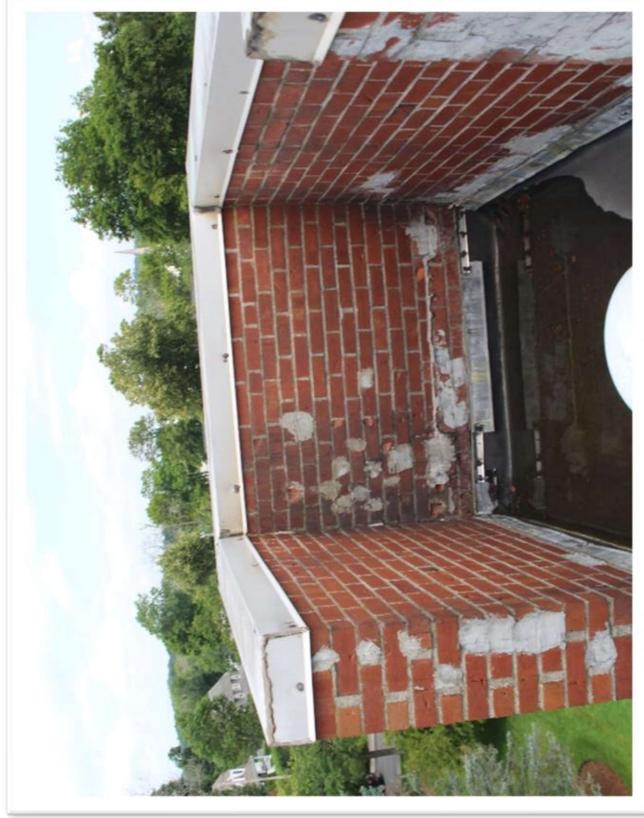
Photo 39: This photo shows back side of roof parapet wall with improper brick masonry repairs.

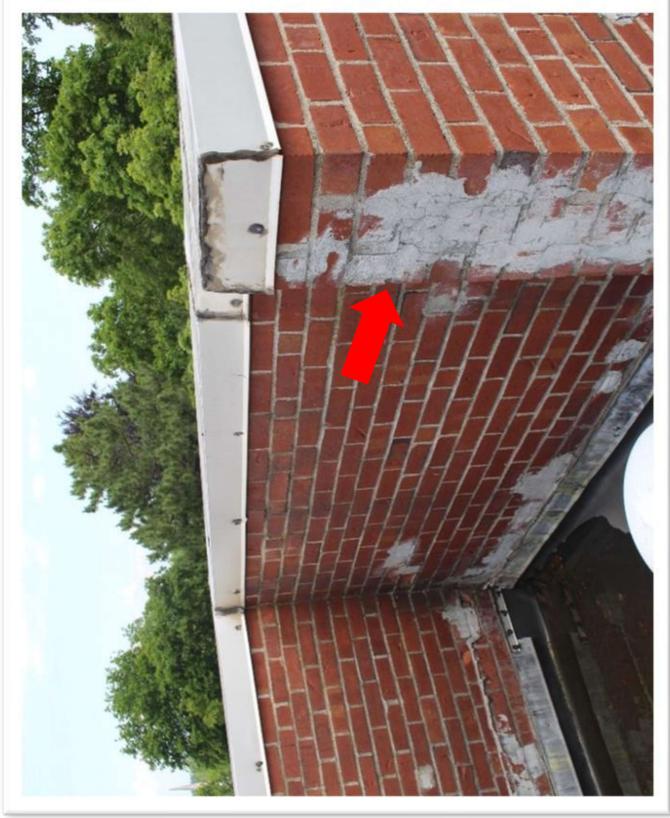
Photo 40: Defective brick patched with slurry coat of cement.

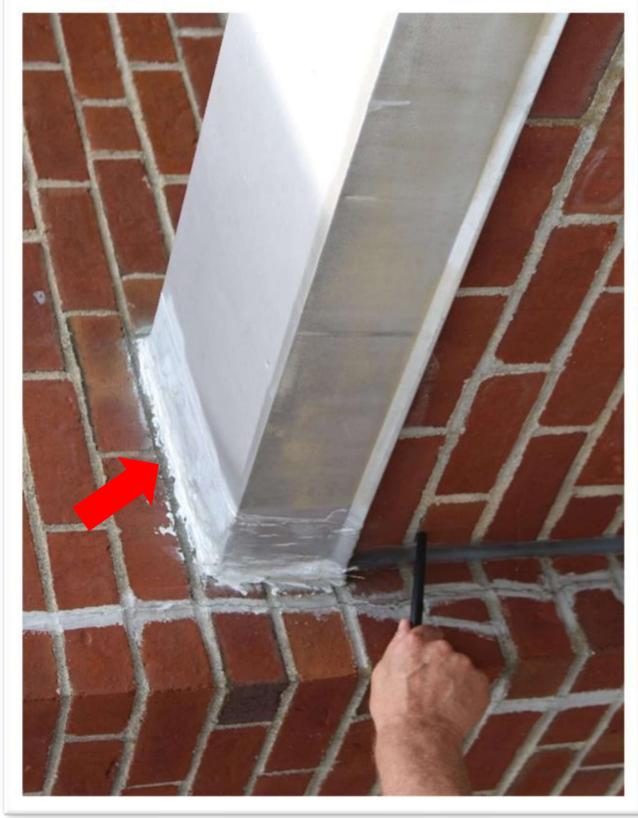
Photo 41: Improper waterproofing termination at parapet wall coping cap.

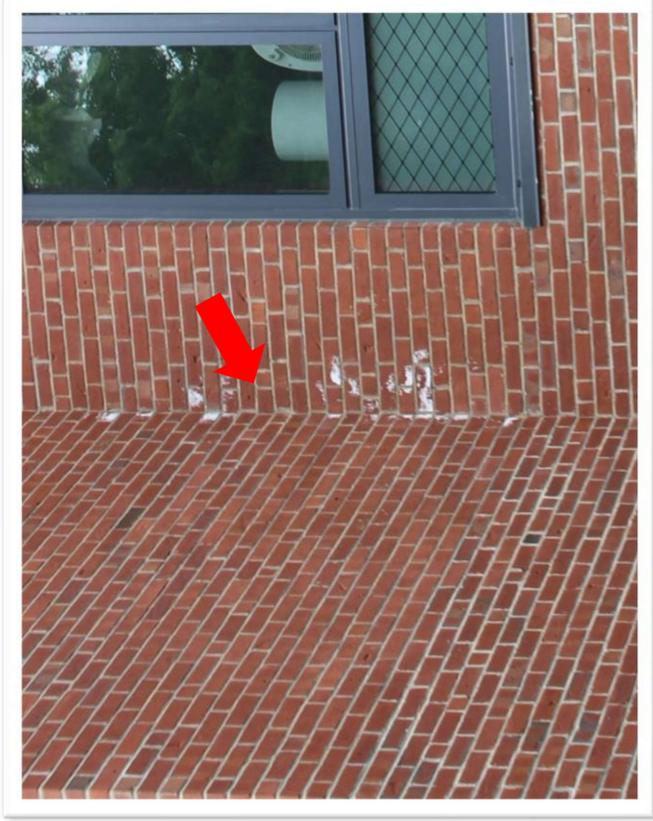
Photo 42: Presents of efflorescence on surface of brick at possible leak location.

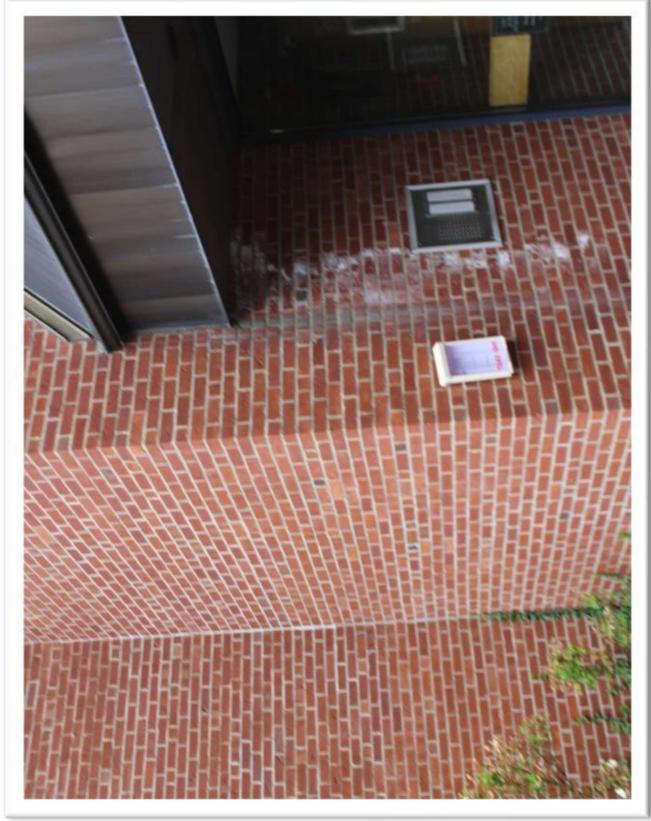
Photo 43: Presents of efflorescence on surface of brick at possible leak location.

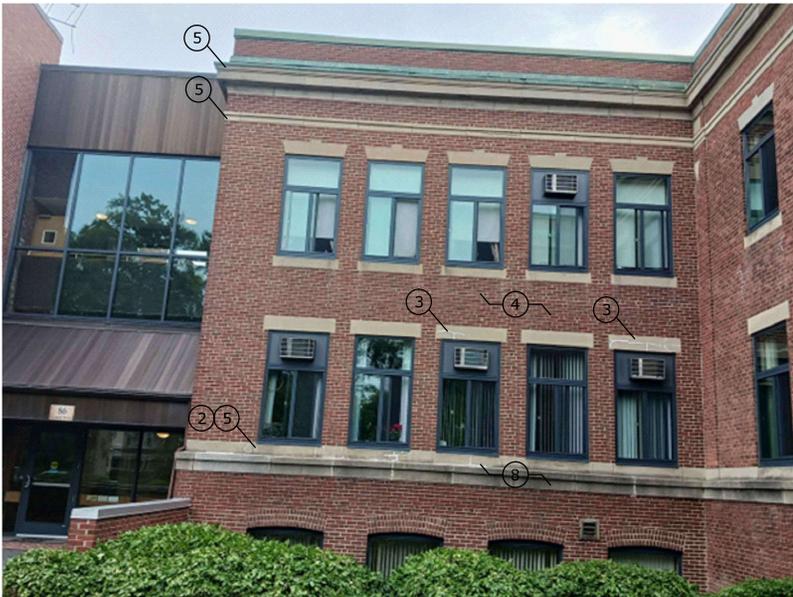
E1 - East Elevation

Deficiency Noted:	Approximate Percentage:
(2)	35%
(3)	20%
(4)	50%
(5)	65%
(8)	30% (Stained Precast)

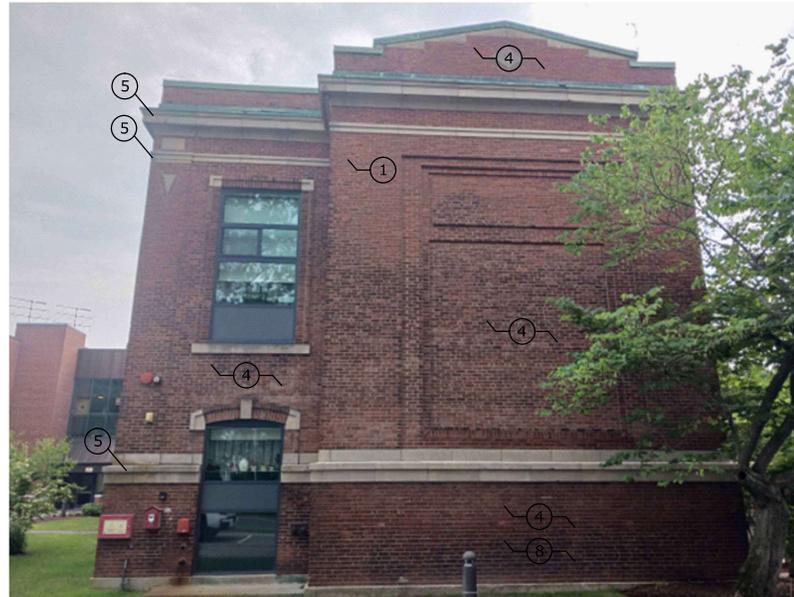
E2 - East Elevation

Deficiency Noted:	Approximate Percentage:
(1)	10%
(4)	50%
(5)	60%
(8)	40% (Stained Precast/Brick)

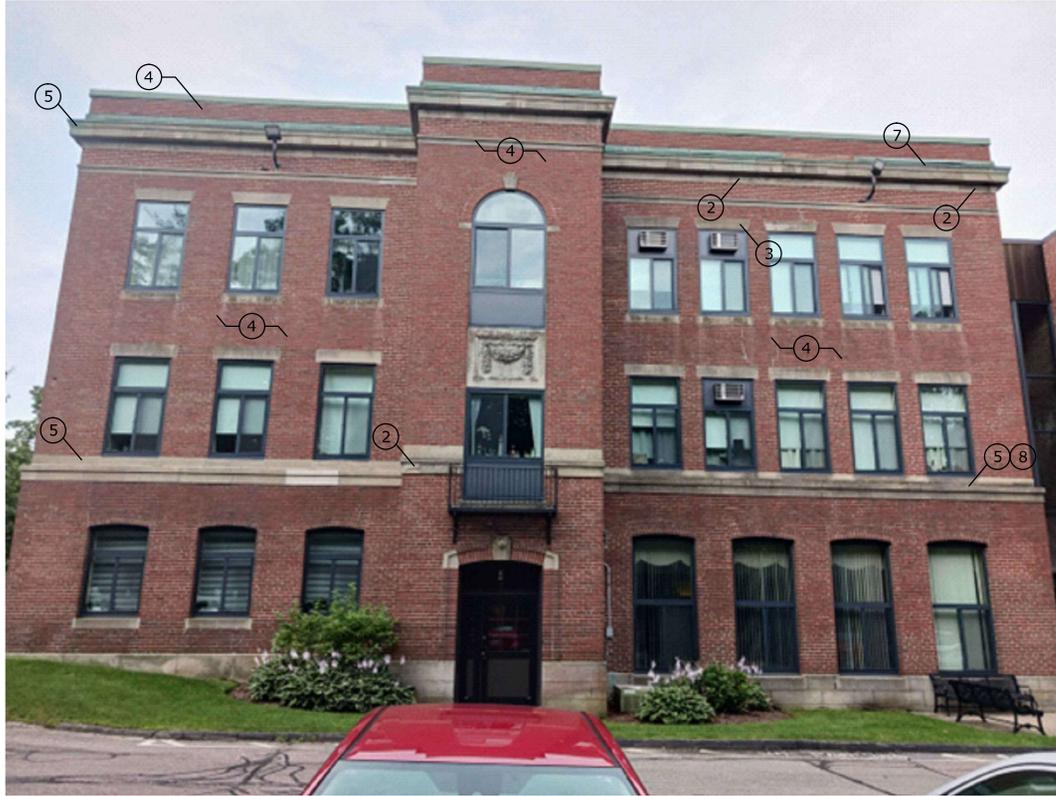
W1 - West Elevation

Deficiency Noted:	Approximate Percentage:
②	30%
③	15%
④	40%
⑤	60%
⑧	60% (Stained Precast)

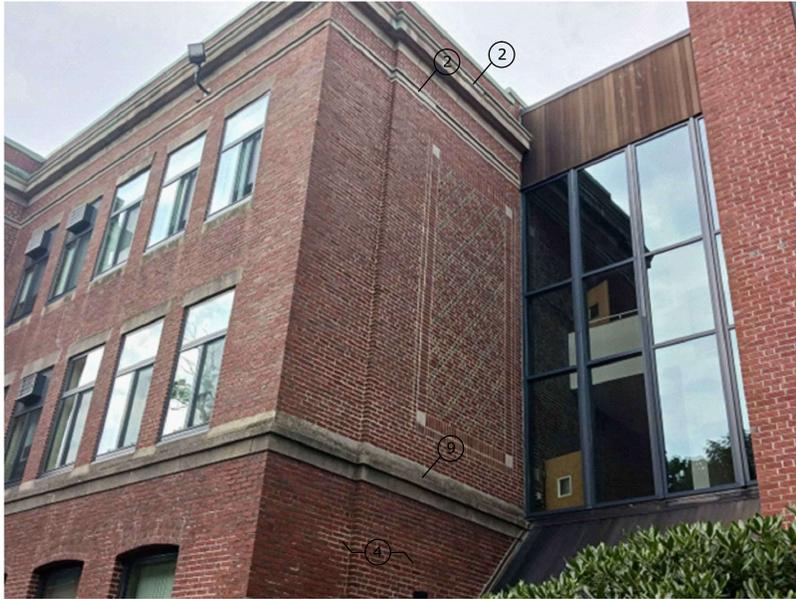
N1 - East Elevation

Deficiency Noted:	Approximate Percentage:
②	40%
④	50%
⑨	80% (Stained Precast)

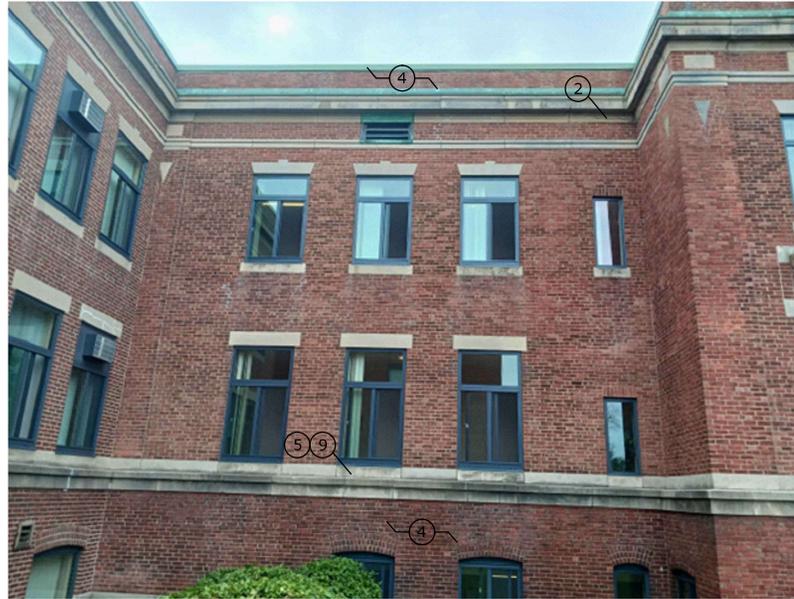
N2 - East Elevation

Deficiency Noted:	Approximate Percentage:
②	20%
④	50%
⑤	50%
⑧	50% (Stained Precast/Brick)

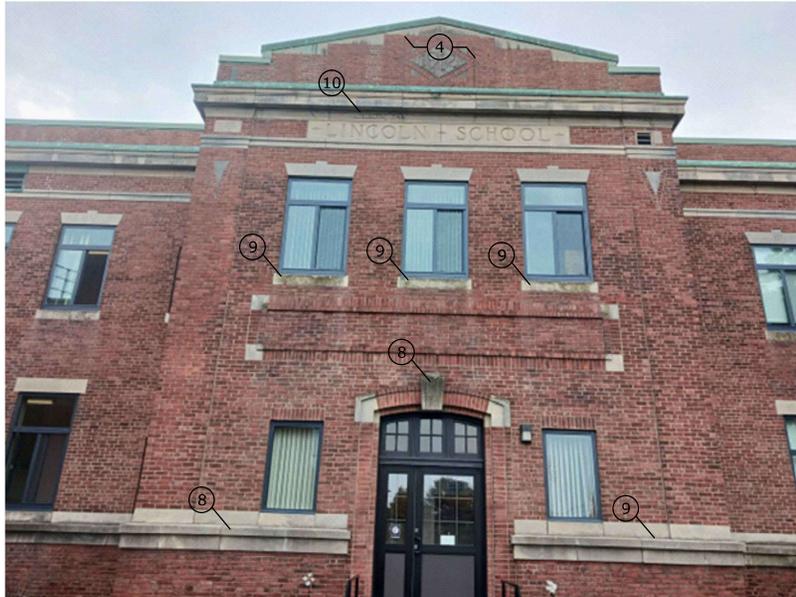
N3 - East Elevation

Deficiency Noted:	Approximate Percentage:
④	50%
⑨	30% (Stained Precast)
⑩	Plant Growth (Vines)

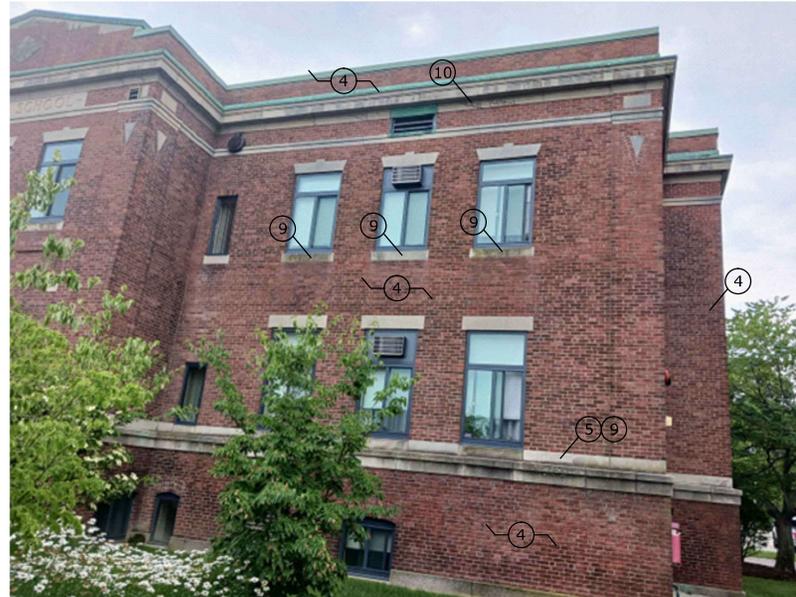
N4 - East Elevation

Deficiency Noted:	Approximate Percentage:
④	40%
⑤	50%
⑨	50% (Stained Precast)
⑩	Plant Growth (Vines)

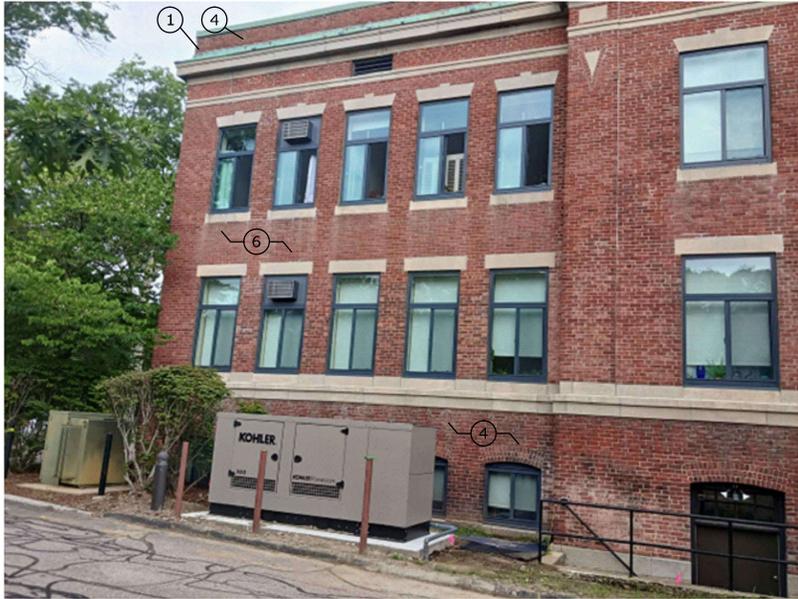
S1 - East Elevation

Deficiency Noted:	Approximate Percentage:
①	10%
④	80%
⑥	Random

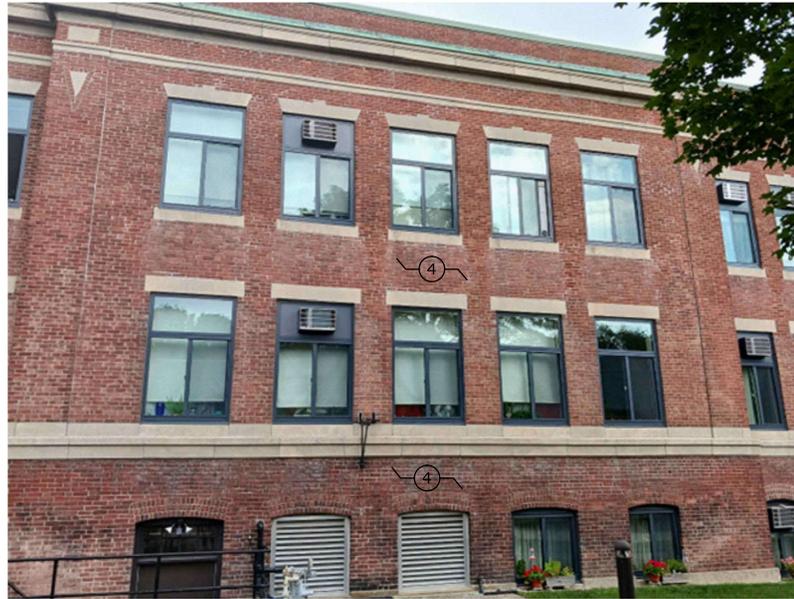
S2 - East Elevation

Deficiency Noted:	Approximate Percentage:
④	70%
⑨	30% (Stained Brick)

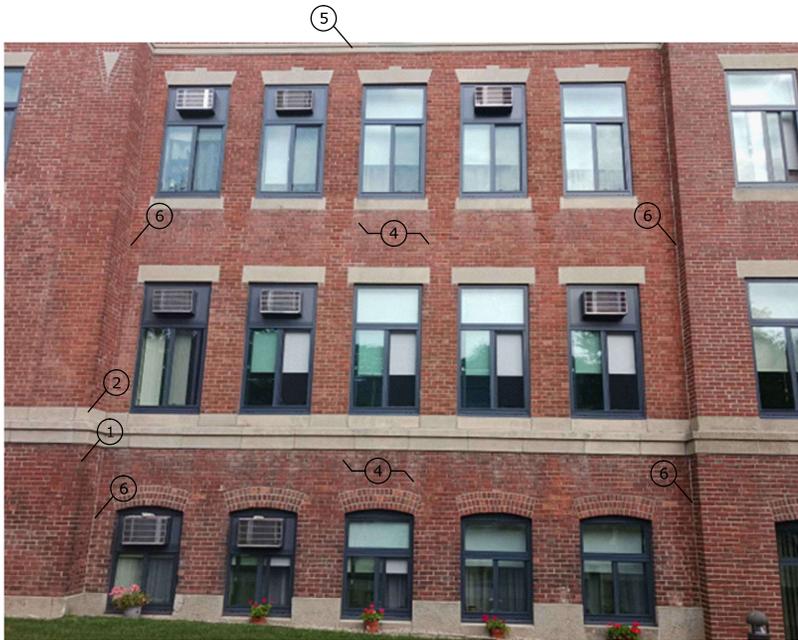
S3 - East Elevation

Deficiency Noted:	Approximate Percentage:
①	Isolated
②	Isolated
④	60%
⑤	50%
⑥	Vertical Masonry Joint
