HINGHAM AFFORDABLE
HOUSING TRUST FY 2027
CPA FUNDS REQUEST

Hingham Affordable Housing Trust

In late June of 2023, BEA performed a Building Envelope Inspection at Lincoln School Apartments in Hingham, Massachusetts. The purpose of this Condition Survey was to assess the condition of the building envelope components and identify exterior deficiencies. The report summarizes our findings, conclusions, recommendations, and associated repair/restoration cost budget estimates.

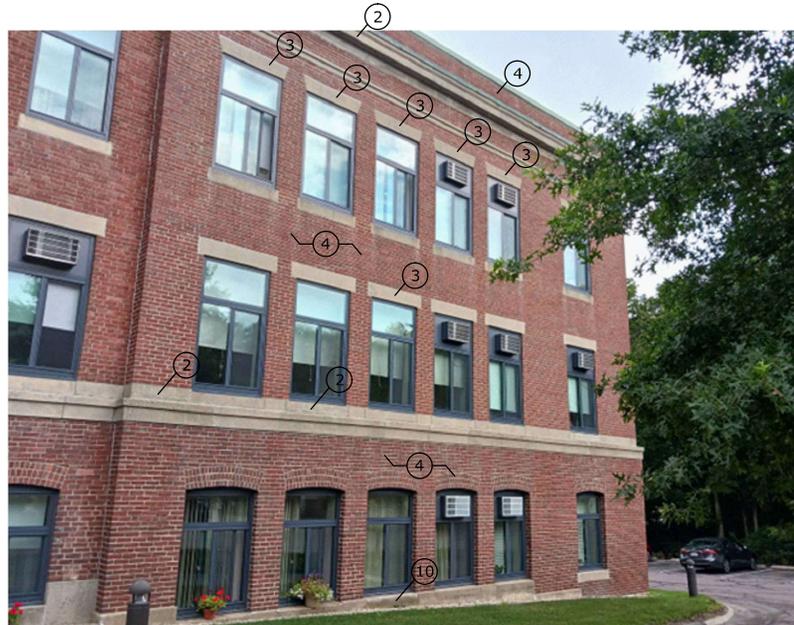
S4 - East Elevation

Deficiency Noted:	Approximate Percentage:
②	10% (Random)
③	50%
④	60%
⑩	70% (Along Foundation)

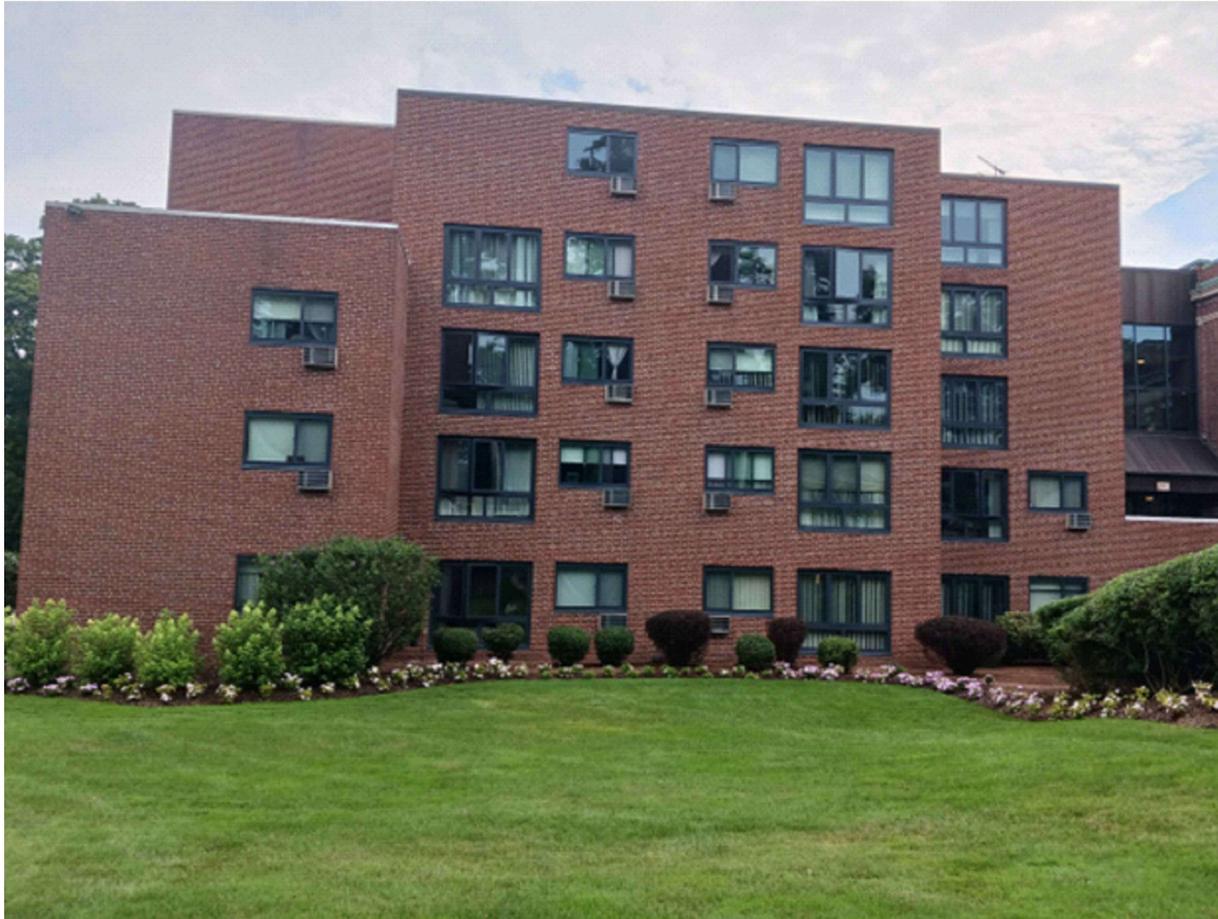
E1 - East Elevations

Deficiency Type:	Approximate Percentage:
④	05% (At Steel Lintels)
⑦	100% (Parapet Wall Coping)
⑧	10% (Vert. Wall Control Joint)
⑨	10% (Efflorescence)

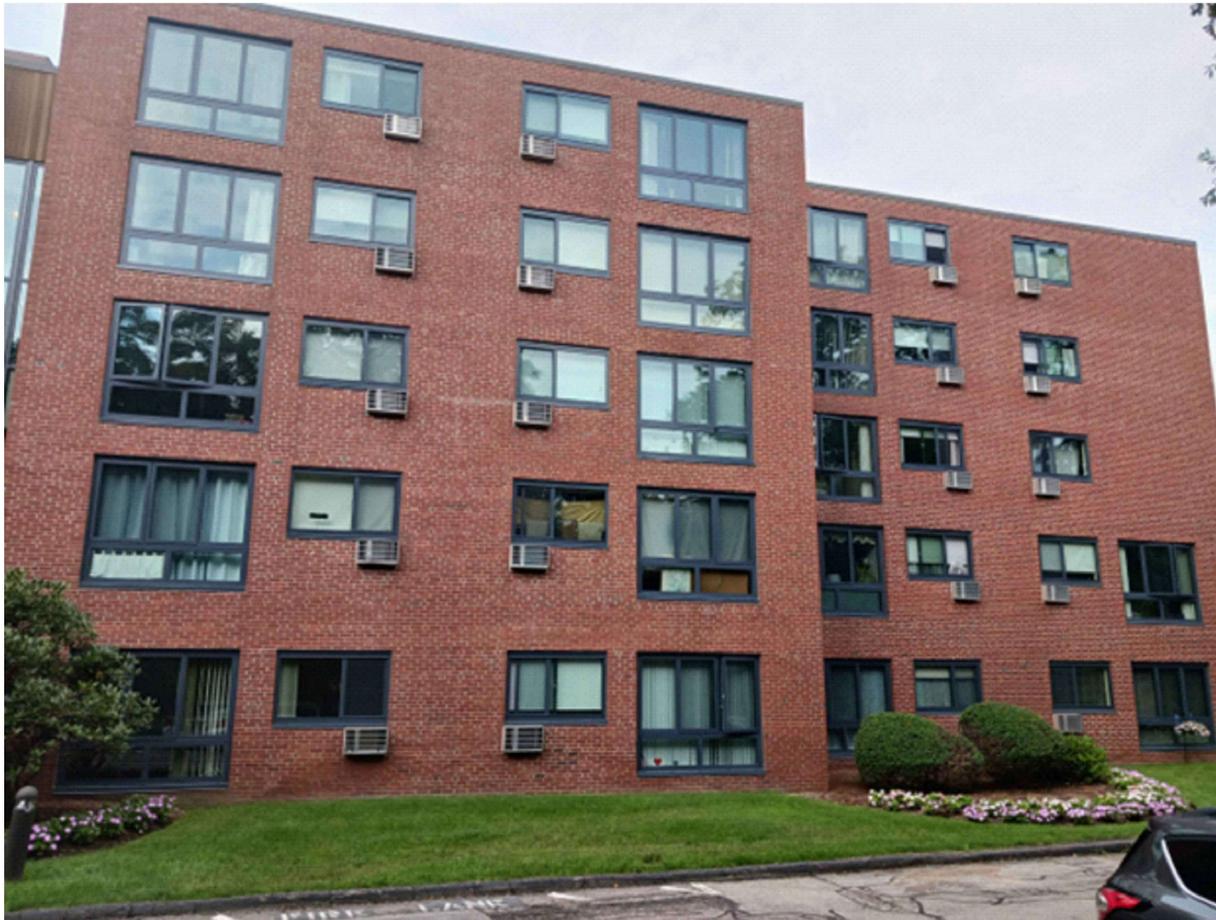
W1 - West Elevations

Deficiency Type:	Approximate Percentage:
①	08% (At Window Returns)
④	10% (At Return Wall)
⑨	10% (Efflorescence)

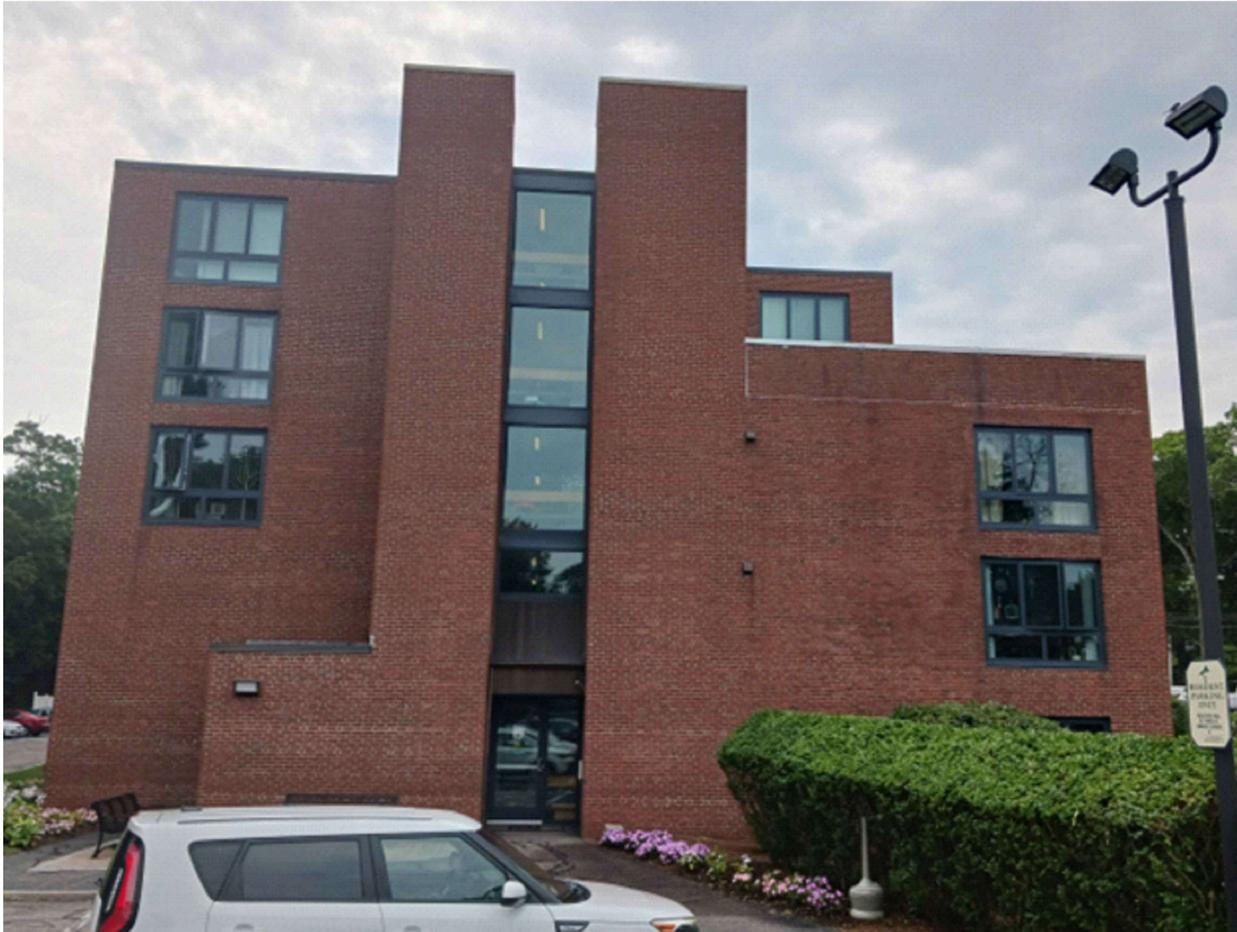
N1 - East Elevation

Deficiency Noted:	Approximate Percentage:
①	05% (At Embedded Steel)
④	10% (Random)
⑦	100% (At Parapet Wall)

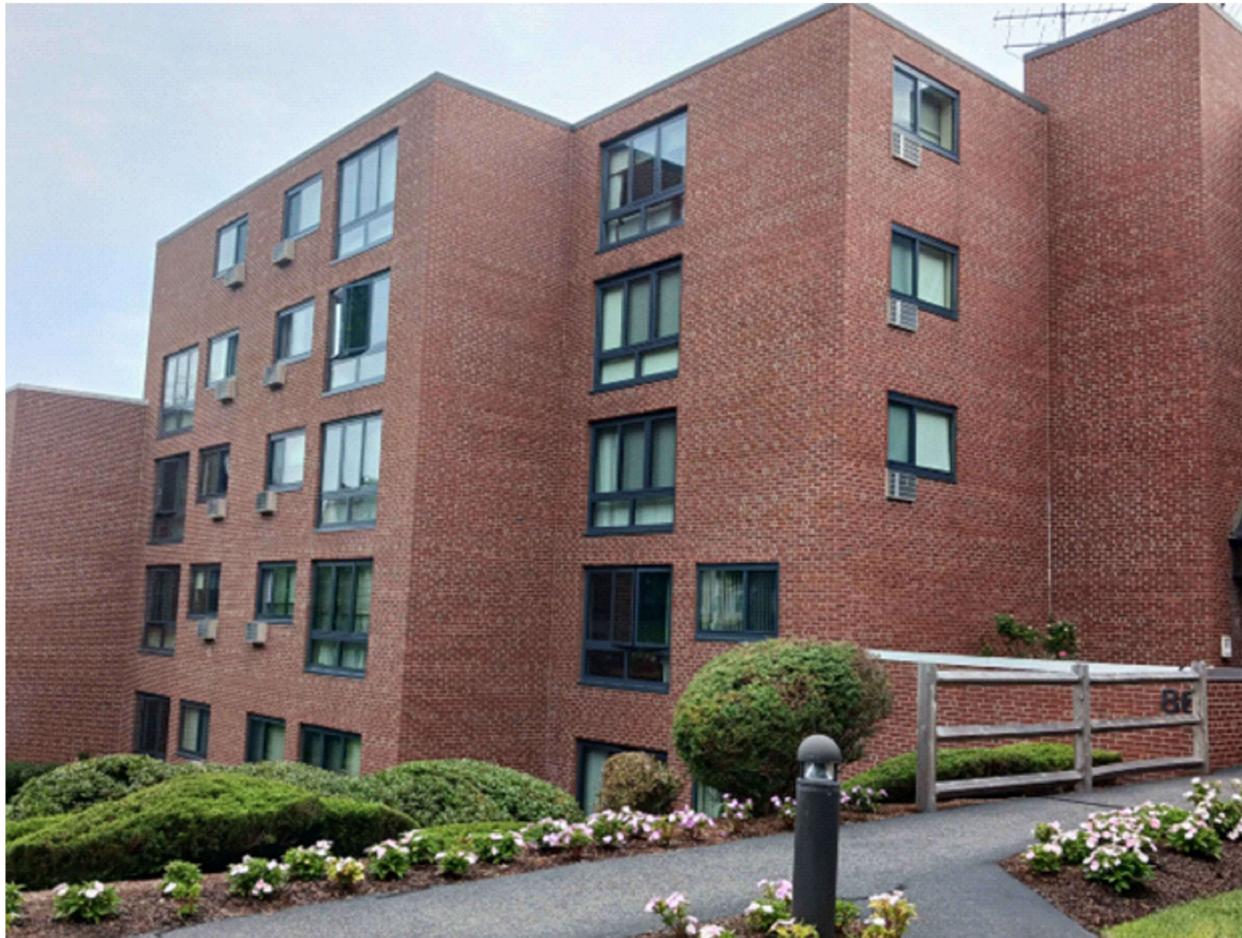
S1 - East Elevations

Deficiency Type:	Approximate Percentage:
④	05% (At Steel Lintels)
⑧	10% (Vert. Wall Control Joint)
⑨	20% (Efflorescence)

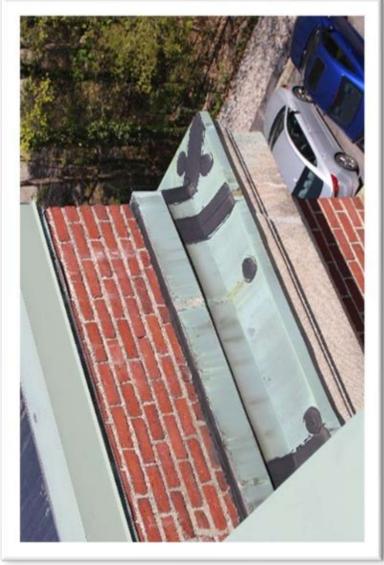
Typical repairs to copper ledge (widespread)

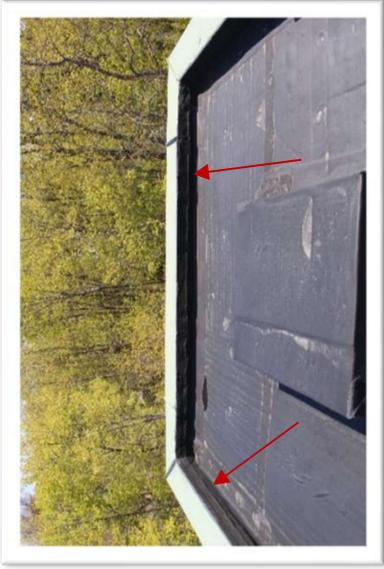
Repair flashing on coping cap

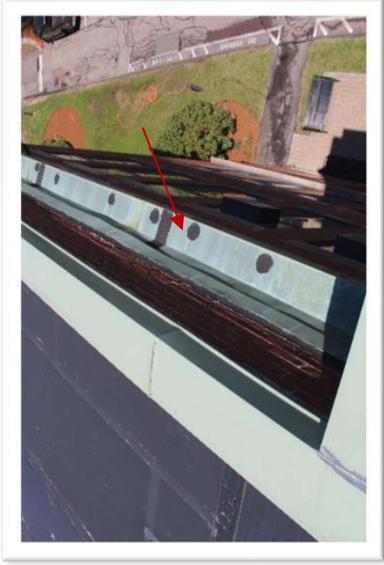
Typical repairs to copper ledge (widespread)

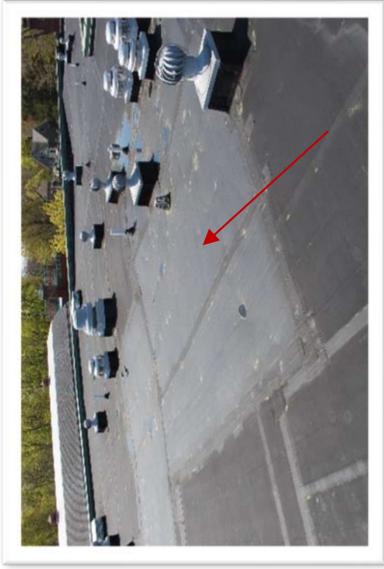
Field patch to membrane

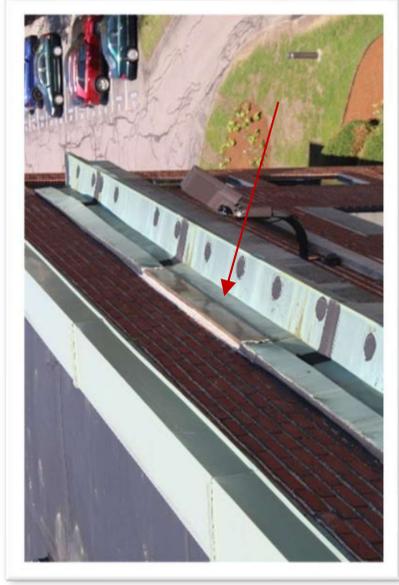
Typical repairs to copper ledge (widespread)

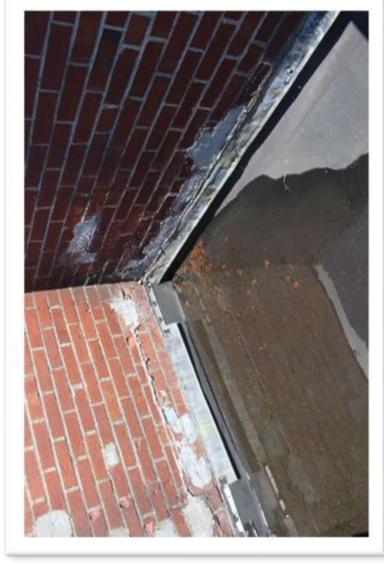
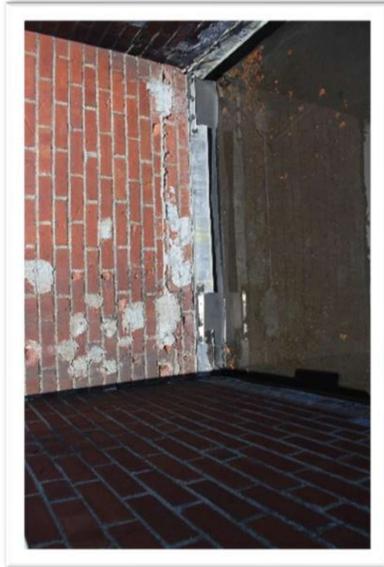
Masonry wall deficiencies – Typical

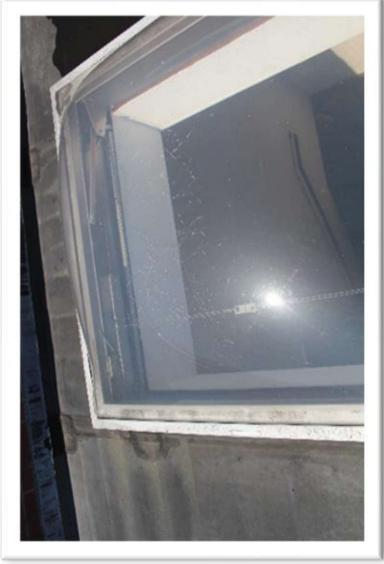
Degraded skylight dome

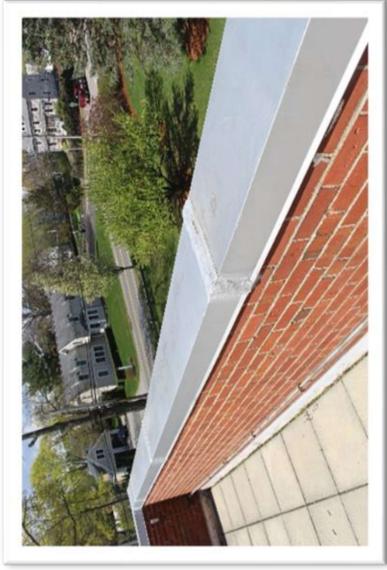
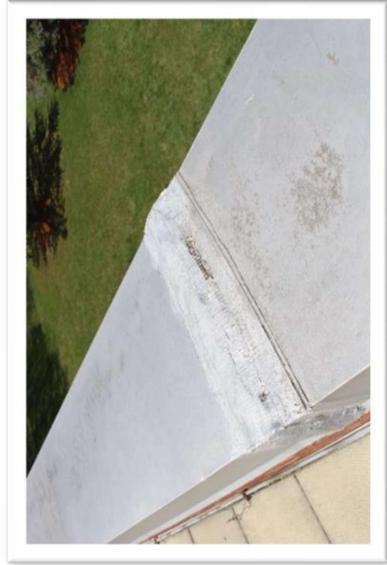
Typical poor repair attempts on the coping cap

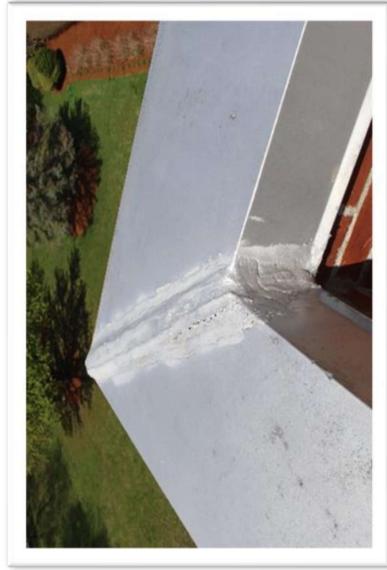
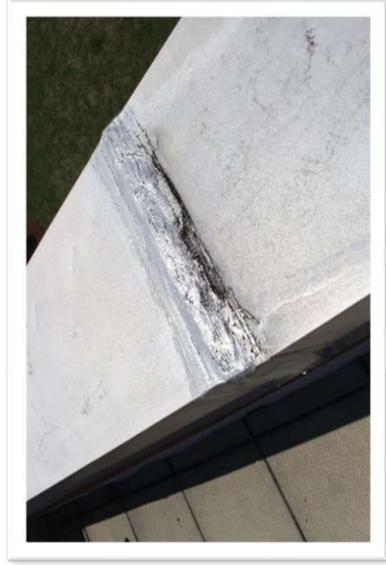
Typical degrading coping cap flashings

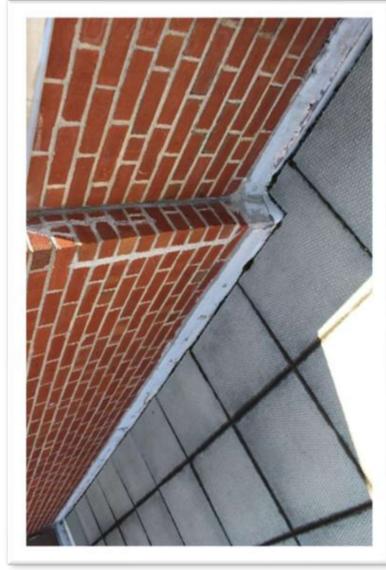
Overview showing minor masonry issues
