October 9, 2025

RE: Interior Moisture Investigation – Follow-up review
Lincoln School Apartments
Hingham, Massachusetts
BET No. 25009

In accordance with your request, Building Envelope Technologies, Inc. (**BET**) visited the Lincoln School Apartments on September 17th, 2025 in order to review the exterior conditions of Apartment 109, specifically the recently completed repairs.

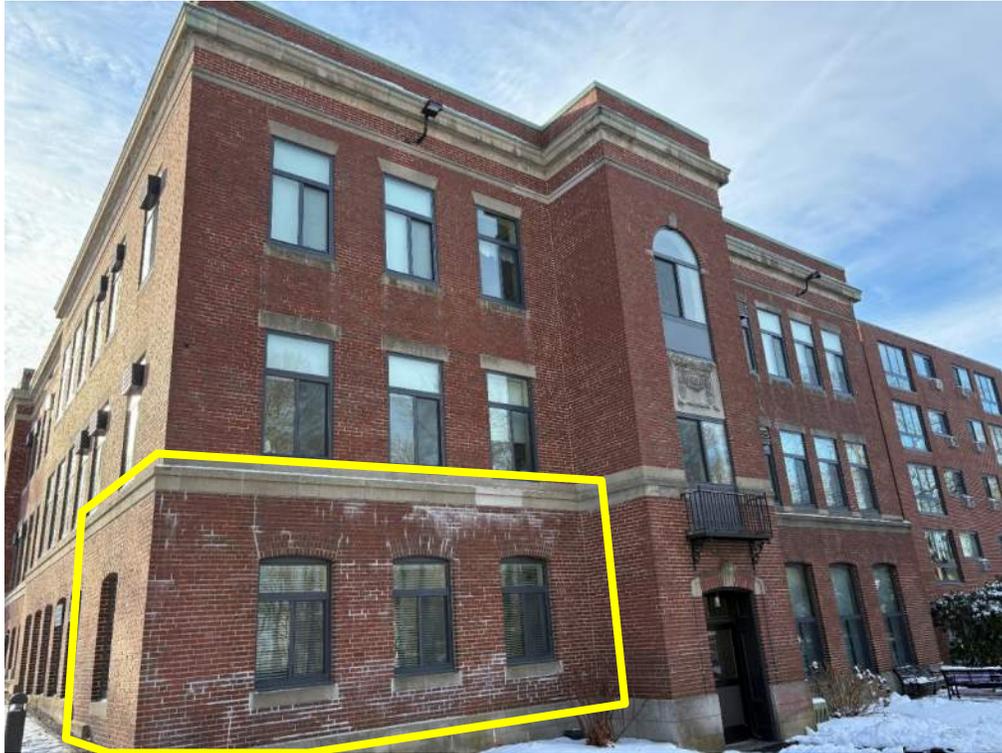
Overview of Apartment 109 (circled) – photo taken January 23, 2025

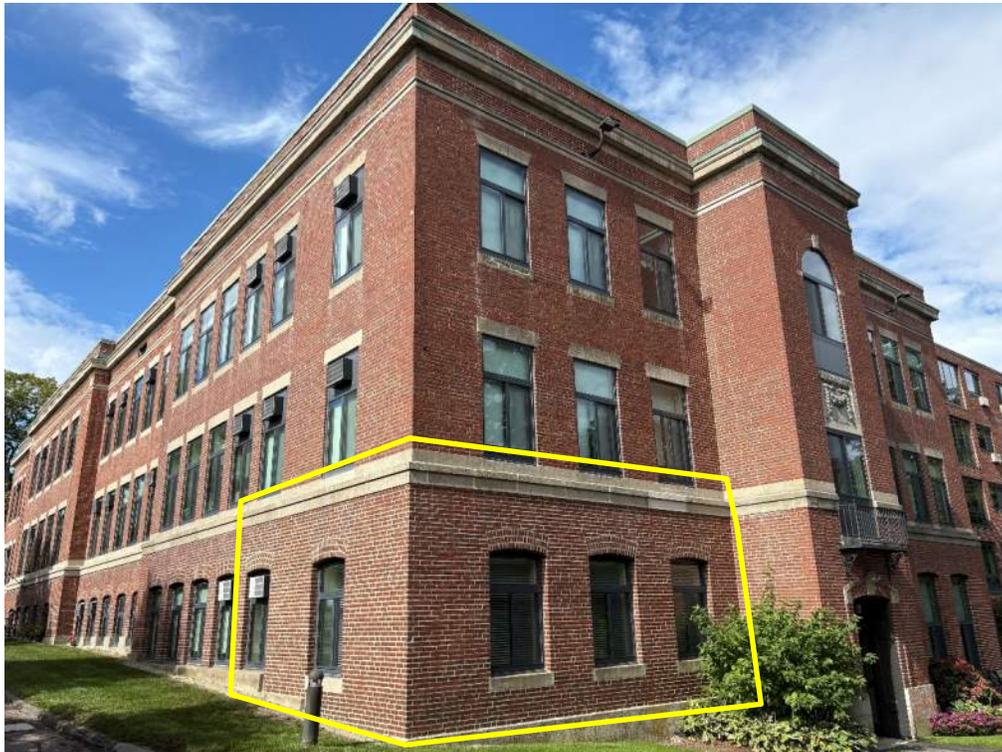
Overview of Apartment 109 (circled) – photo taken September 17, 2025

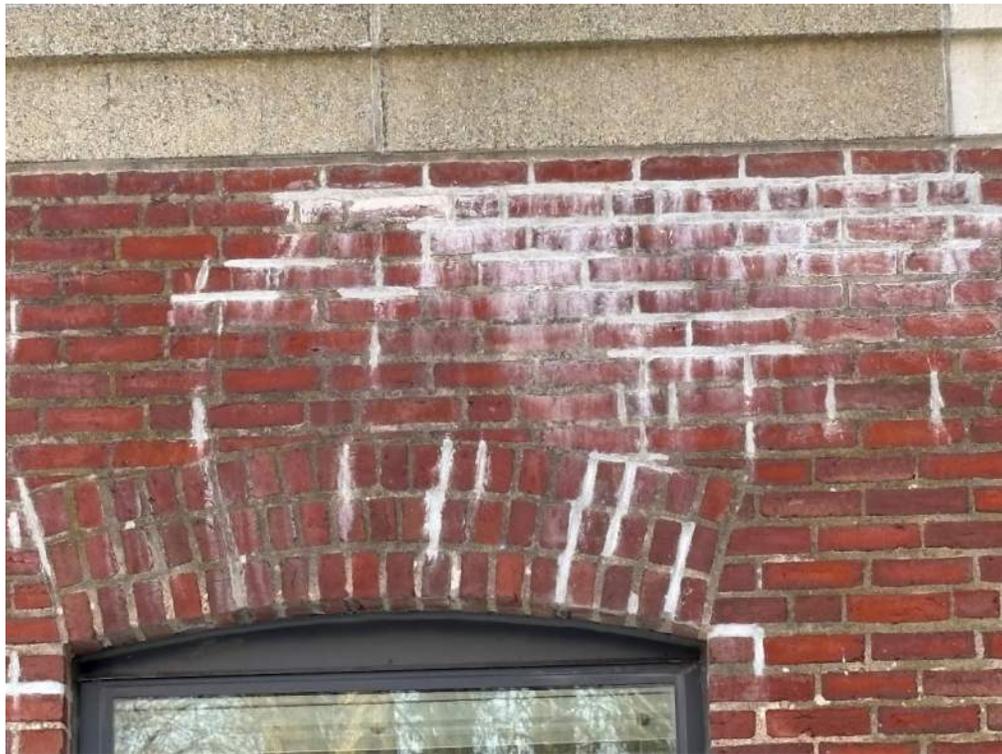
Heavy staining on rear elevation – photo taken January 23, 2025

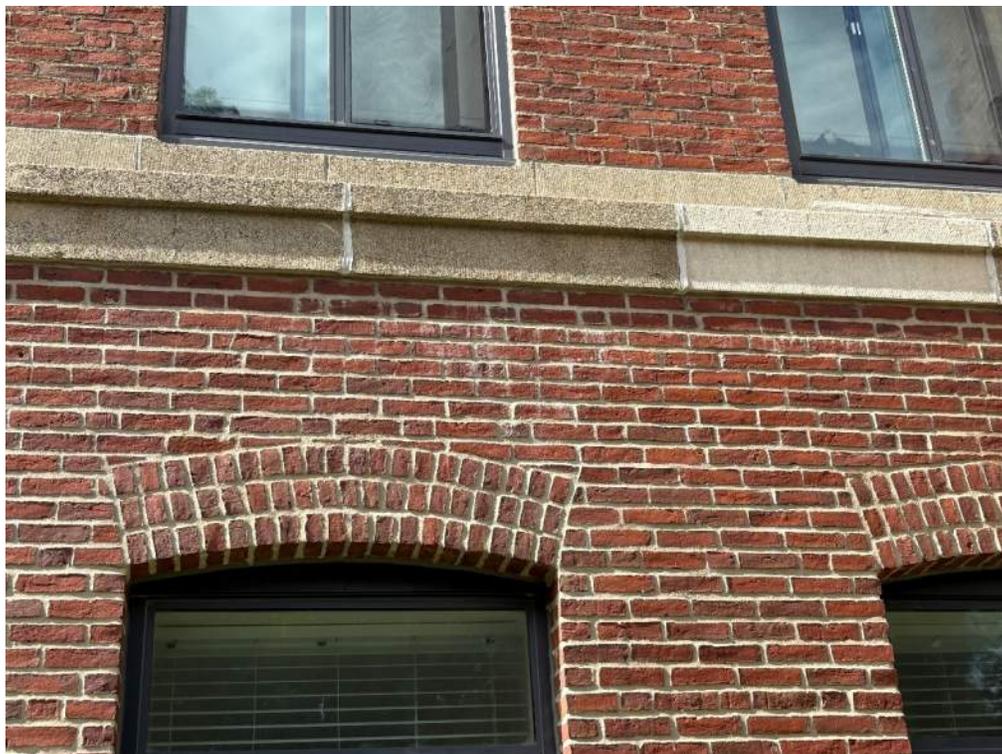
At first glance, the ground floor brick masonry exterior wall on the rear of the building is notably cleaner and nearly free of efflorescence staining and moss/algae. Only small faint areas of the white, chalky stains were observed above two of the three rear windows.

Majority of stains have been removed – photo taken September 17, 2025

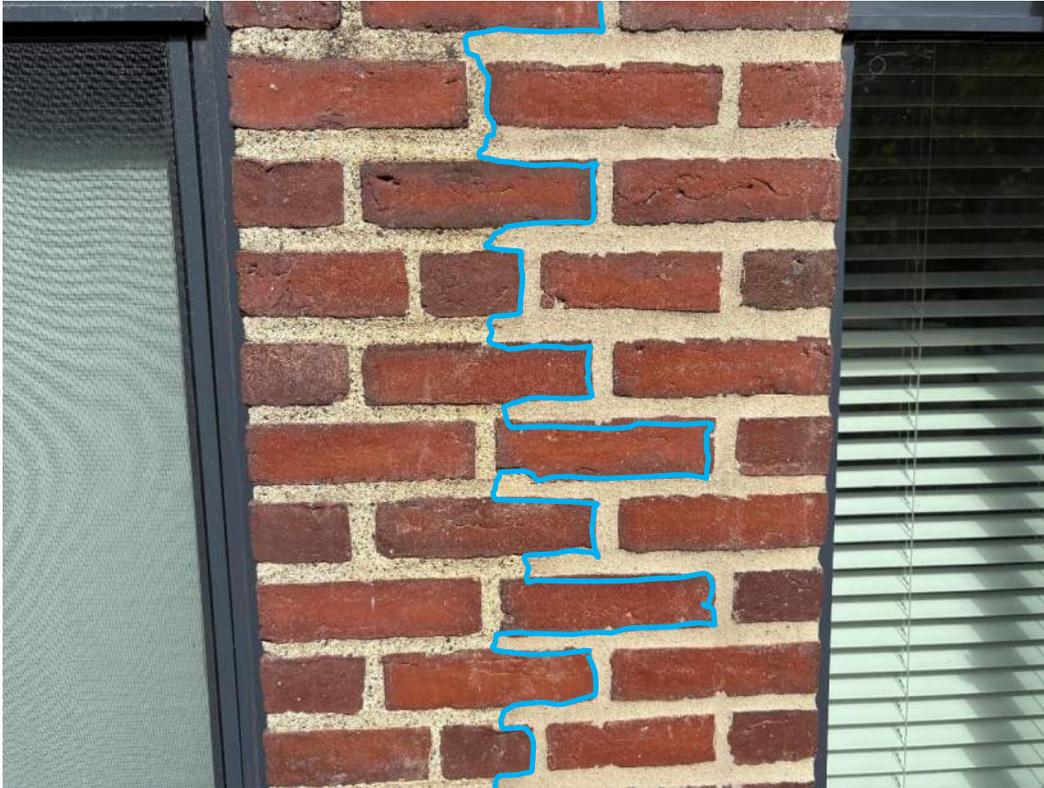
Upon examination, it was found that the brick masonry joints between the cast stones at the foundation level and the cast stone water table below the second floor windows have been repointed. Although it is unknown whether the workers removed the mortar to a minimum depth of 1", the new mortar appears solid and continuous with no cracking. A small hammer was used to test the strength and thickness of the new mortar in several random locations via hammer strikes. No cracks or chipping were produced, indicating the new mortar has been set to solid materials. If the substrate materials were soft/deteriorated, or if the new mortar was not pressed into the substrate, the hammer blows would typically crack the new mortar.

Wall area between windows with original mortar (left) meeting the new mortar (right)

The newly applied mortar has less exposed aggregate than the original mortar, however it should be noted that the original mortar is heavily weathered. The color of the new mortar appears to closely replicate the original. It was also found that the new mortar was applied so that it is nearly flush with the exterior surface of the bricks.

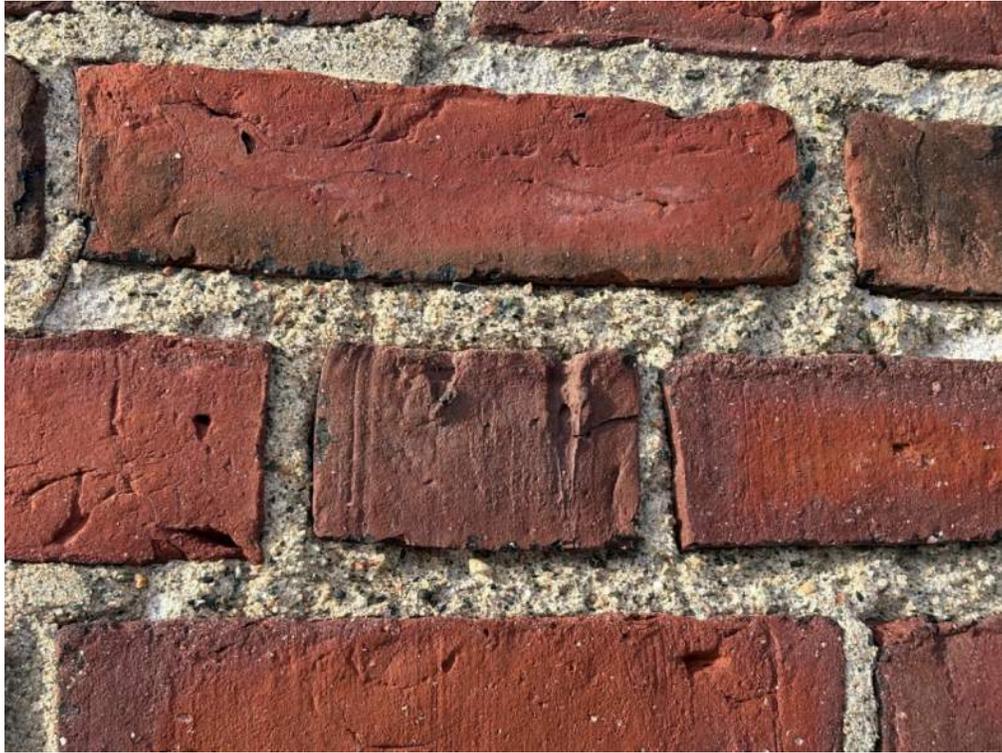
Typical original weathered mortar joints on side elevation

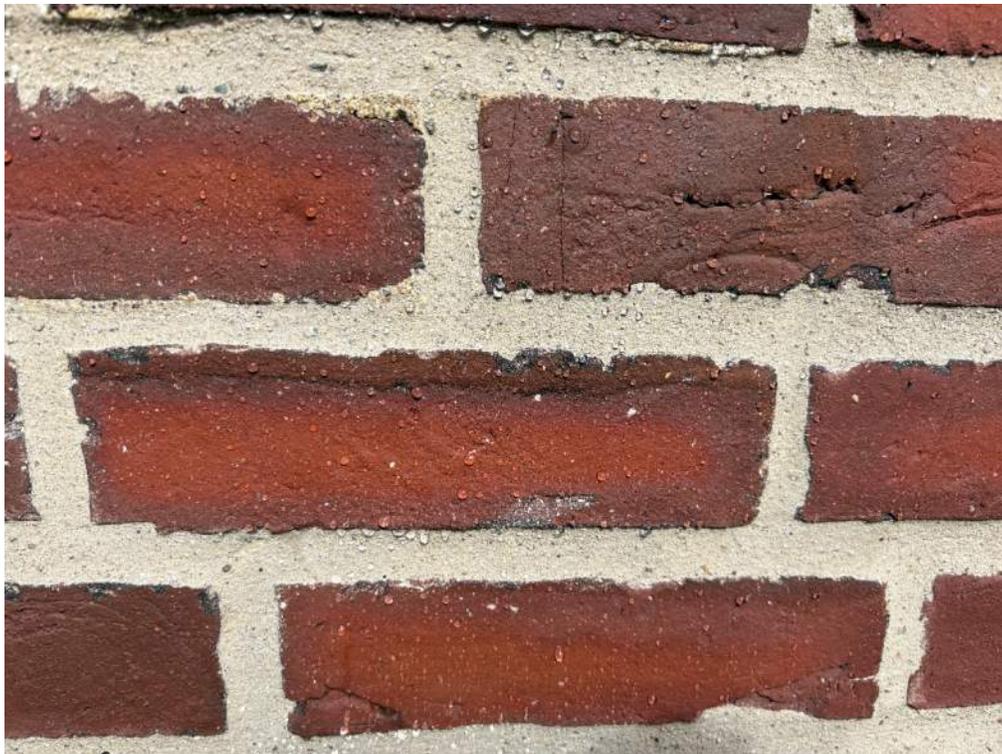
Newly applied mortar joint outside Apartment 109

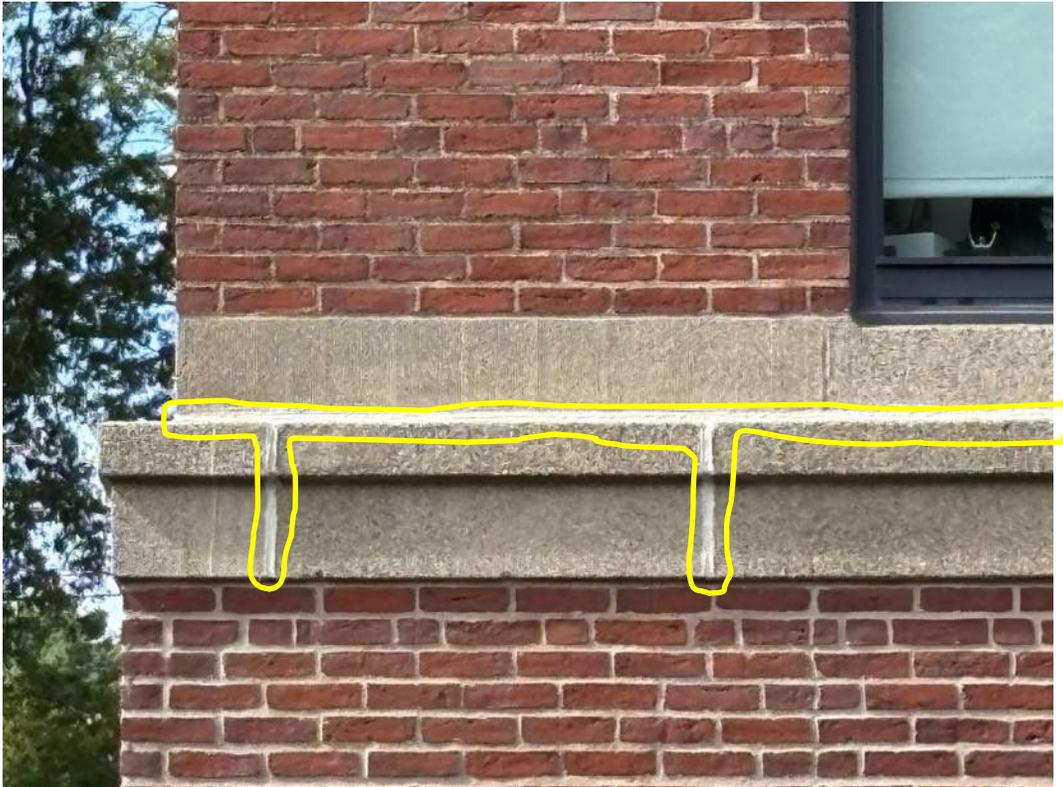
The vertical joints between the cast stones of the water table below the second floor windows above Apartment 109 have been covered with sealant. Further, the horizontal joint above the water table and cast stone above (above Apartment 109 only) has been covered with sealant. Two cast stones above the water table, one on the rear elevation and one on the side elevation have horizontal cracks that have been covered with sealant. It appears that the vertical sealant joints were not well tooled, leaving a rough appearance. It should also be noted that the color of the sealant does not match the color of the stone or mortar.

Sealant applied in vertical joints between water table cast stones and horizontal joint above water table

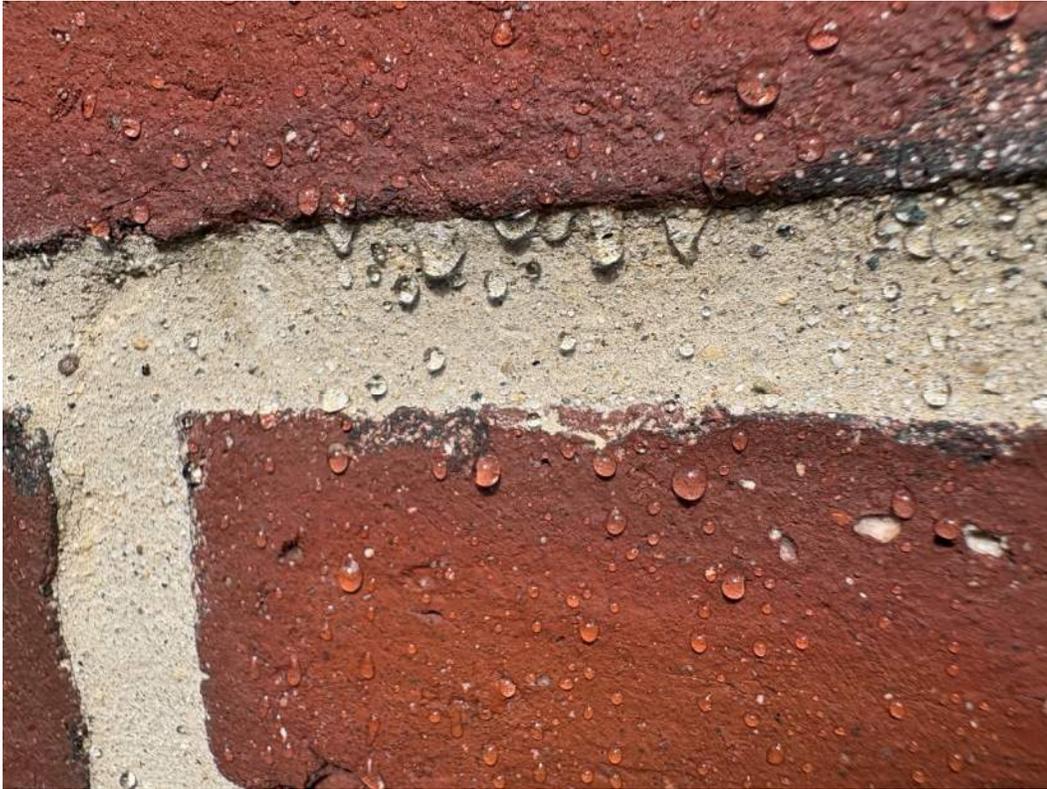
After reviewing the overall appearance of the brick masonry (cleaner than surrounding surfaces due to removal of moss/algae and most of the efflorescence, but with no discoloration), water was splashed onto the wall surfaces in a few random locations. The water immediately beaded up and rolled off both the face of the bricks and the mortar joints. Despite no obvious outward appearance such as discoloration (typically darkening) or change in sheen (i.e. glossy), a water repellent was applied.

Close-up photo of water beading (not absorbing) on brick masonry

The next step should include controlled and systematic water testing of exterior walls. Water testing should be completed in multiple locations beginning at lower elevations where the recent repair work was completed using a spray rack to provide long term and distributed exposure to water. Water should be sprayed at the wall for a minimum of 30 minutes, but ideally 60 minutes. Upon completion of the water test, the interior of Apartment 109 should be monitored for at least another 60 minutes. After the monitoring period, another water test should be conducted at the second floor level. The process should continue to include the third floor as well, on both the rear and side elevations.
