From: Whalen, Kevin
Sent: Friday, November 1, 2019 2:41 PM
To: Savage-Dunham, Mary
Subject: Pool Engineering reports
Attachments: 20190927_083458.jpg; 16-021. SSCC - Str memo-17.pdf; 16-021. SSCC - Str memo-13.pdf; 16-021. SSCC - Str memo-12.pdf

PROJECT MEMO

To: Michael Clancy, Building Commissioner
Town of Hingham Inspectional Services
From: Scott Orlowski
Job No. 16-021
Re: South Shore Country Club
274 South Street
Hingham, MA
Date: 10/23/2018

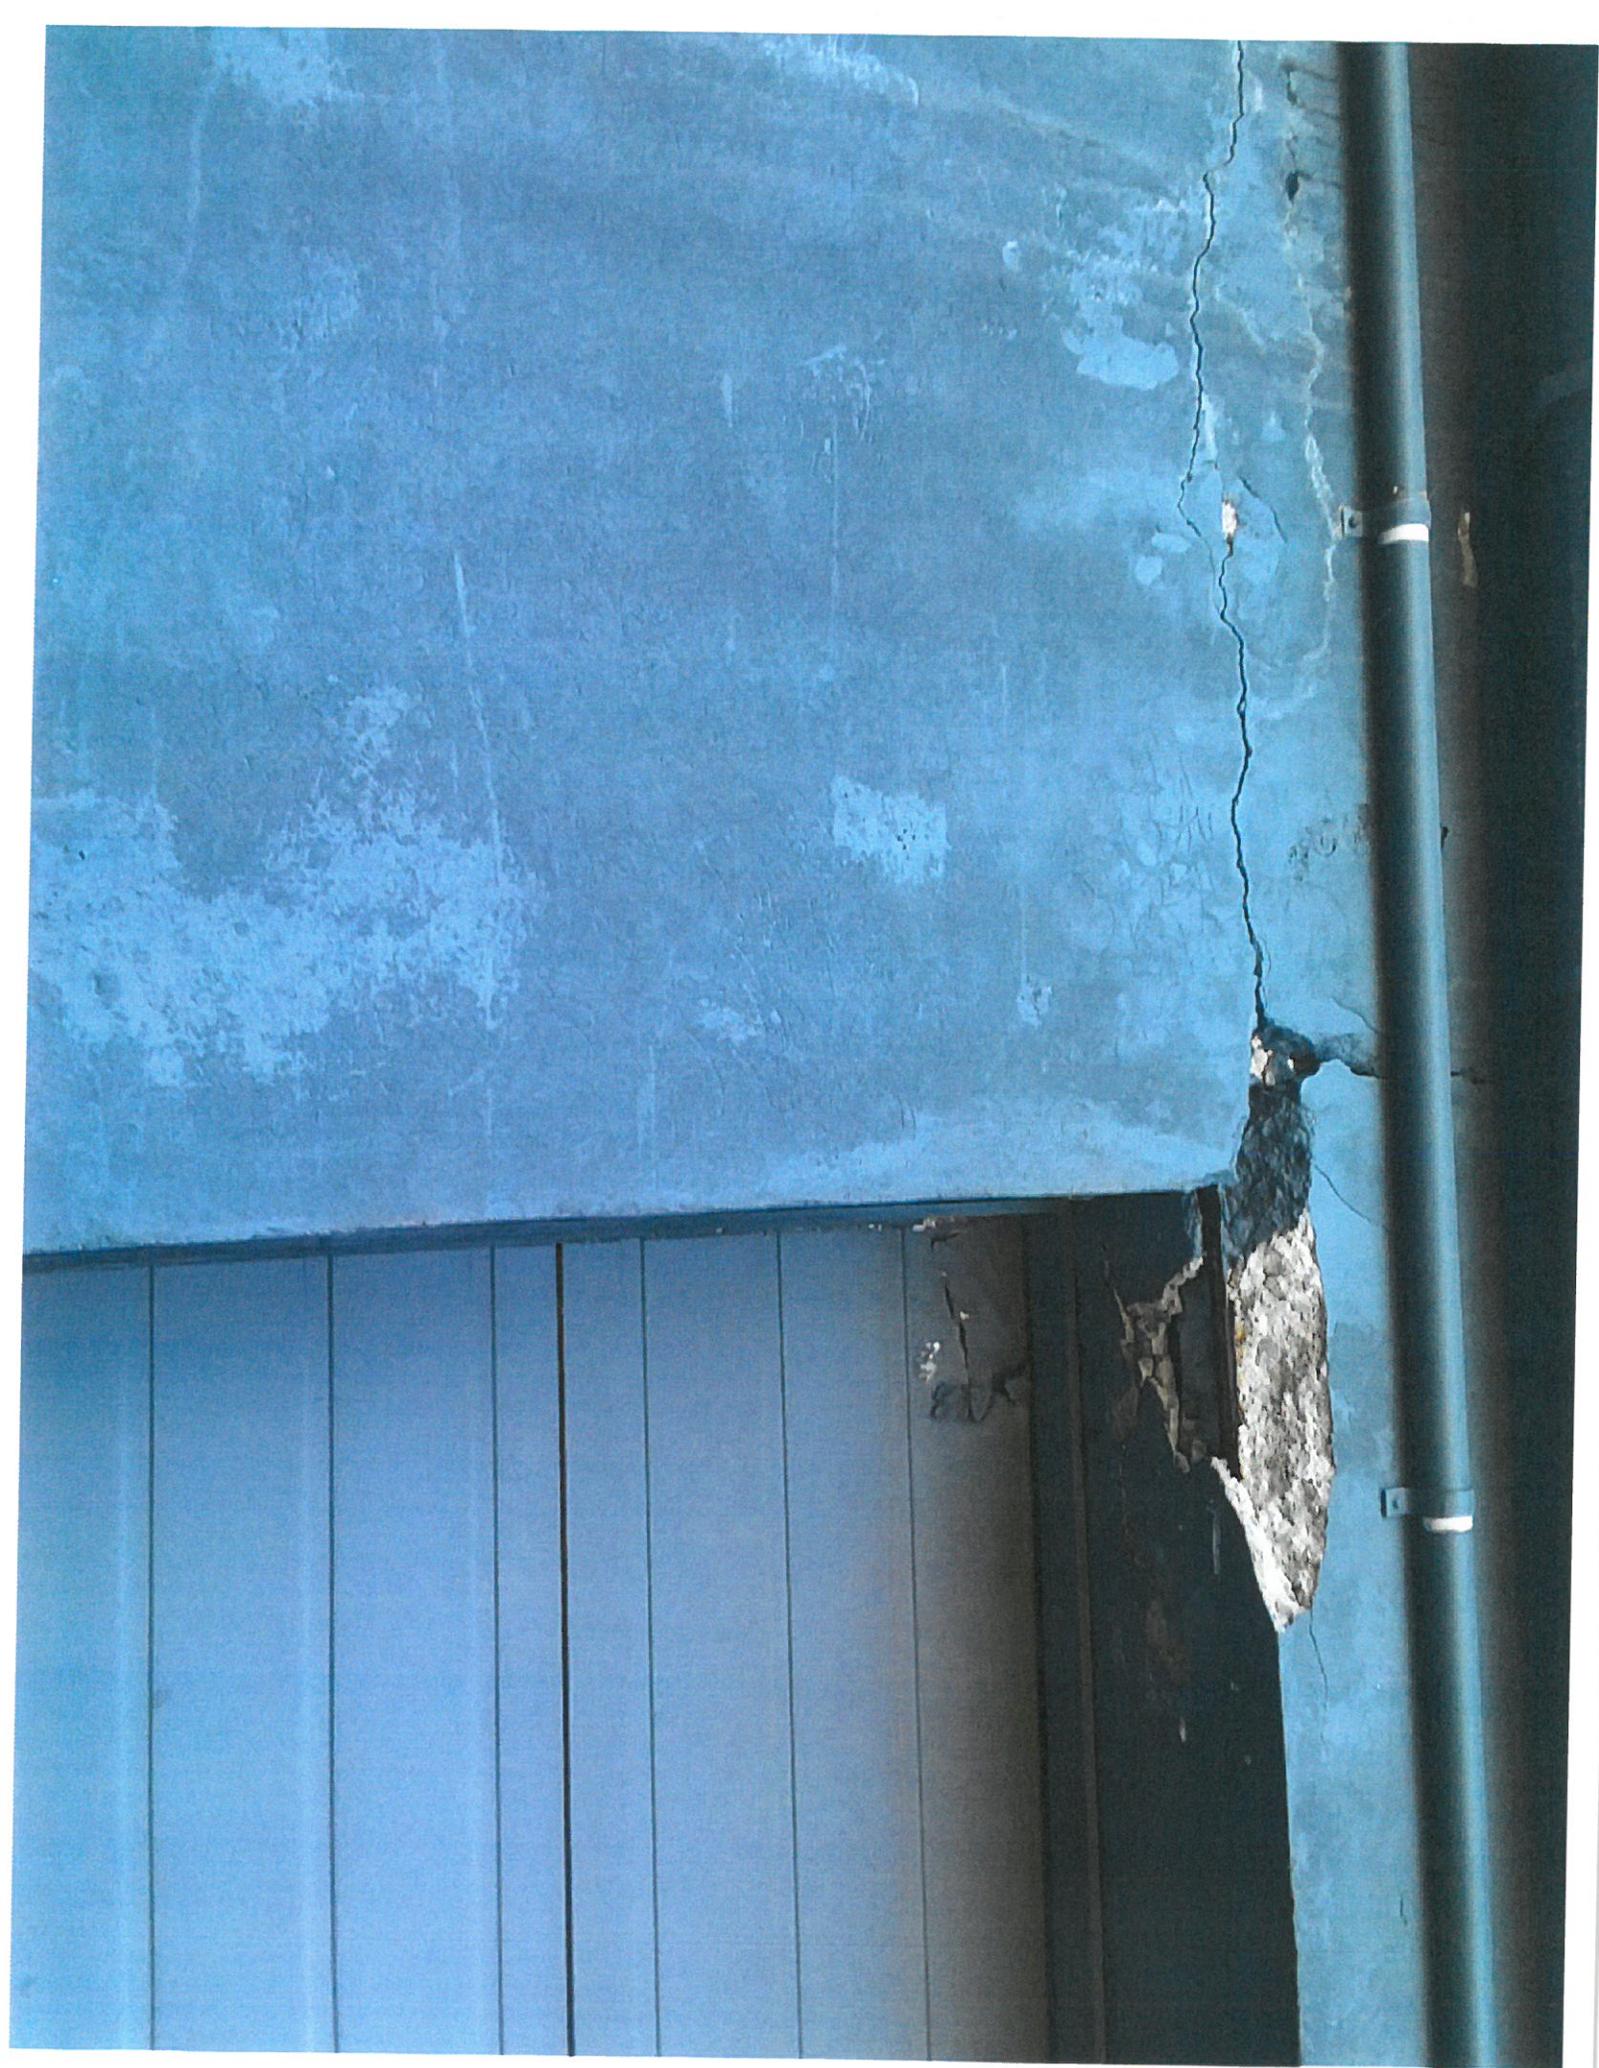
I have attached a picture of the latest problem with the pool structure and several engineering inspections over the last year. I will send additional information.
