South Shore Country Club  
 Engineering Facility Study  
 Cubellis Associates

**APPENDIX B**  
**PHOTOGRAPHS**

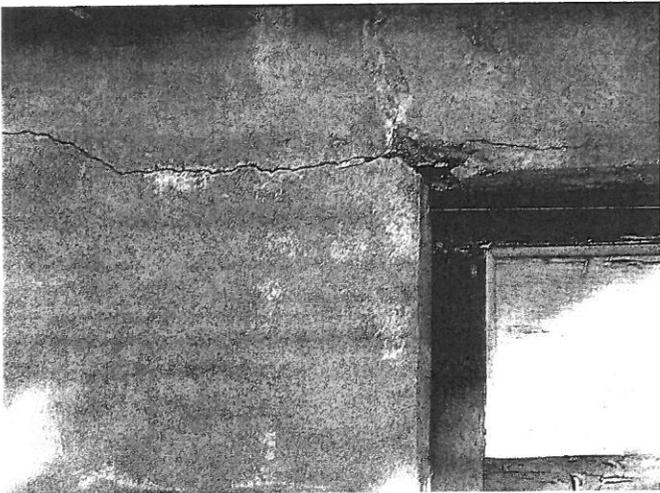
EXTERIOR CRACK IN EXPOSED CONCRETE WALL

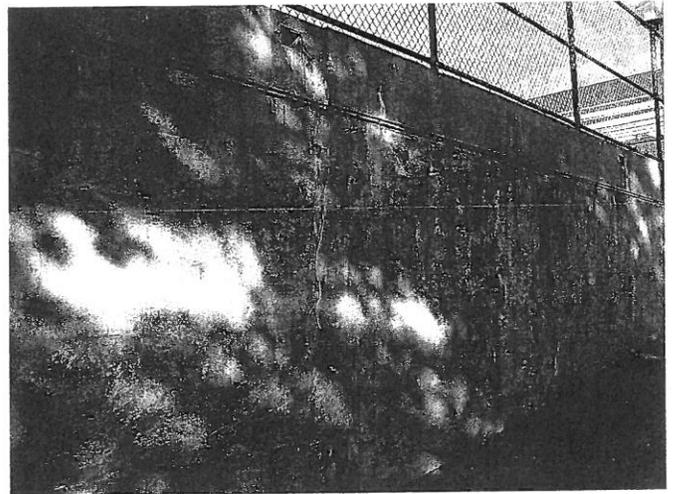
EXTERIOR CRACK IN END WALL

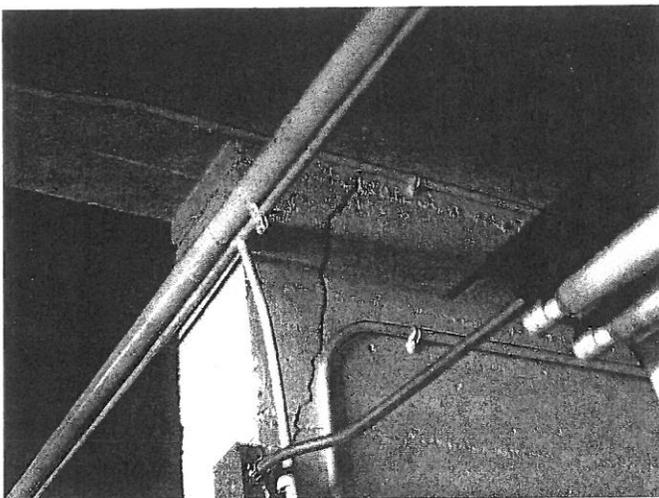
INTERIOR CRACKS IN CAST-IN-PLACE CONCRETE FRAME

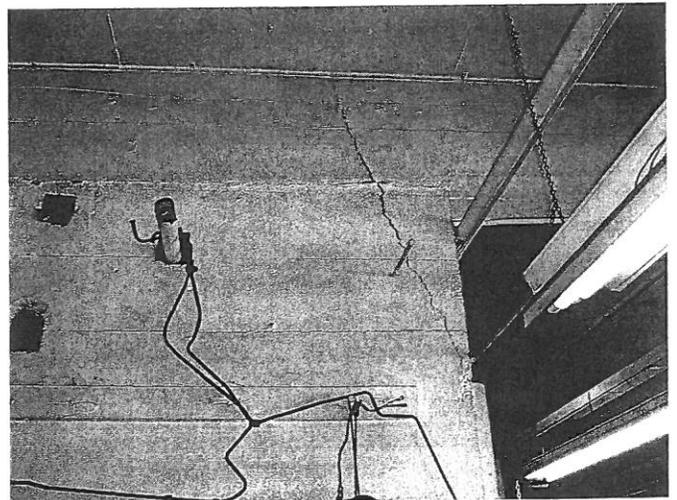
INTERIOR CRACKS IN CAST-IN-PLACE CONCRETE FRAME

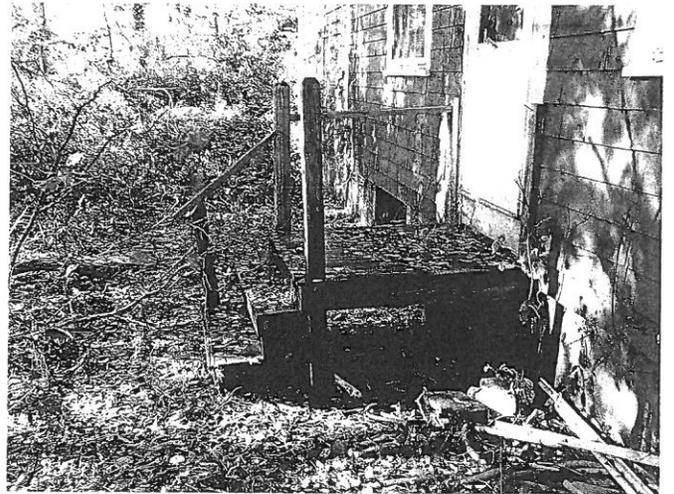
The main door to the building is insulated metal and is in good condition. The side door is wood, is in need of painting and has a deteriorated screen door that needs replacement. The stairway serving this side door is also deteriorated and has missing handrails. This should be replaced with a stair that conforms to the current building code requirements. At present, this stairway, which is part of the building's means of egress, is a liability to the Town if someone were to be injured while using it.

CARETAKER'S HOUSE SIDE STAIR WITH MISSING RAILINGS

- Clear overgrowth from entire perimeter of the building.
- Replace damaged trim and siding.
- Replace screen door, stairs and handrails and deck at side door.
- Re-point and repair masonry chimney.

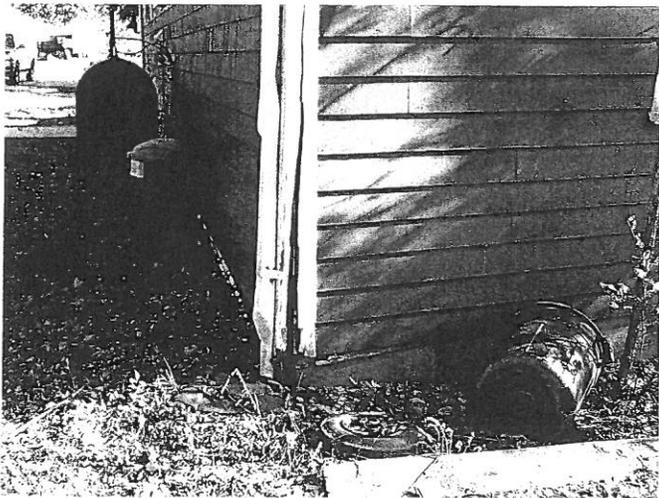
The exterior of the building includes wood shingle siding, clap board siding and wood trim. The paint is peeling and the building is in need of painting. The trim is split at the gutter and downspout location at the rear corner where it appears it has been struck by a vehicle. This trim should be repaired. There is considerable plant overgrowth on the side and back of the house that should be cleared away.

CARETAKER'S HOUSE SPLIT SIDING AND OUTDOOR OIL TANK

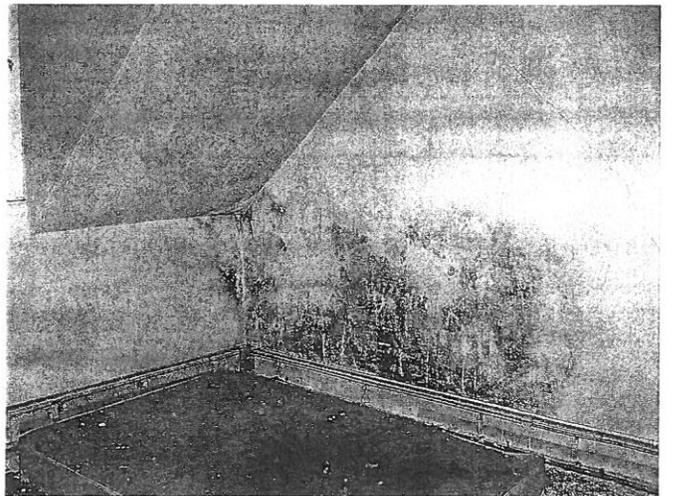
SECOND FLOOR BEDROOM WITH MILDEW GROWTH

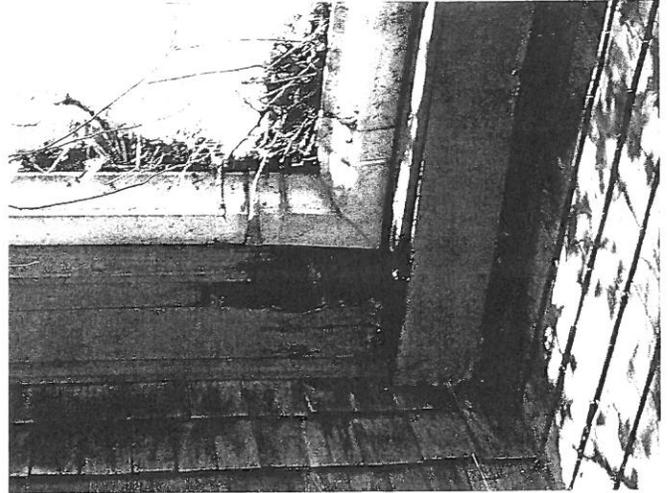
The building is a wood frame structure with wood exterior trim and moldings and cedar shingle siding. The moldings are deteriorated due to neglect over time with approximately 25% of the moldings either missing or deteriorated. The exterior siding is missing in some locations. The siding is in better condition than the other exterior wood trim; however, if this building were to be renovated, the exterior siding would require replacement as well as extensive replacement of the trim.

DETERIORATE ROOFING EAVE AND TRIM

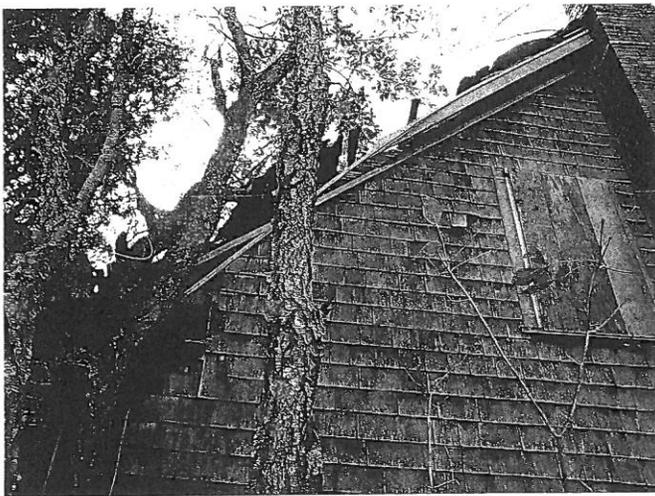
The roof is an asphalt shingle roof that is in a state of disrepair. There are torn and missing shingles and debris from the overgrowth has accumulated in the valleys of the roof and is now growing weeds. The building needs a new roof and other associated waterproofing repairs if it is to be reoccupied or saved for future use. The overgrowth is significant with several good size trees growing too close to the foundations and the building eaves. Although no cracking was observed at the foundation level, the overgrowth has contributed to the accumulated debris on the roof and to the decay of the moldings at the roof line. These trees should be removed if this structure is to be saved.

OVERGROWTH CLOGGING GUTTERS AND ROOF VALLEYS

- Remove overgrowth from entire building perimeter.
- Clean/replace gutters and downspouts and temporarily patch water infiltration points.

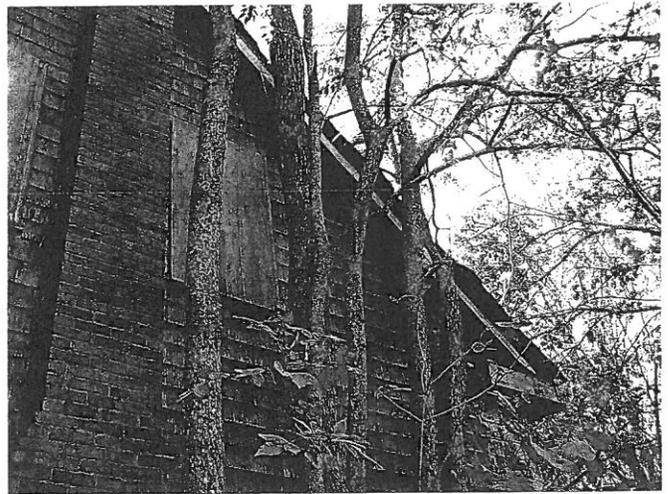
TREES GROWING TOO CLOSELY TO BUILDING

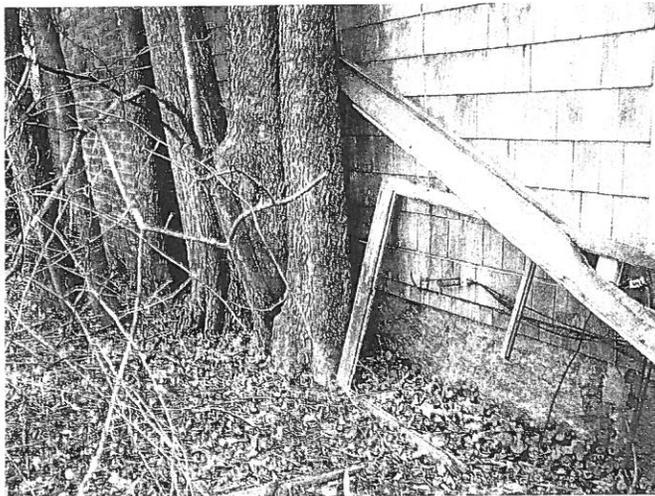
TREES GROWING IN CLOSE PROXIMITY TO FOUNDATION

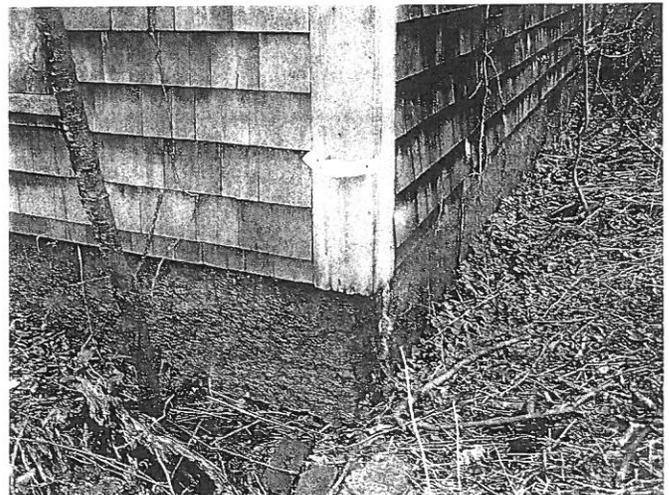
The abandoned house is a two story wood framed building with full basement. The foundations walls are granite and appear to be straight and level. There does not appear to be significant damage to the building foundation, however if the building were to be revitalized an allowance should be included for foundation maintenance work. The wood framing appears to be substantially intact. The walls are plumb and the building roof ridges are level. There is significant damage to roof and wall sheathing and building eaves and trim. Review of the expose roof framing in the attic indicated that this framing appeared to be intact. The exterior chimney is separate from the building and must be removed or stabilized if the building is to be reused.

FOUNDATION GRANITE APPEARS LEVEL AND STABLE

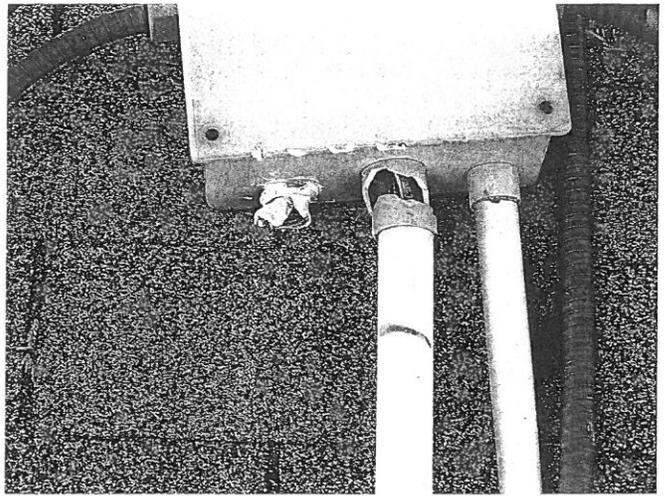
DAMAGED ELECTRICAL FEED

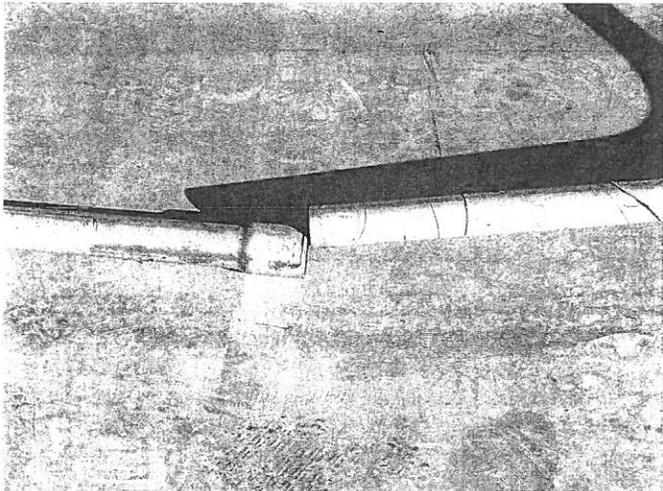
BROKEN ELECTRICAL CONDUIT

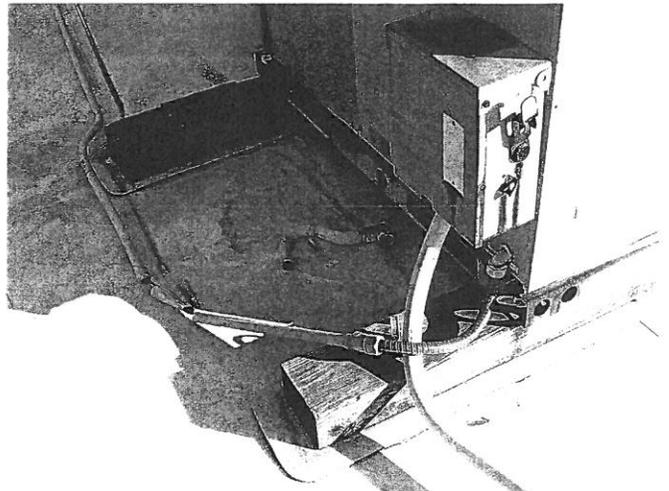
DAMAGED ELECTRICAL AND CONDENSATE DRAIN

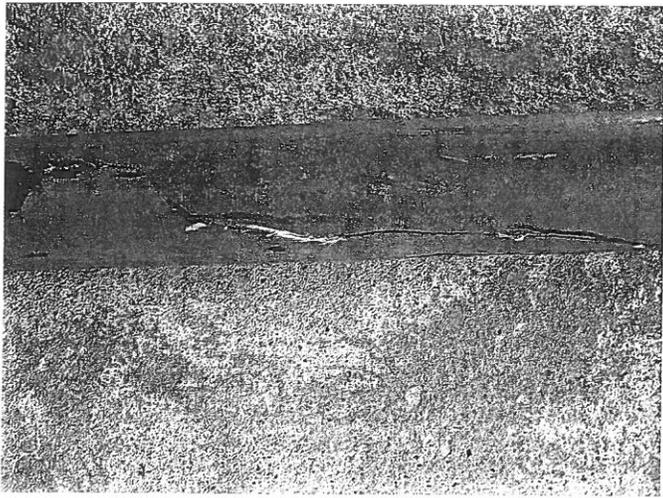
DAMAGED ROOF DRAIN

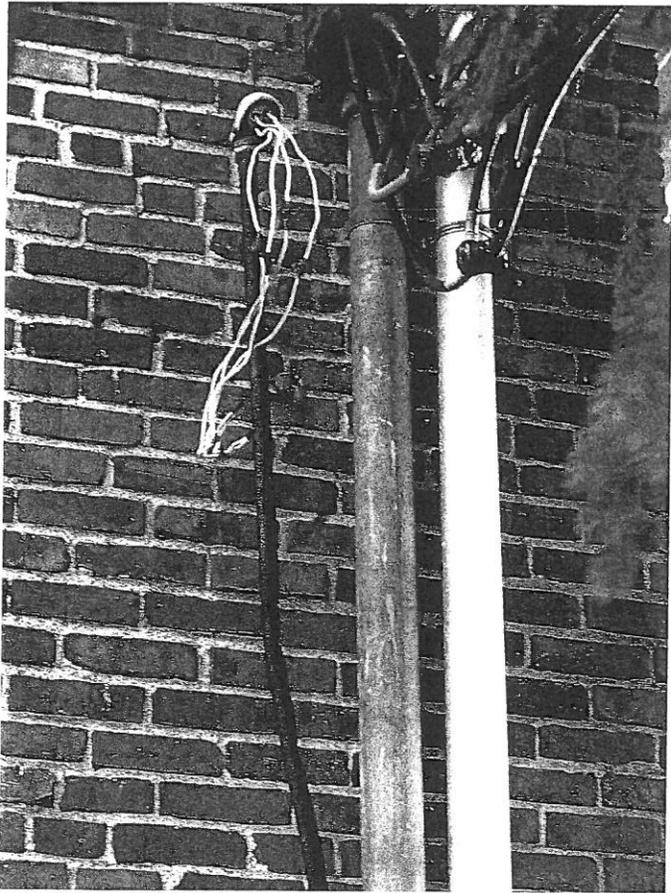
ABANDONED TELCO SERVICE

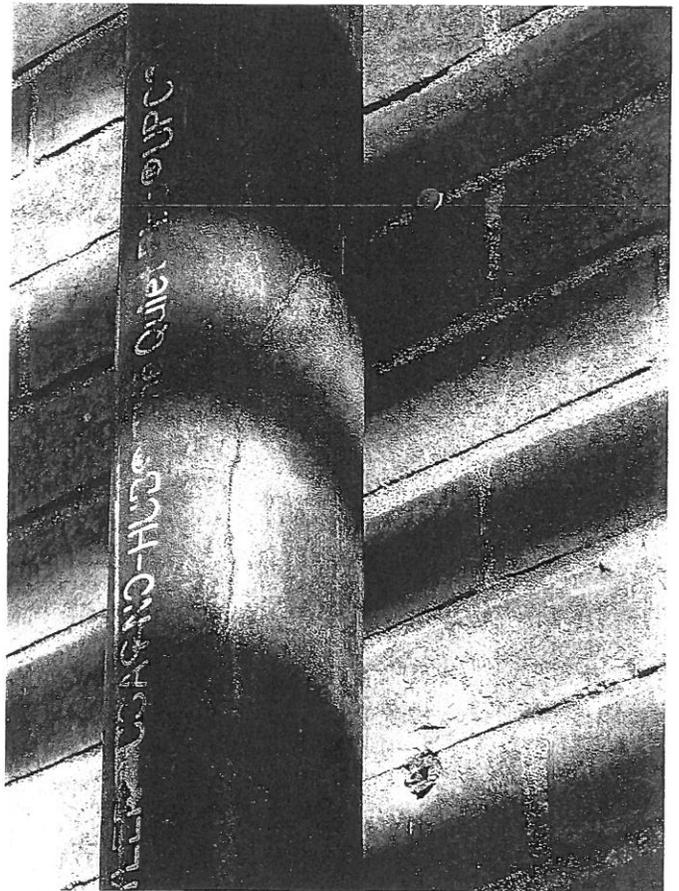
DAMAGED ROOF DRAIN
