RE: Shellfish Survey, 35 Bel Air Road, Hingham, Massachusetts

SHELLFISH SURVEY REPORT

35 Bel Air Road, Hingham
Shellfish Survey Photographs

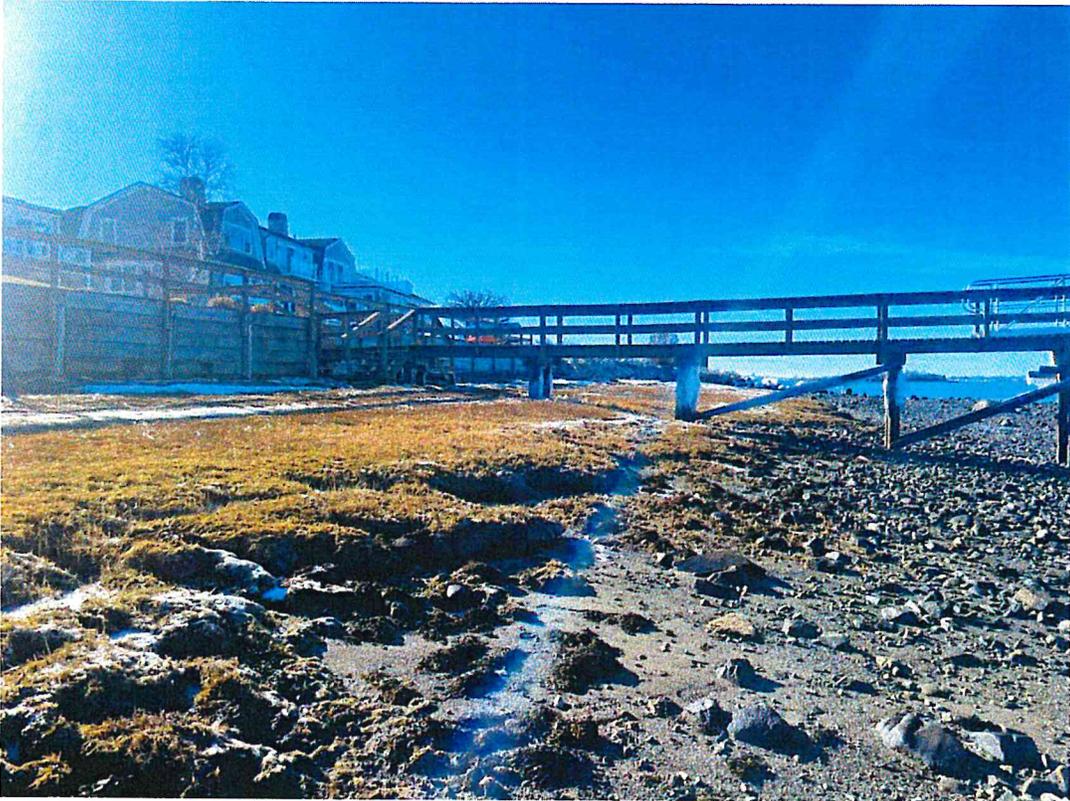
Photograph #1 – View west toward the existing pier.

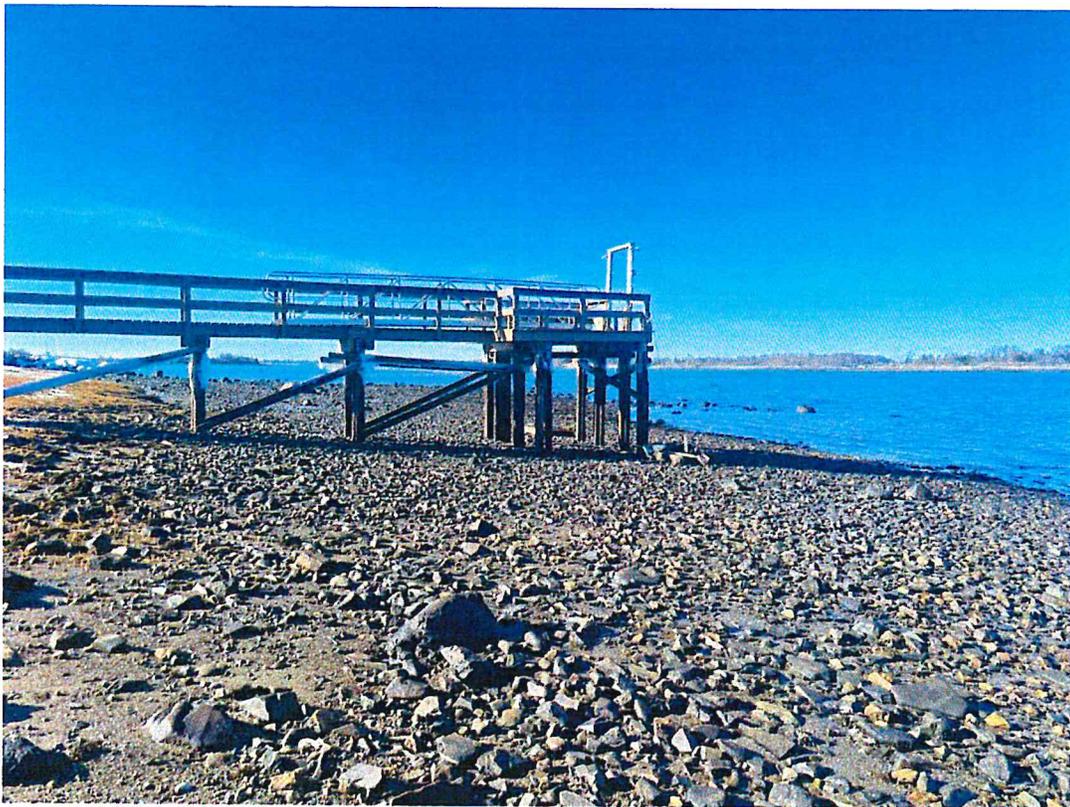
Photograph #2 – Another view west toward the end of the existing pier.

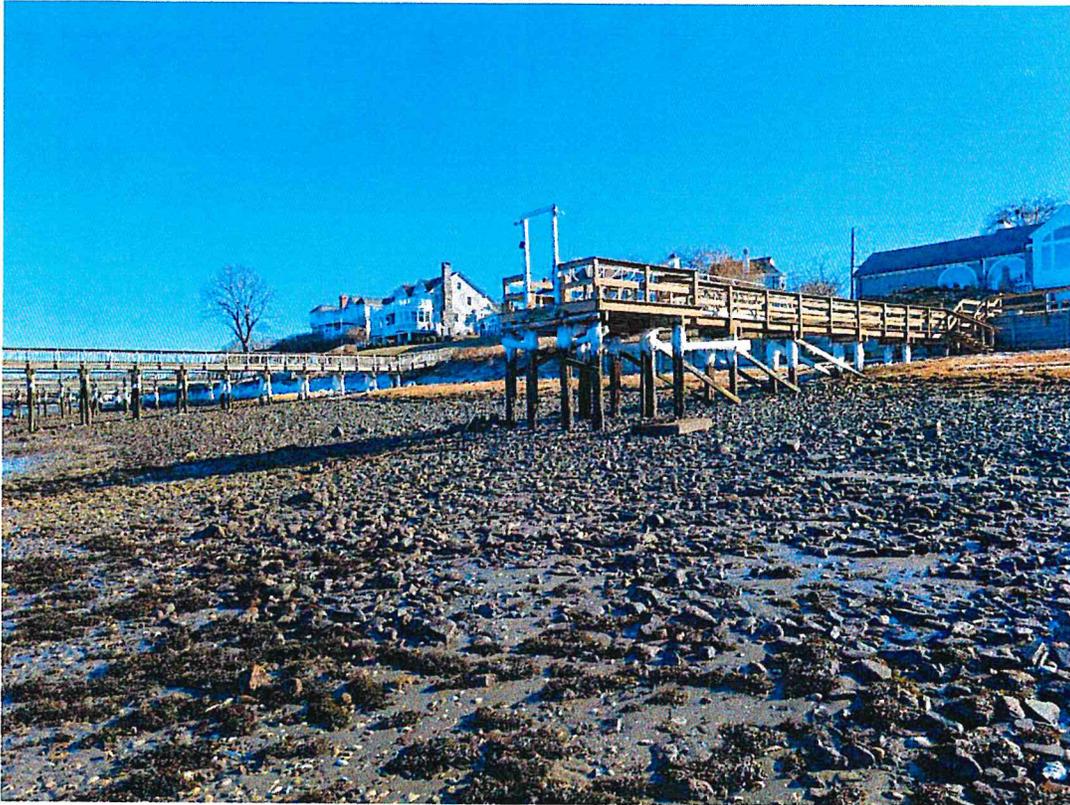
Photograph #3 – View east toward the end of the existing pier.

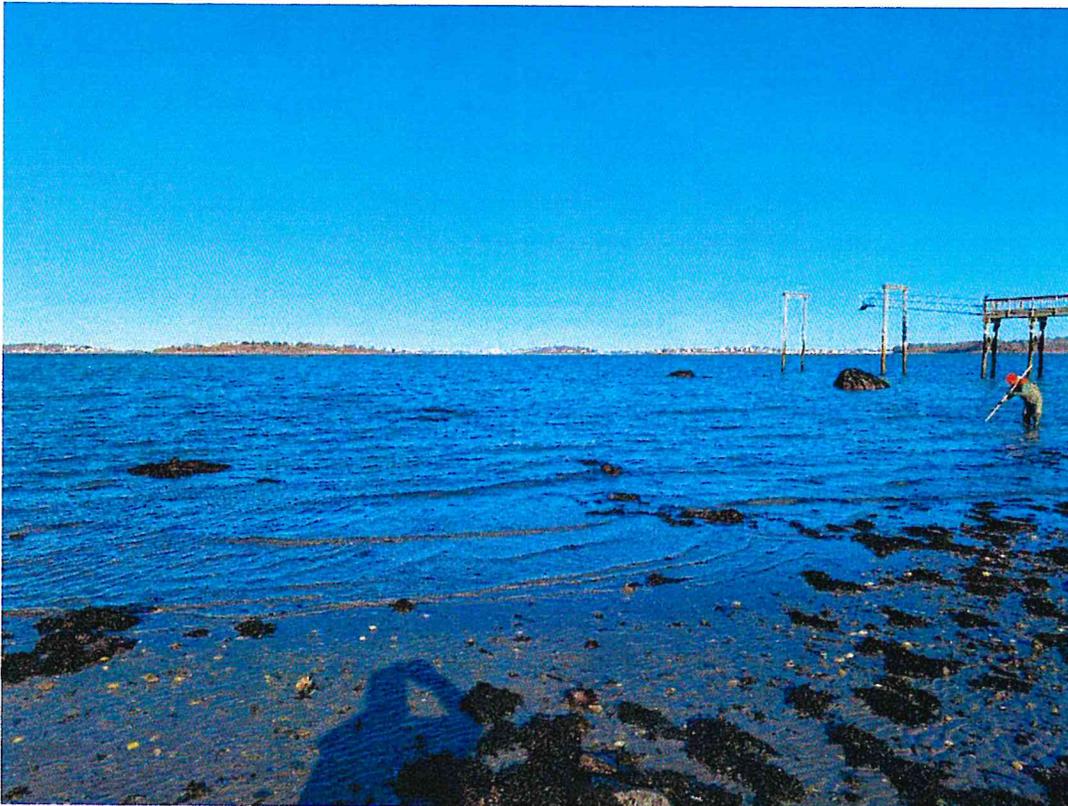
Photograph #4 – View across the survey area just north of the existing pier.

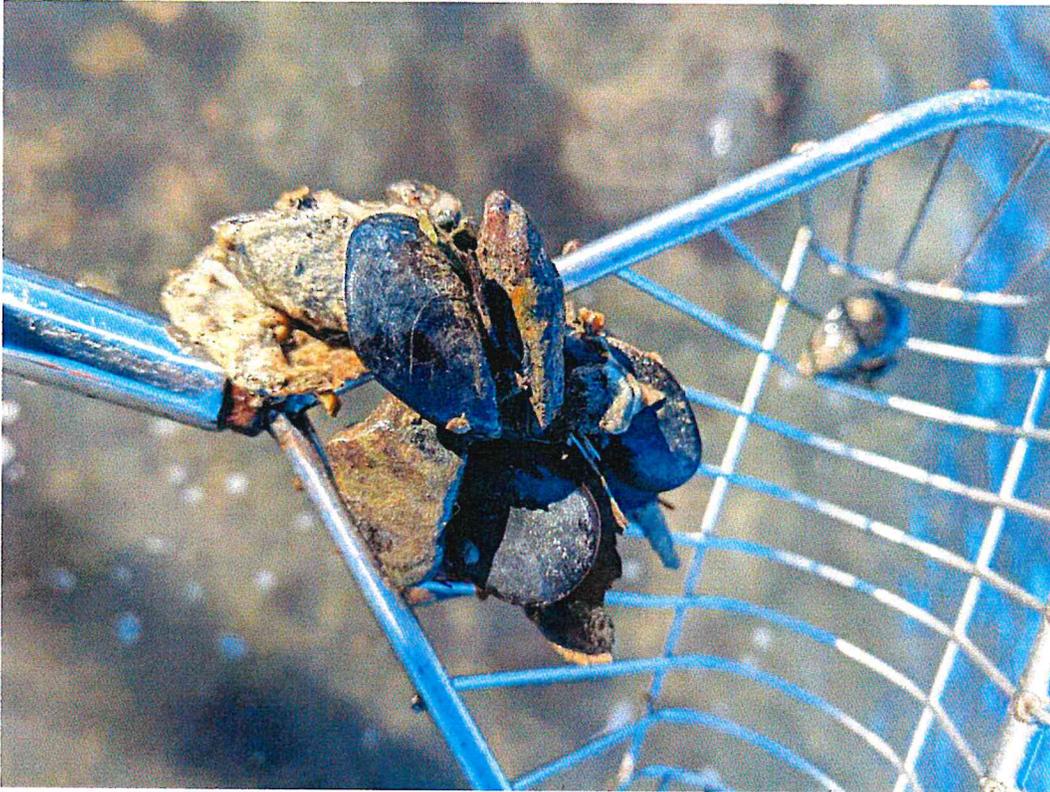
Based on ECR's survey, Softshell Clams (*Mya arenaria*) were the only species recorded within the survey plots. Near Transect A and to the west of the survey area, ECR found a small number of Blue Mussels attached to scattered rocks lying on the ocean floor. The Blue Mussels (*Mytilus edulis*) consist of small clusters attached to the rocks, which are below the Mean Low Water line and outside the project area. Additionally, a minimal number of Oysters (*Crassostrea virginica*) were found in the survey area beyond the examination plots. No other shellfish were found during the survey.

Photograph #5 – View of Blue Mussels found attached to rocks within the survey area.

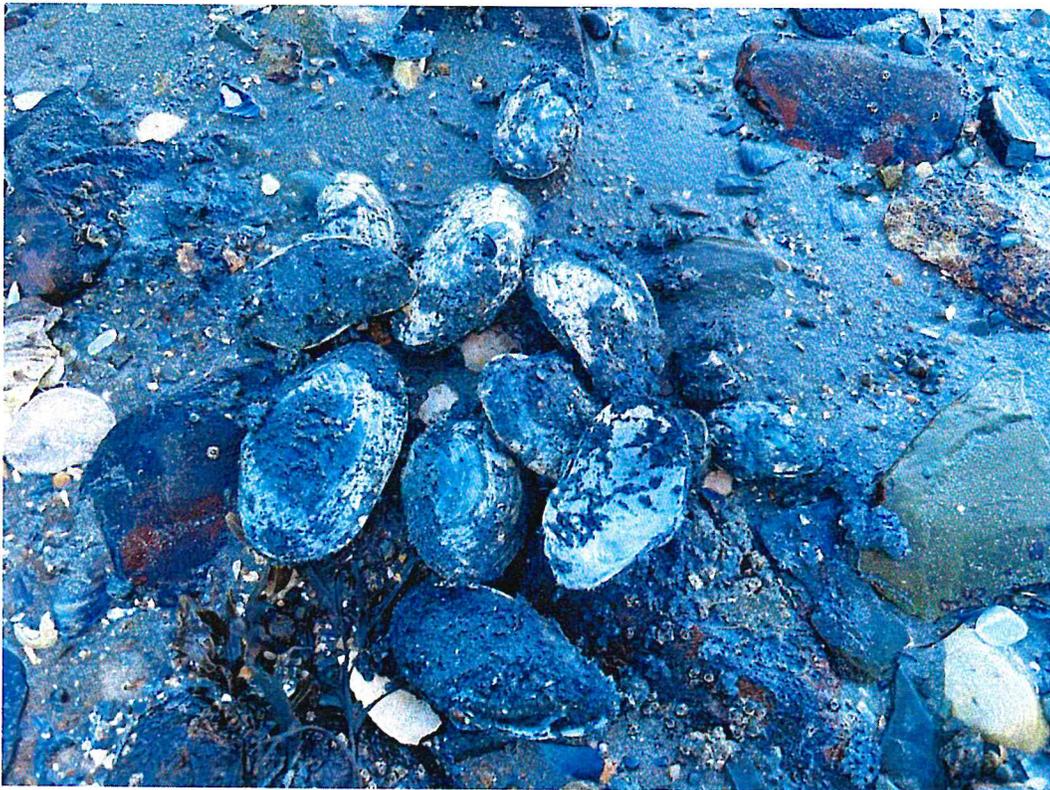
An analysis of shellfish density across the 11 survey plots reveals a very low density of Softshell Clam. As noted above, a minimal number of Oysters and Blue Mussels were found near the project area. Within the survey plots, ECR found a significant amount of dead Softshell Clams and shell hash throughout the intertidal zone. It appears the site may have historically been a productive habitat for Softshell Clams, but that is no longer the case. This may be due to the presence of the invasive Green Crab, which extensively feeds on Soft Shell Clams. ECR observed similar conditions in Hingham near the Weymouth Back River where survey plots were abundant with dead Soft Shell Clams from the invasive Green Crab.

Photograph #6 – View of numerous dead soft shell clams found within a plot within the survey area.

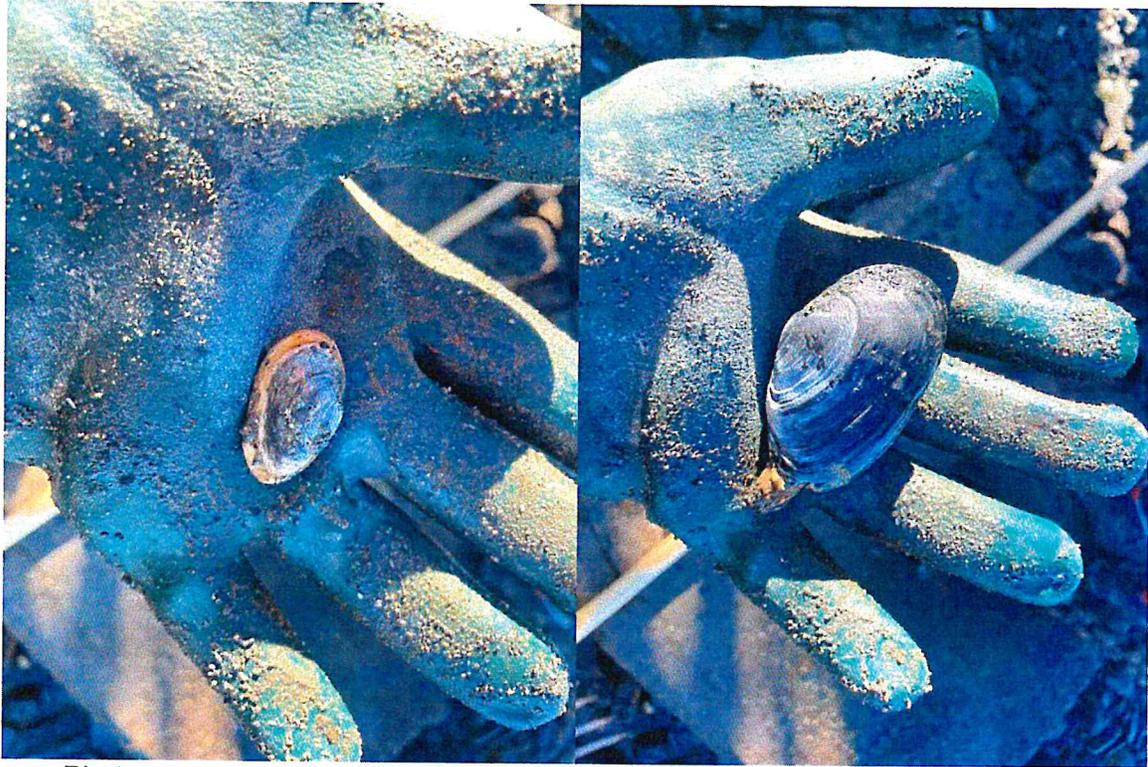
Photograph #7 – View of two softshell clams found alive within the survey area.

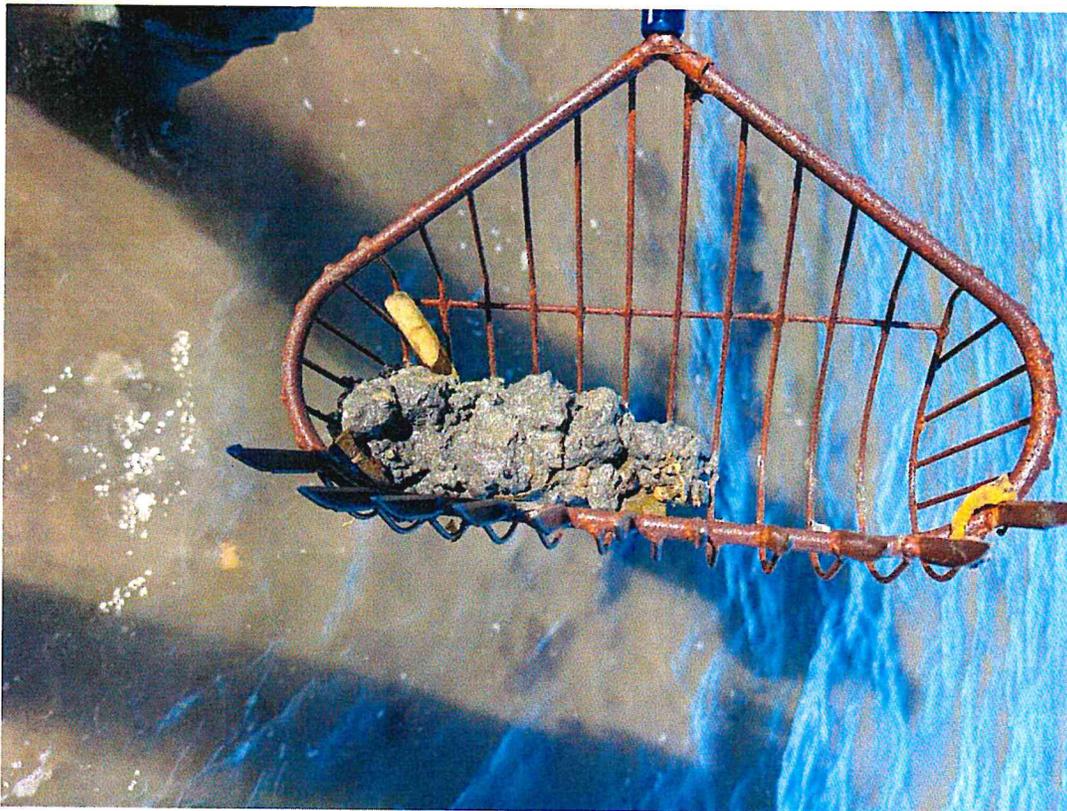
Photograph #8 – View of the sediment found within the survey area. Sediment was silty with a significant amount of cobble present.
