May 08, 2025

**RE: 53 Bel Air Road, Hingham, MA  
Response to Comments from Conservation Officer**

**Tree and Shrub Care Plan**

## TREE AND SHRUB CARE PLAN

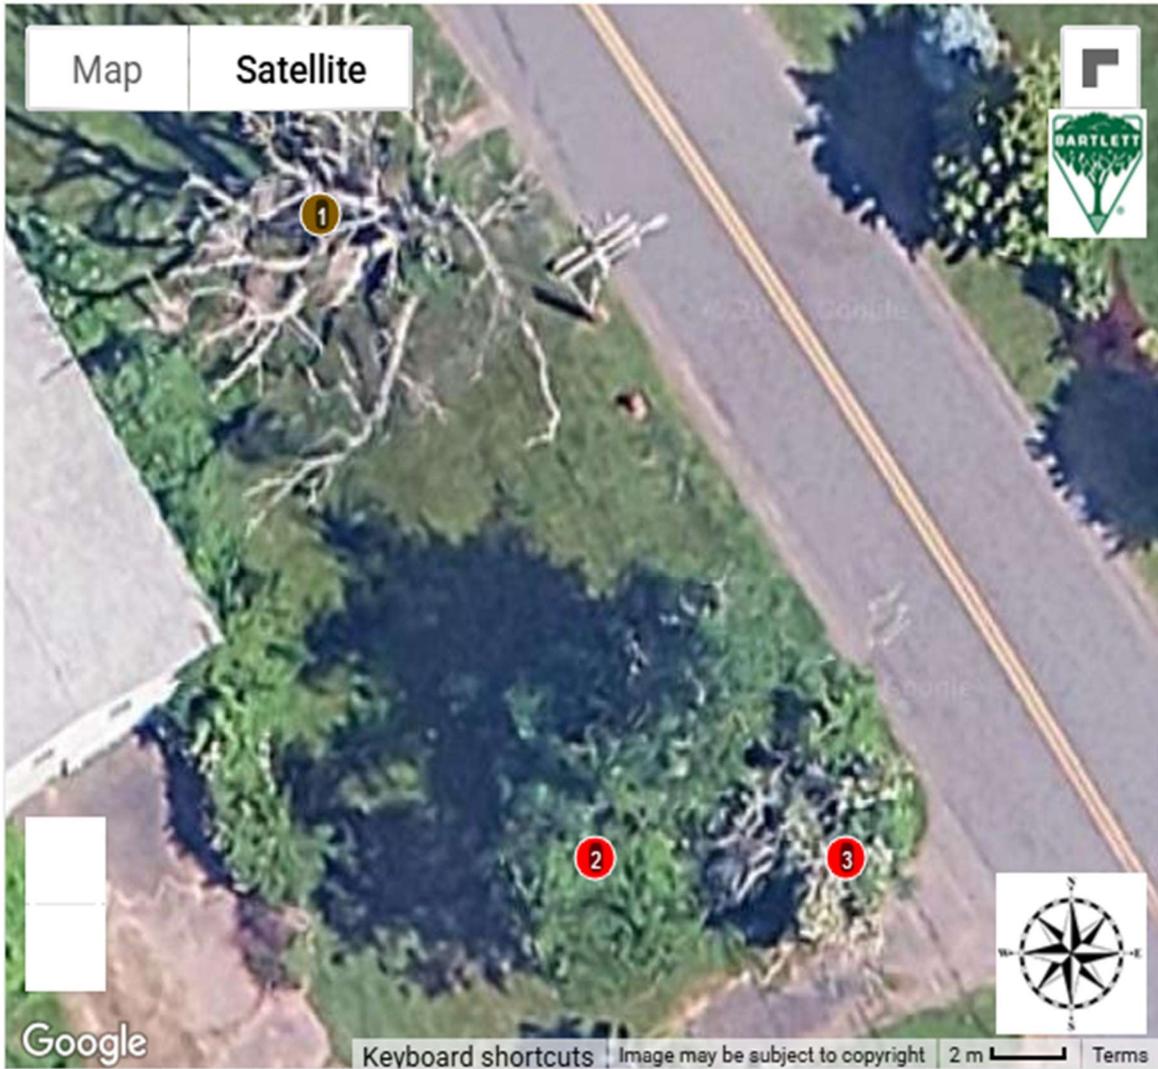
Tree #1 is a 48” multi-stem Black Cherry. This tree is dead. Given its proximity to electrical wires, Bel Air Road and the existing structure, it would be my professional opinion that this tree poses an unreasonable risk of failure and should be removed as soon as possible.

Tree #2 is a 28” Black Cherry. This tree is in very poor condition and should not be considered viable. There is significant dieback in the upper crown as well as areas with significant decay present. Given its proximity to electrical wires, Bel Air Road and the existing structure, it would be my professional opinion that this tree poses an unreasonable risk of failure and should be removed as soon as possible.

Tree #3 is a 40” multi stem Apple tree. This tree is in very poor condition and should not be considered viable. Given its proximity to electrical wires, Bel Air Road and the existing structure, it would be my professional opinion that this tree poses an unreasonable risk of failure and should be removed as soon as possible.

**Condition:** ● Poor ● Dead

Tree ID	Common Name	Condition Class	Recommendations
1	Cherry-Black	Dead	<ul style="list-style-type: none"> <li>Remove</li> </ul>
2	Cherry-Black	Poor	<ul style="list-style-type: none"> <li>Remove</li> </ul>
3	Apple-Common	Poor	<ul style="list-style-type: none"> <li>Remove</li> </ul>
