Re: Sight Distance Assessment  
Corey's Way Subdivision – 213 Cushing Street  
Hingham, Massachusetts

**Corey's Way Subdivision Sight Distance Assessment  
October 27, 2020**

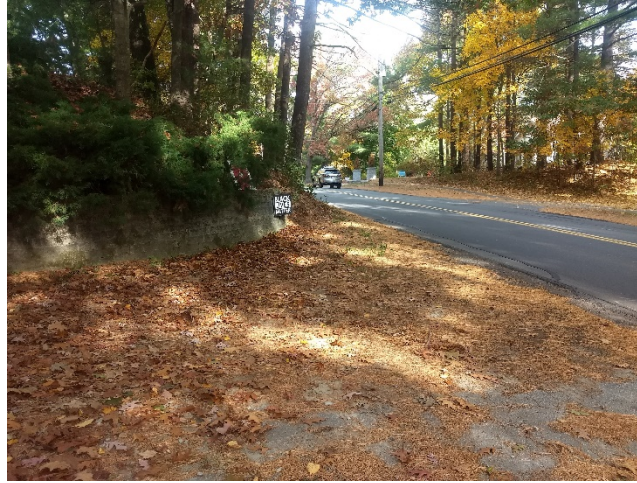
**Looking to the North from Corey's Way**

As can be seen in Table 1, the available lines of sight along Cushing Street approaching Corey's Way were found to exceed the recommended minimum sight distances for safe operation for both the posted speed limit and the measured 85<sup>th</sup> percentile vehicle travel speed. Lines of sight for a motorist exiting Corey's Way were found to be **below** the recommended minimum sight distances for both the posted speed limit and measured 85<sup>th</sup> percentile vehicle travel speed. The limiting factors were identified as four (4) large pine trees, an embankment and a block retaining wall to the north, and two (2) large pine trees to the south.

The Project proponent applied for and has received approval to remove the subject trees pursuant to M.G.L. c. 87 § 3, the Public Shade Tree Act. In addition to the tree removal, the Project proponent will need to regrade the embankment situated to the north of Corey's Way and reconstruct a portion of the existing block wall in order to achieve the recommended minimum sight distance (280 feet) looking to the north of the driveway. It appears that the required improvements can be completed within the Project site or the public right-of-way.

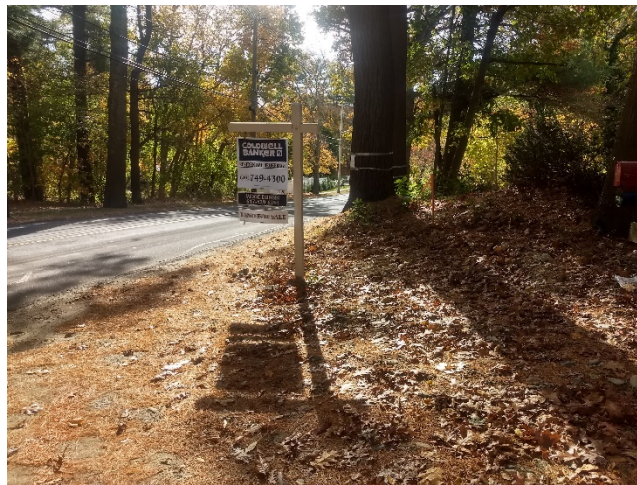
**Looking to the South from Corey's Way**
