Re: Statement of Catch Basin construction under Order of Conditions

On Saturday, January 25, 2025, I performed a field inspection of all the catch basins at Ridgewood Crossing in Hingham, shown as Lot 96 on Map 115 of the Town of Hingham. Of the twenty-four catch basins in the development, twenty-two are roadway catch basins. All of the roadway catch basins contained sumps and Oil/Gas traps. See figure 1, however in CB 3 (5+36.98 Rt) the Oil/Gas trap is broken. See figure 2.

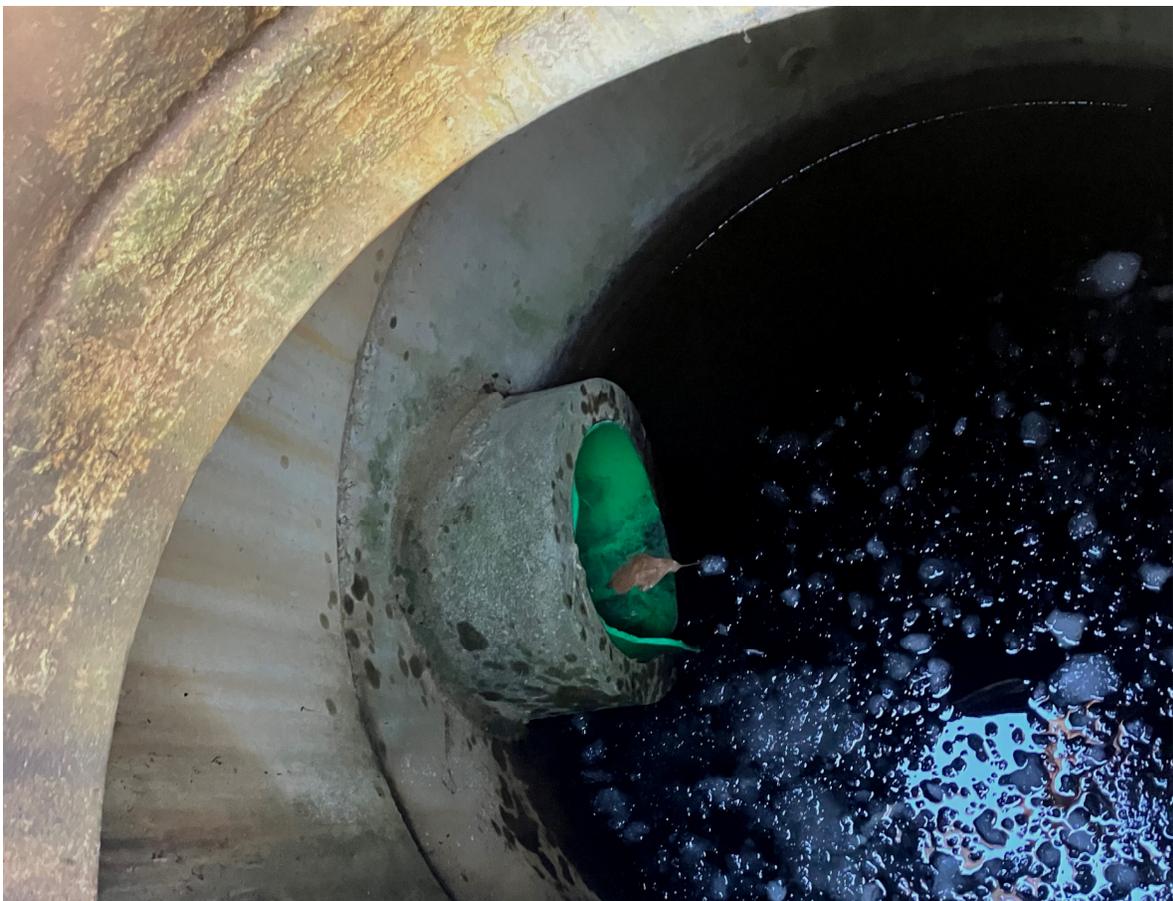
Figure 2.

In conclusion, the only potential discrepancy I observed is CB 3 in which the Oil/Gas trap is broken off, most likely by cleaning equipment.
