December 2, 2025

Re: Peer Review of Request for Determination of Applicability  
Carlson Complex Pickleball Courts, 25 Bare Cove Park Drive, Hingham, MA

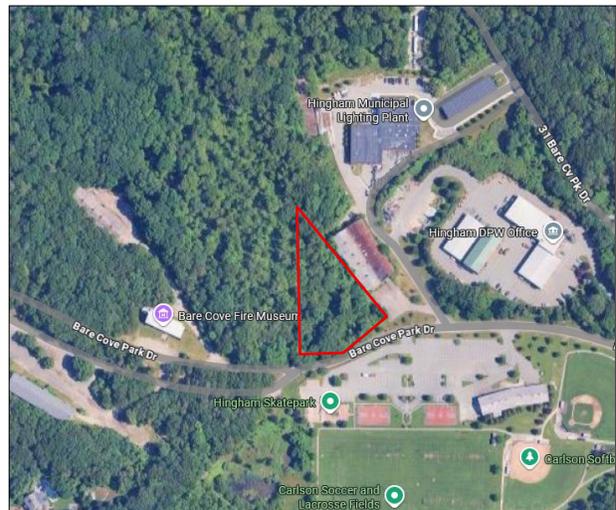
Figure 2. Aerial view of the Project area; Site outlined in red.

The Site consists of an undeveloped forested area adjacent to the abandoned structure noted above, with an associated parking lot between the building and Bare Cove Park Drive to the south. Bare Cove Park Drive forms the Site's southern boundary and separates it from additional town-owned property containing Bare Cove Park across the street. The Hingham Municipal Lighting Plant, Department of Public Works, and Sewer Department currently operate within additional buildings located farther east of the Site within the same parcel. The Bare Cove Fire Museum is on a separate parcel to the east of the Site, located east of its associated access drive off Bare Cove Park Drive and approximately 350 linear feet from the Site. Additional undeveloped forest is present between the Museum's access drive and the Site, covering a narrow strip of a third parcel, which connects to Beal Street northeast of the Site. The majority of the CVP is contained within this third parcel, which widens as it spans farther north. A USGS topographic map depicting the parcel boundaries and an aerial view of the Site and surrounding lands is provided in [Figures 1 and 2](#).

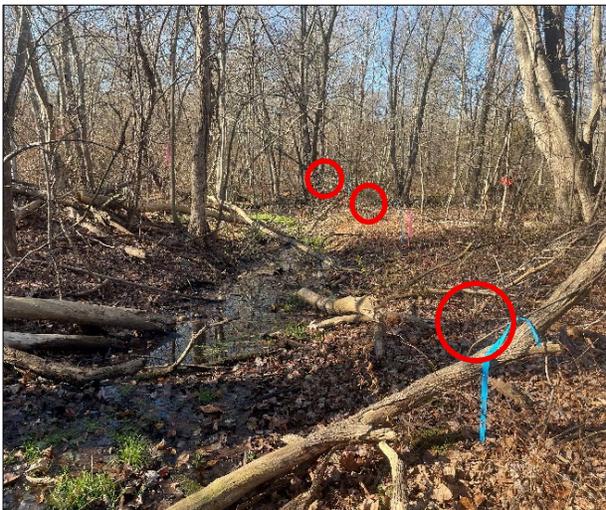
HW found that the Banks of Channel 1 extended beyond flag CH1-1 as the channel bends to the southeast, and added three additional blue flags, labeled as CH1-1-HWA1, CH1-1-HWA2, and CH1-1-HWA3, to demarcate the full extent of its eastern bank (Figure 3). No flags were added to its western Bank, as no work is proposed on that side of the stream.

Figure 3. HW's blue flags (circled) demarcating the extension of Channel 1 along its eastern Bank. Looking north

1. HW recommends that Applicant update the Existing Conditions Plan with the GPS coordinates provided by HW to accurately depict the revised extent of Channel 1 and the Banks of the tributary to Channel 1, identified as "HWS1", and that the updated plans be provided to the Commission.

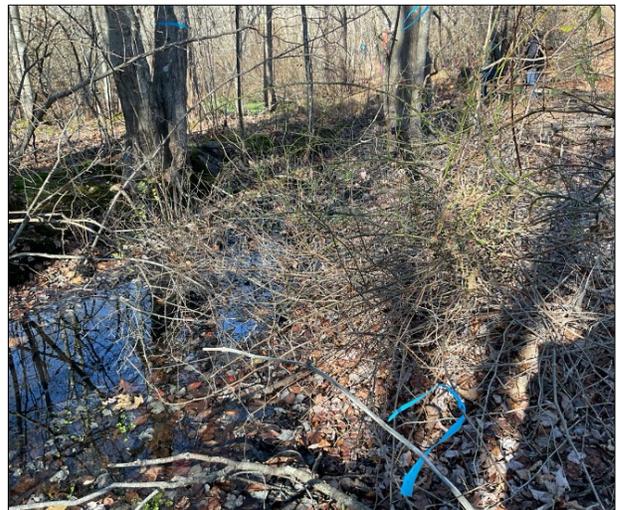
HW also identified a small tributary to Channel 1, converging with the stream at flag CH1-1. HW and the CHA added blue flags labeled as HWS1-100 to HWS1-102 along its eastern Bank, and HWS1-200 to HWS1-203 along its western Bank (Figure 4).

Figure 4. HW's blue flags demarcating either side of a tributary to Channel 1, identified as "HWS1". Looking west

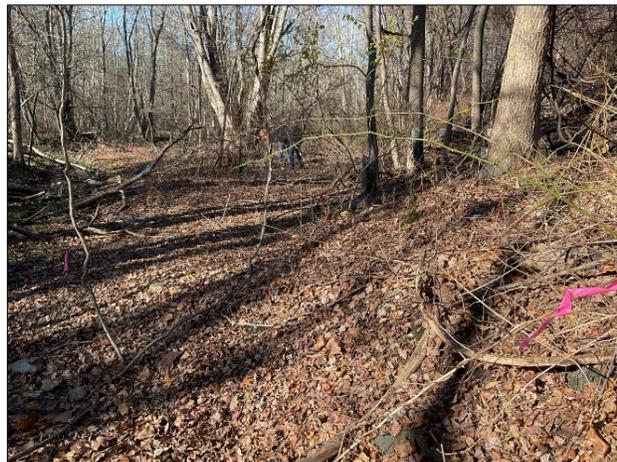
- Remove BVW boundary flags WFA-6 through WFA-9<sup>1</sup>, such that flags WFA-5 and WFA-10 connect directly ([Figure 5](#)); and
  - Relocate WFA-2 approximately eight feet to the northwest, where HW's revised pink flag labeled as HWR-WFA-2 was hung ([Figure 6](#)); and
  - Extend the BVW in a southwesterly direction ([Figure 7](#)), demarcated with HW's additional pink flags labeled sequentially as HWA1-WFA-1, which connects to CHA's flag WFA-4, through HWA7-WFA-2, which connects to HW's revised HWR-WFA-2 flag, and that CHA's flag WFA-3 be removed.
2. HW recommends that Applicant update the Existing Conditions Plan with the GPS coordinates provided

Figure 5. View of BVW expanded between CHA flags WFA5 and WFA-10. Looking northwest from WFA-5

by HW to accurately depict the revised extent of BVW as detailed above, and that the updated plans be provided to the Commission.

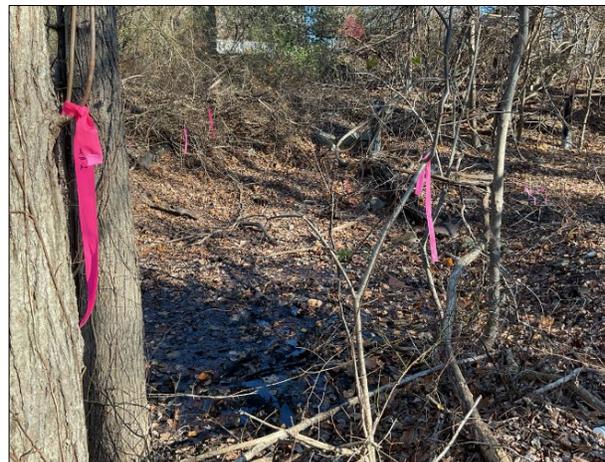
Figure 6. Figure 6. HW's revised HWR-WFA-2 flag at left, and CHA's original WFA-2 flag in view to the right. Looking southeast

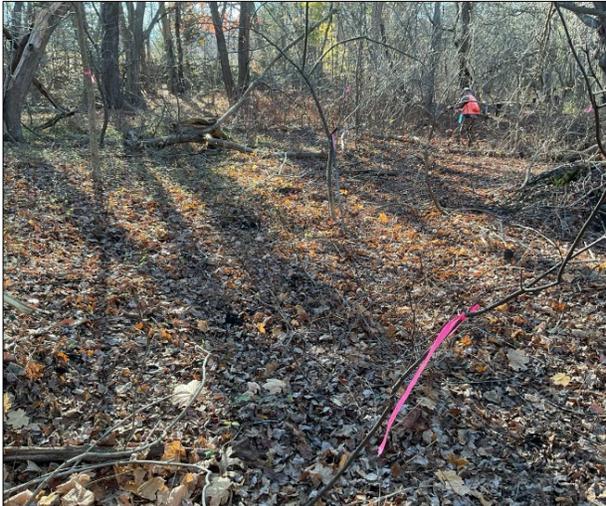
Figure 7. View of area where BVW was extended to the southwest. Looking southwest from the same position as Figure 6

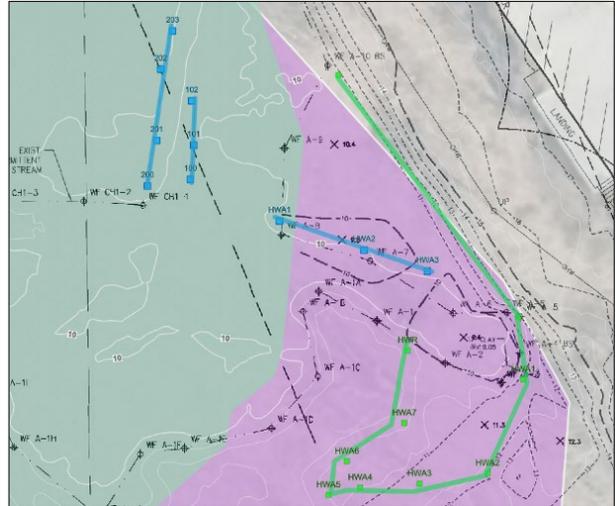
An aerial view of HW's revised flagging locations overlain on the Existing Conditions Plan is provided in [Figure 8](#).

Figure 8. Aerial view of HW's revised flagging locations overlain on the Existing Conditions Plan. Connected green points indicate the revised wetland boundary; connected blue points indicate the revised Wetland Banks; sequential flag nomenclature depicted.

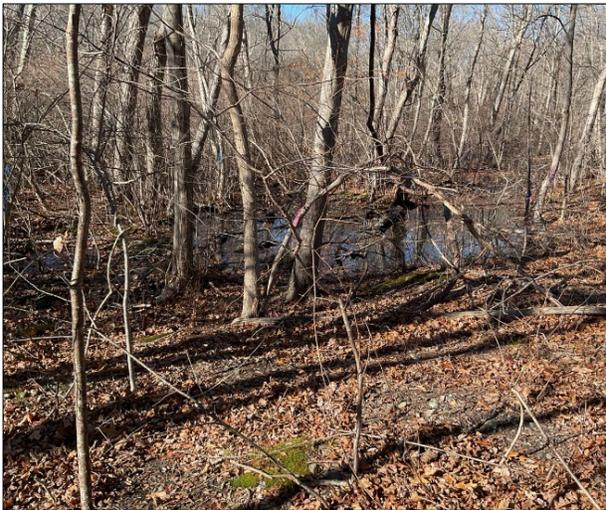
The CVP boundary closely aligns with the 9 foot contour elevation, as shown in the Existing Conditions Plan. This topographic break was clearly evident in the field ([Figure 9](#)), and the immediately adjacent areas at higher elevations supported herbaceous and shrubby vegetation ([Figure 10](#)). The presence of non-aquatic vegetation indicates that these areas are less likely to provide the minimum two months of inundation in the spring and summer of most years, as necessary for a CVP hydroperiod.

Figure 9. CVP demarcated by CHA's blue flagging (inundated area). *Looking northwest*

4. HW recommends that the Commission accept the boundary of the CVP as delineated by CHA and as depicted in the Existing Conditions Plan for the purposes of any Determination the Commission may issue.

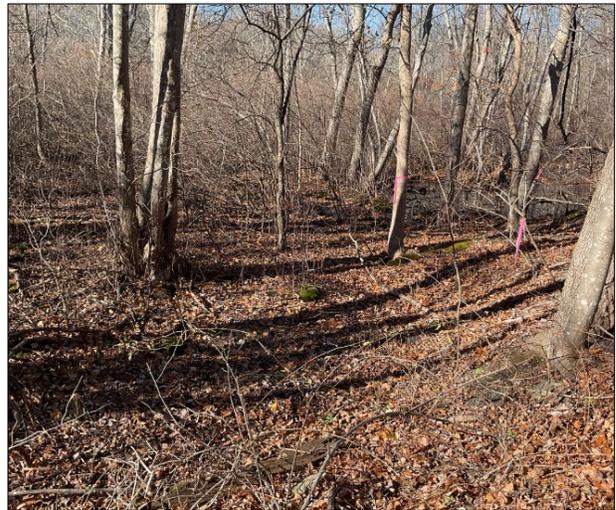
Figure 10. Area just south of Figure 8, showing herbaceous and shrubby vegetation in the immediately adjacent area of higher elevation. *Looking northwest*

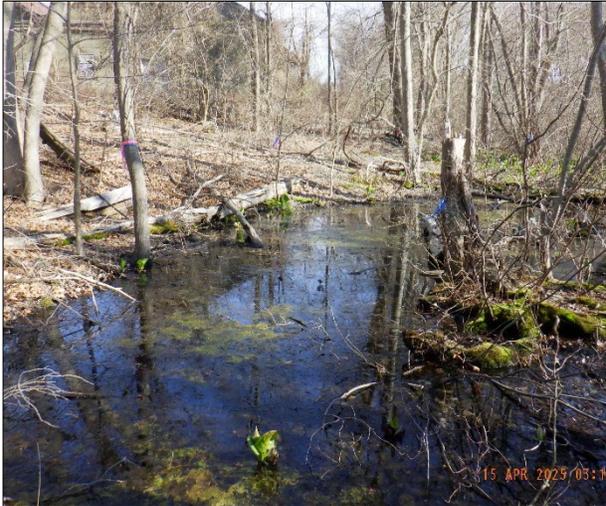
HW requested that CHA provide additional photos of the CVP taken during their delineation in April 2025, and CHA sent these photos to HW and the Commission via email on November 20, 2025. CHA's photos show that the inundation in the CVP at that time was covering a similar area and is consistent with the topographic break as observed during HW's visit ([Figures 11](#) and [12](#)).

Figure 11. CVP demarcated by CHA's blue flagging (inundated area); photo taken by CHA in April 2025. Looking southeast

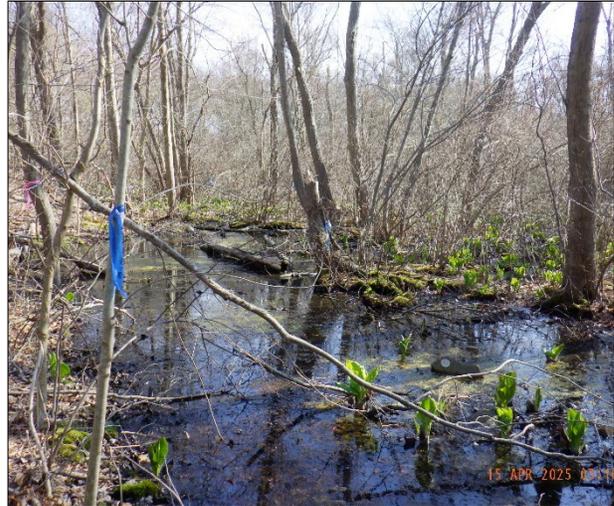
Figure 12. Additional view of the CVP shown in Figure 9; photo taken by CHA in April 2025. Looking south
