# Wetland Delineation Report

## Proposed Hingham Center for Active Living Facility

### EDM Studio, Inc

SLR Project No.: 141.051021.00001

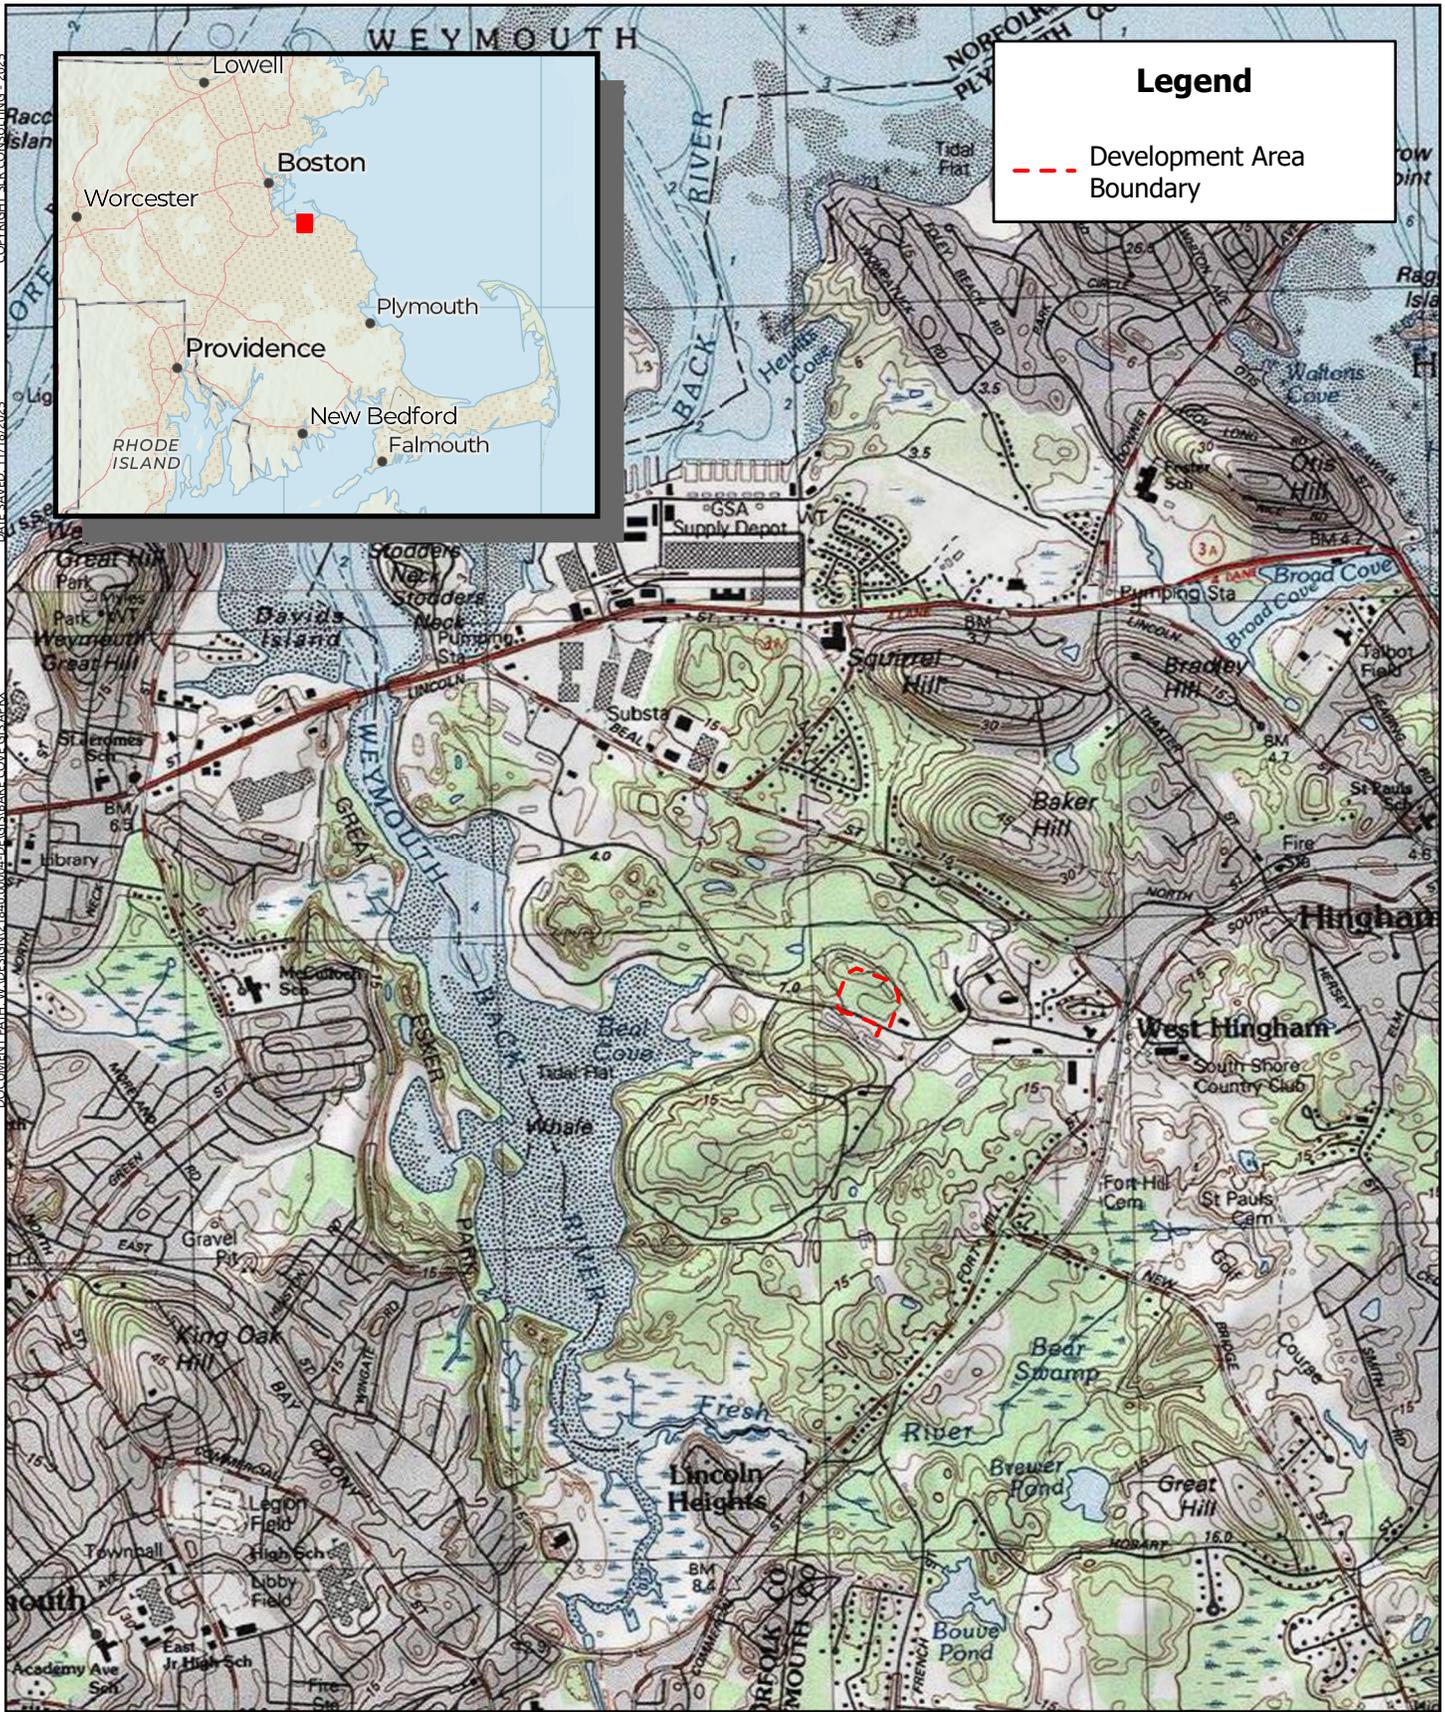
**FIG. 1**

Proposed activities are limited to a  $\pm 5.3$ -acre area, referred to herein as the “Development Area Boundary”, **Figure 1**. Resource delineation efforts and classification of existing natural communities within approximately 200 linear feet of this area were completed as part of this study to support land-use decision making. In total, the “study area” is approximately 20 acres and the Development Area Boundary is  $\pm 5.3$  acres.

**USGS LOCUS MAP**

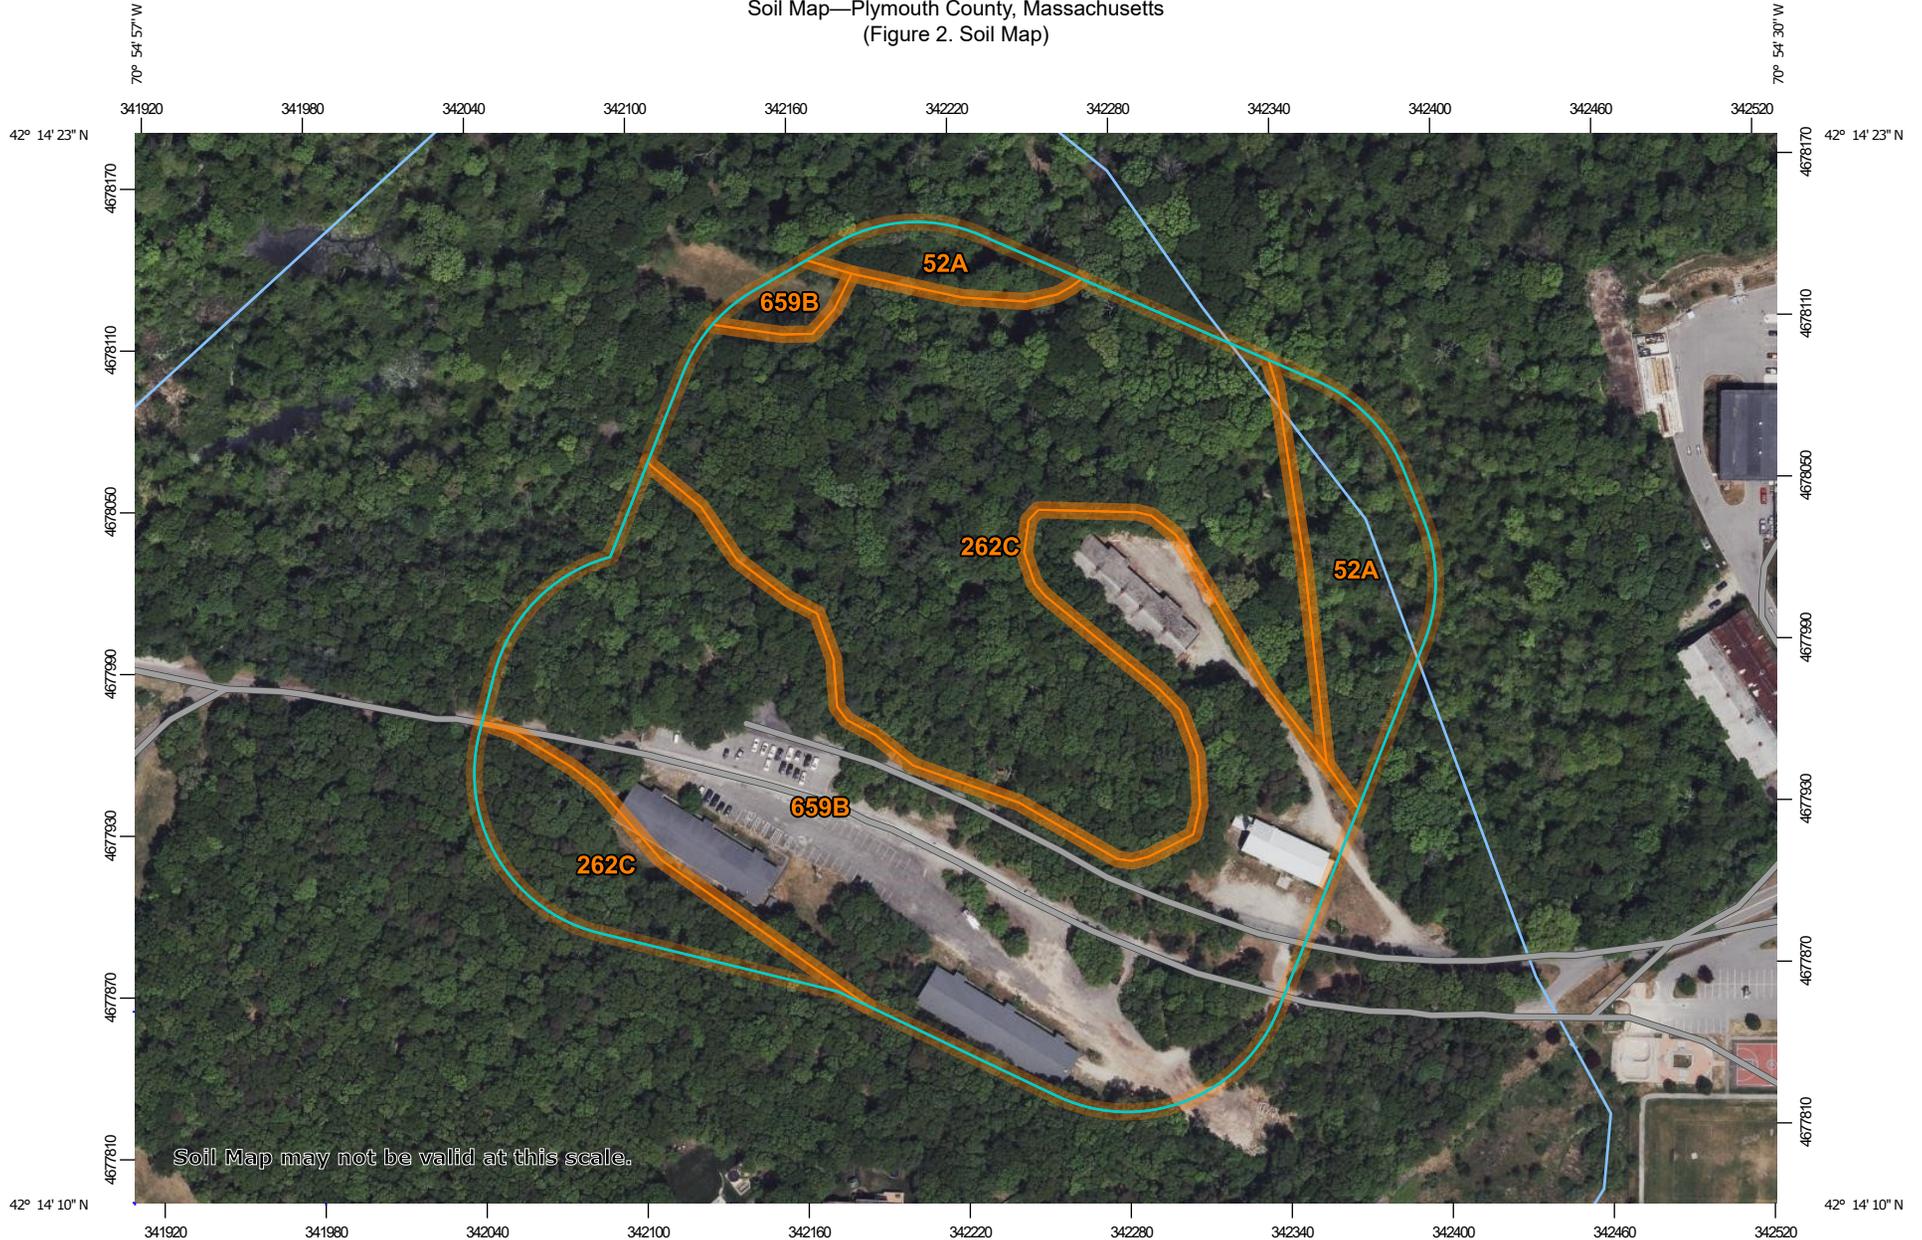
Soil Map—Plymouth County, Massachusetts  
(Figure 2. Soil Map)

Geospatial data were accessed via the USDA – Natural Resources Conservation Service (USDA-NRCS) web soil survey mapping. The soil survey mapping is appended (**Figure 2**). The survey identifies the following soil mapping units with associated NRCS map number in the study area:

- Freetown muck, 0 to 1 percent slopes (52A) – Very poorly drained
- Quonset sandy loam, 8 to 15 percent slopes (262C) – Excessively drained
- Udorthents, 0 to 8 percent slopes, gravelly (659B) – Well drained

The soil survey mapping identified one very poorly drained soil unit within the study area, Freetown muck. In general, soils were found to be consistent with those mapped by NRCS.

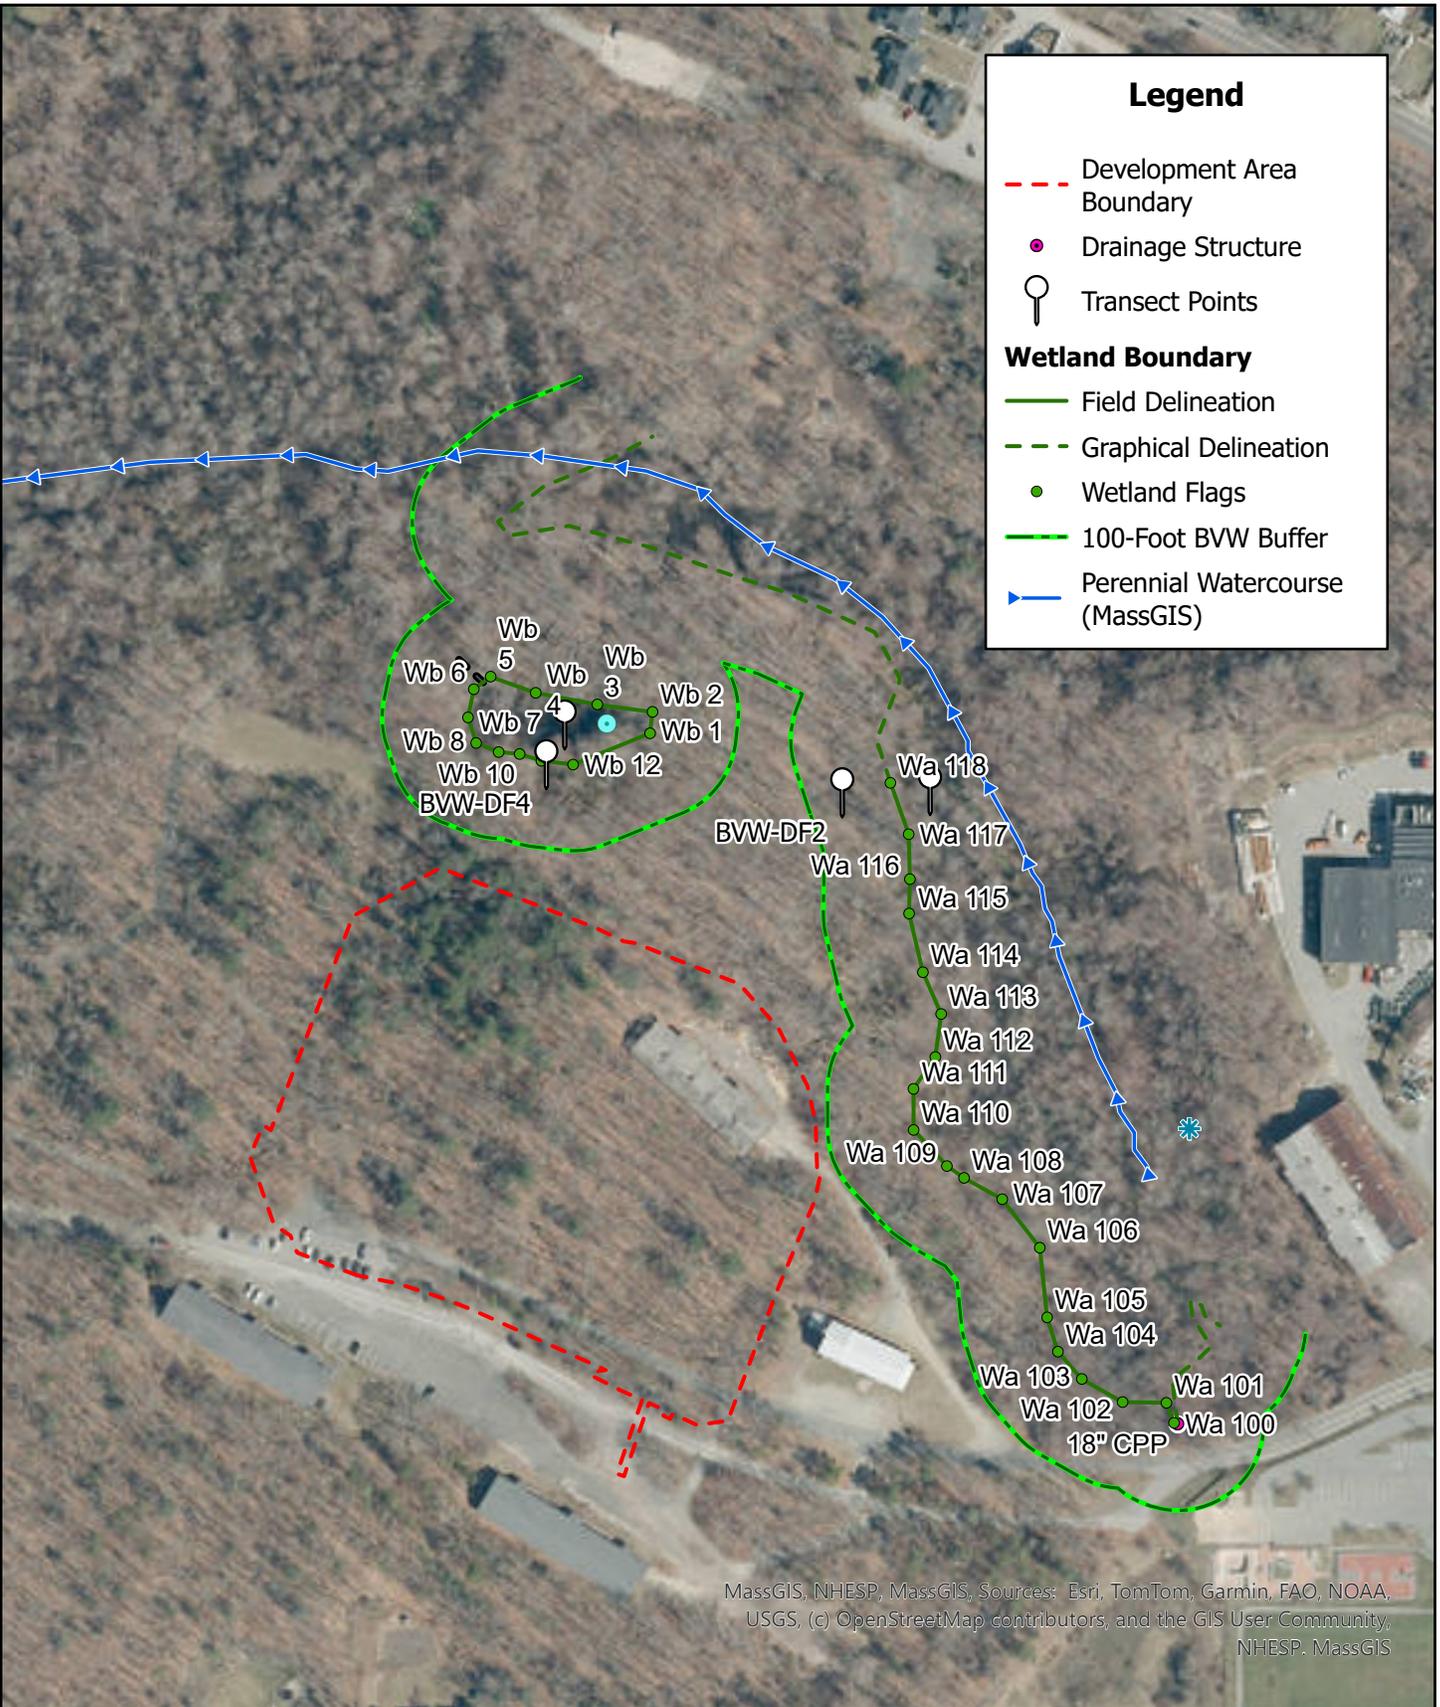
**FIG. 3**

Two palustrine forested wetland areas were delineated east and north of the Development Area Boundary. The eastern resource area is delineated by flag series WA-100 through WA-118 (Wetland A) on **Figure 3**.

The northern resource area, delineated by flag series WB-1 through WB-12 (Wetland B), is an isolated depression (i.e., isolated vegetated wetland) approximately 0.75 acres in area. At the time of SLR's site visit, standing water was present in the central, deeper portions of the depression. Water depths reached a maximum of approximately 10-inches. Leaf staining adjacent to areas with standing water were observed and are indicative of fluctuating water levels throughout the seasons. This wetland is mapped as a potential vernal pool by MassDEP.

**WETLANDS AND WATERCOURSES**  
HINGHAM CENTER FOR ACTIVE LIVING  
EDM STUDIO, INC.  
BARE COVE PARK DRIVE  
HINGHAM, MASSACHUSETTS

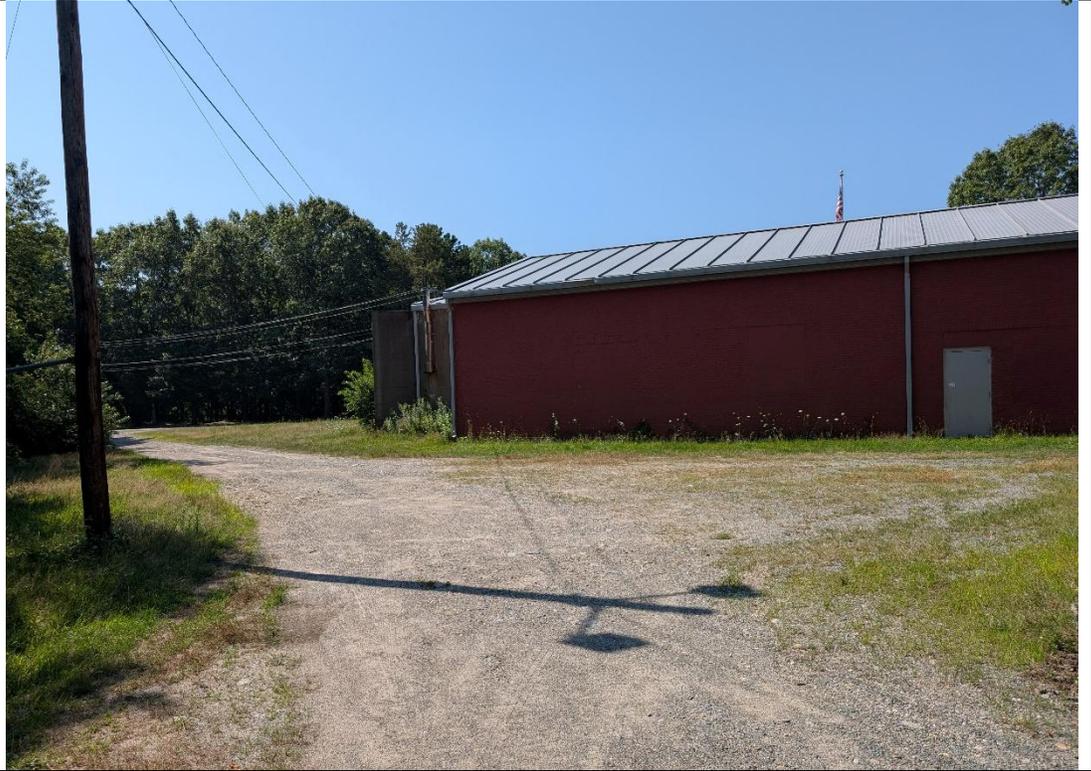
Direction Photo Taken:  
South

Description:  
Existing building (Bare Cove  
Fire Museum) and gravel  
roads

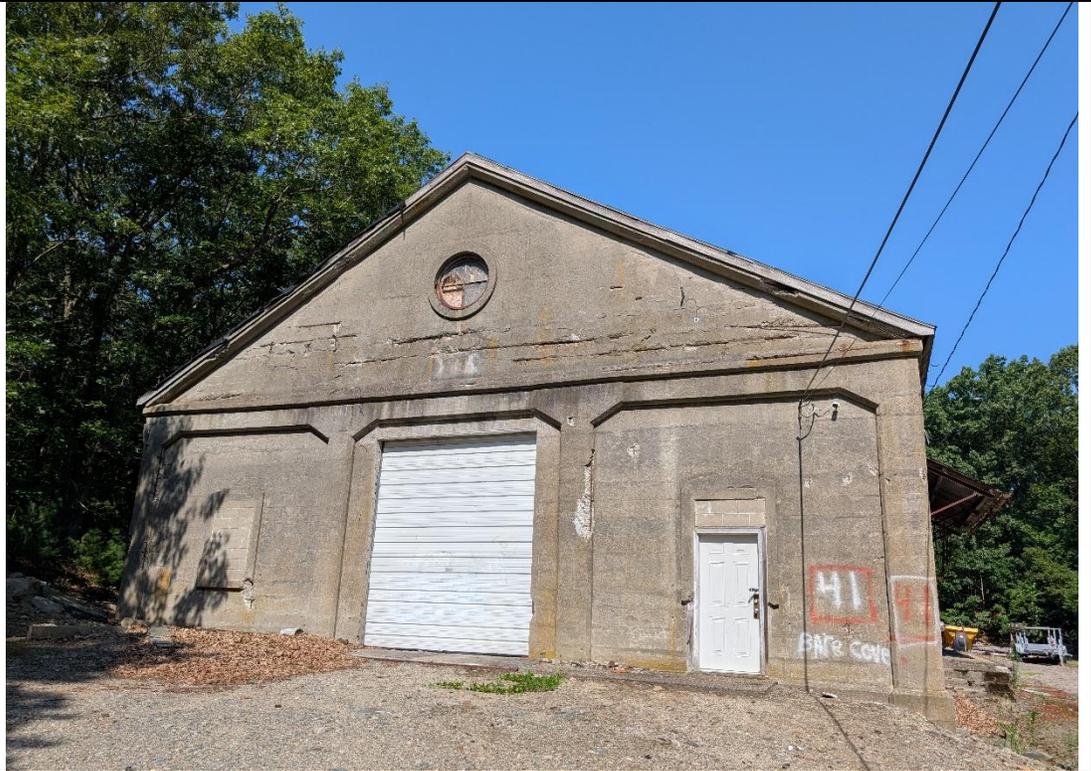
Photo No.  
2

Description:  
Existing, vacated  
commercial building.

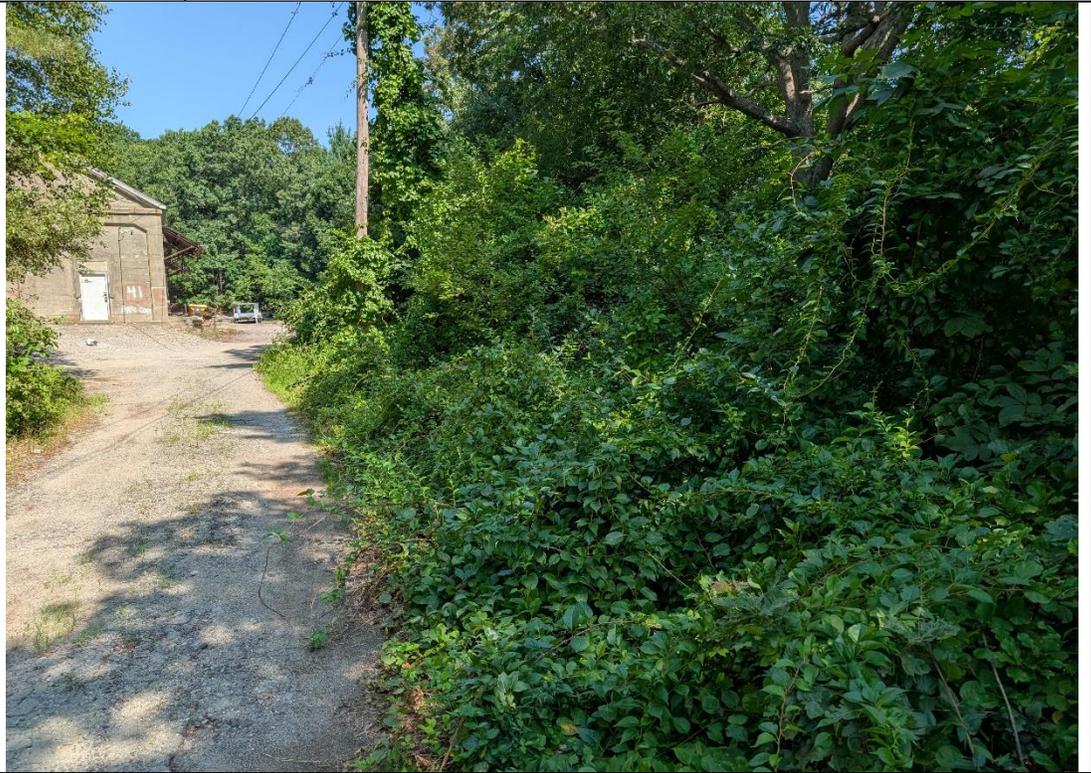
Photo No. 3	Date: 7/31/25
Direction Photo Taken: Northwest

Description:  
Edge habitats between the existing built environment (left) and protected resource areas (off frame right) are colonized by non-native species, like Asiatic bittersweet (*Celastrus orbiculatus*) shown here.

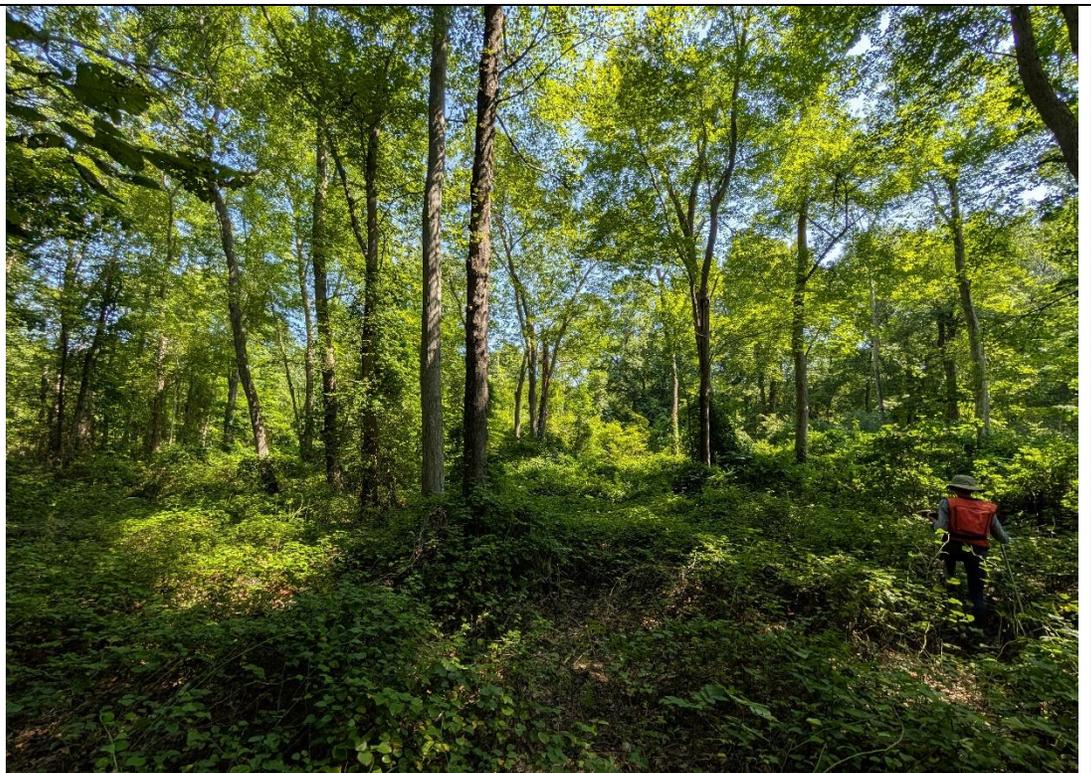
Photo No. 4	Date: 7/31/25
Direction Photo Taken: Northeast

Description:  
The buffer zone to the BVW east of the study area.

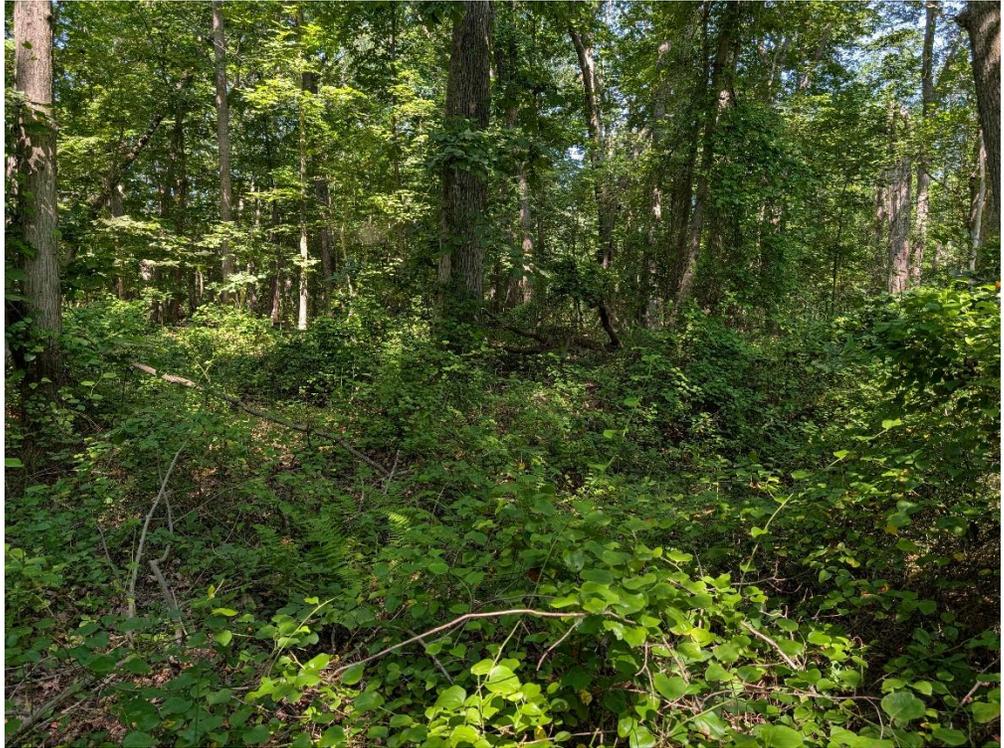
Typical vegetation within 100' buffer zone and edge of wetlands.

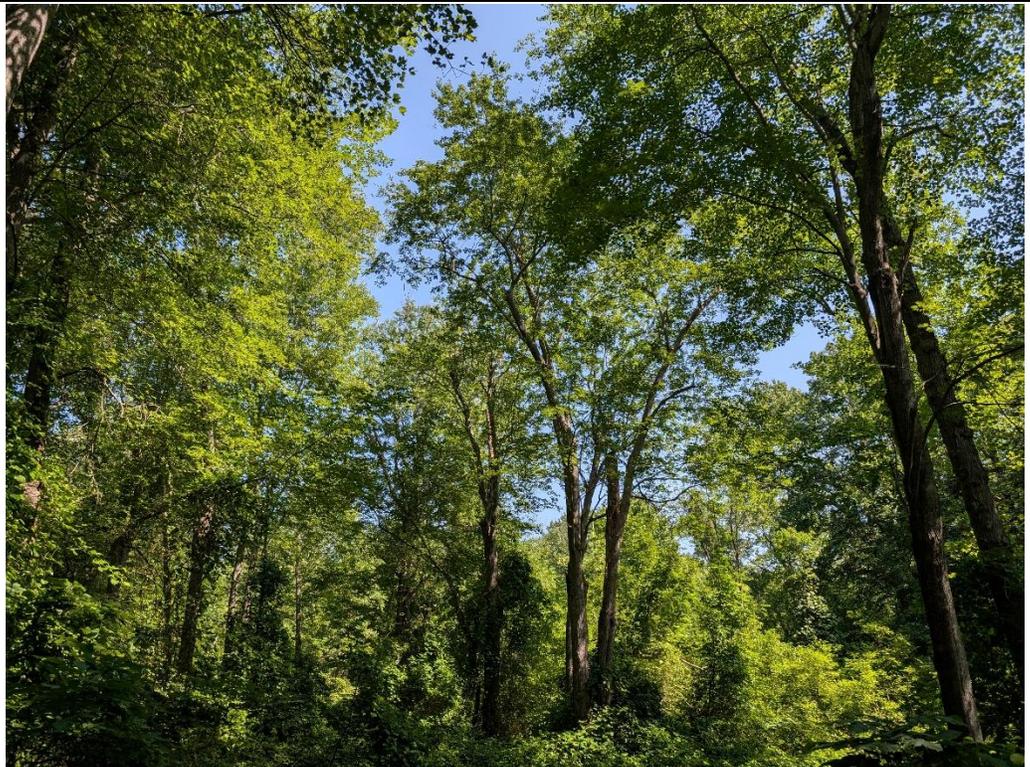
Photo No. 6	Date: 7/31/25
Direction Photo Taken: East

The canopy over the BVWs is nearly closed, however, is partially open due to the presence of standing/flowing water and scrub-shrub vegetation dominating wetter areas (i.e., closer to the stream).

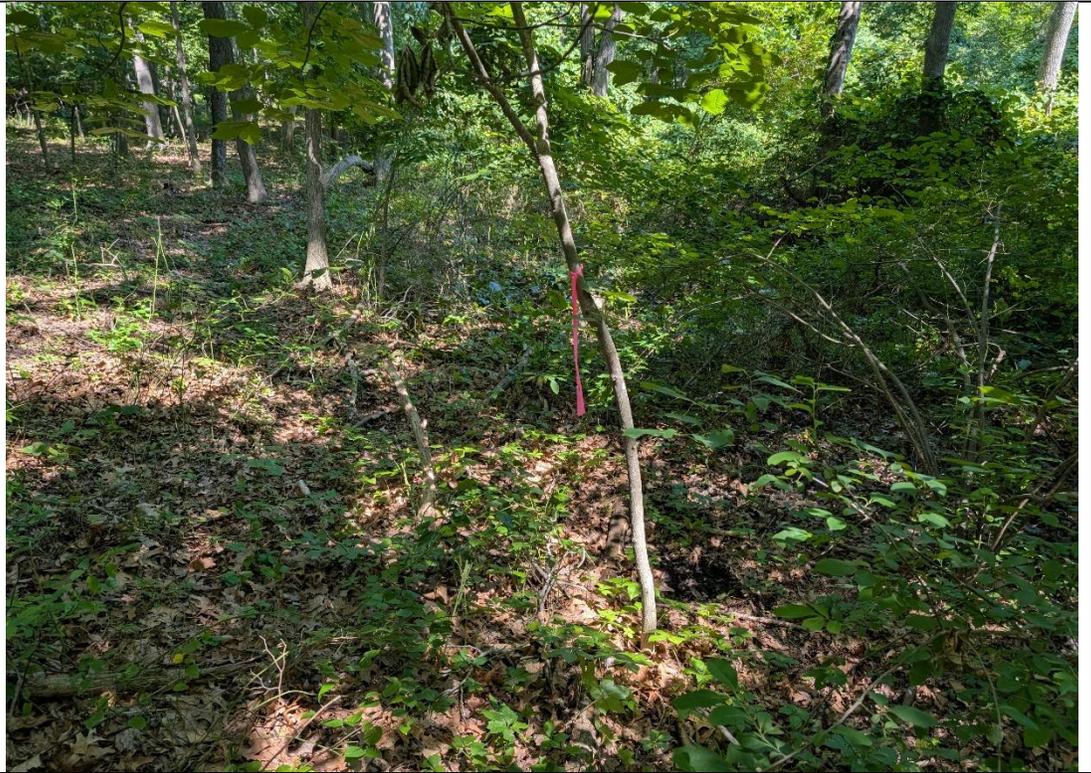
Photo No. 7	Date: 7/31/25
Direction Photo Taken: North

Description:  
The wetland boundary was previously delineated, as evidenced by pre-existing flags.

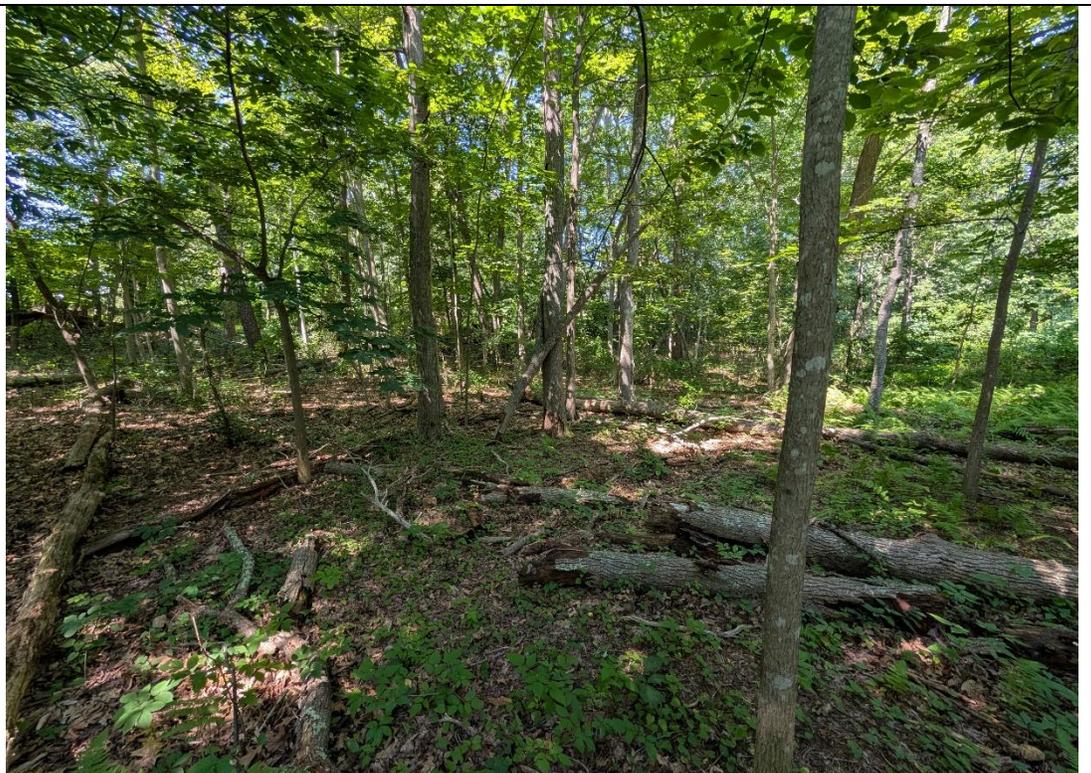
Photo No. 8	Date: 7/31/25
Direction Photo Taken: Southeast

Description:  
Typical view of understory wetland areas.

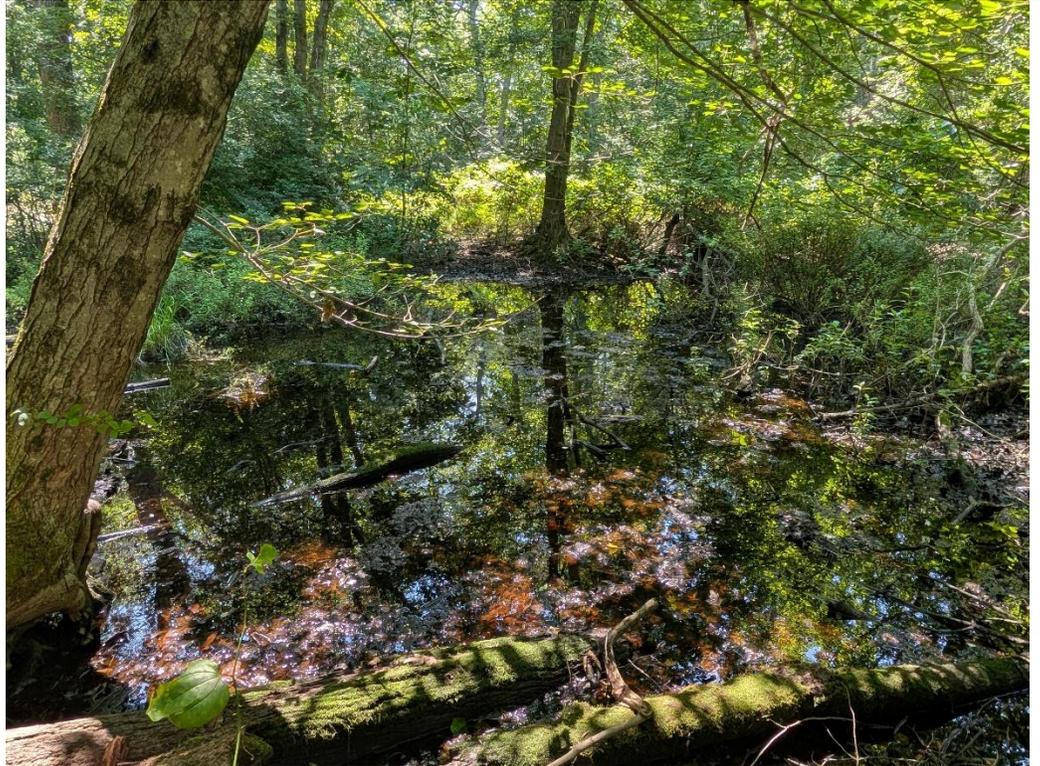
An isolated depression with standing water north of the development limit boundary. A Potential Vernal Pool is mapped within this wetland area.

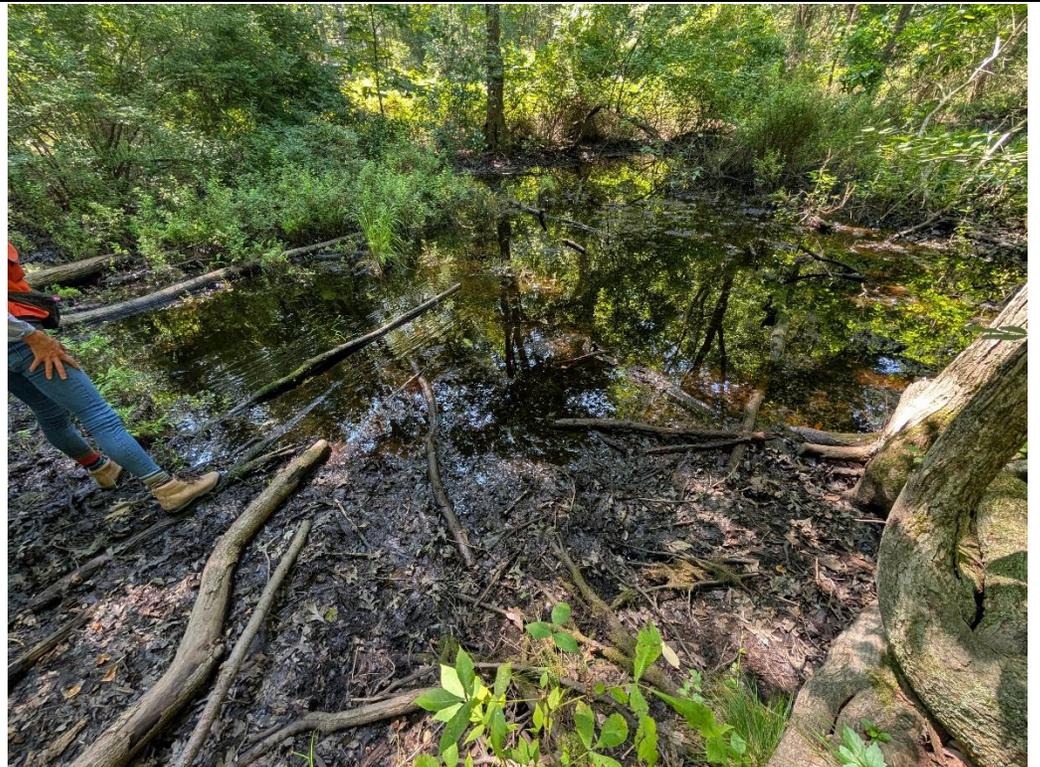
Photo No.  
10

Stained leaves indicate fluctuating water levels within the PVP.
