HINGHAM AFFORDABLE HOUSING TRUST FY 2027 CPA FUNDS REQUEST

In late June of 2023, BEA performed a Building Envelope Inspection at Lincoln School Apartments in Hingham, Massachusetts. The purpose of this Condition Survey was to assess the condition of the building envelope components and identify exterior deficiencies. The report summarizes our findings, conclusions, recommendations, and associated repair/restoration cost budget estimates.

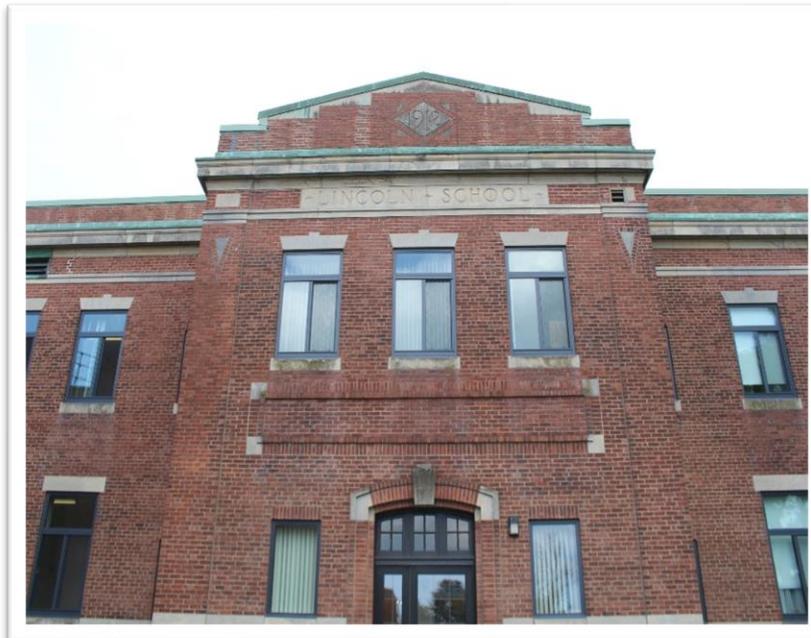
Photo 2: View of the old Lincoln School entrance.

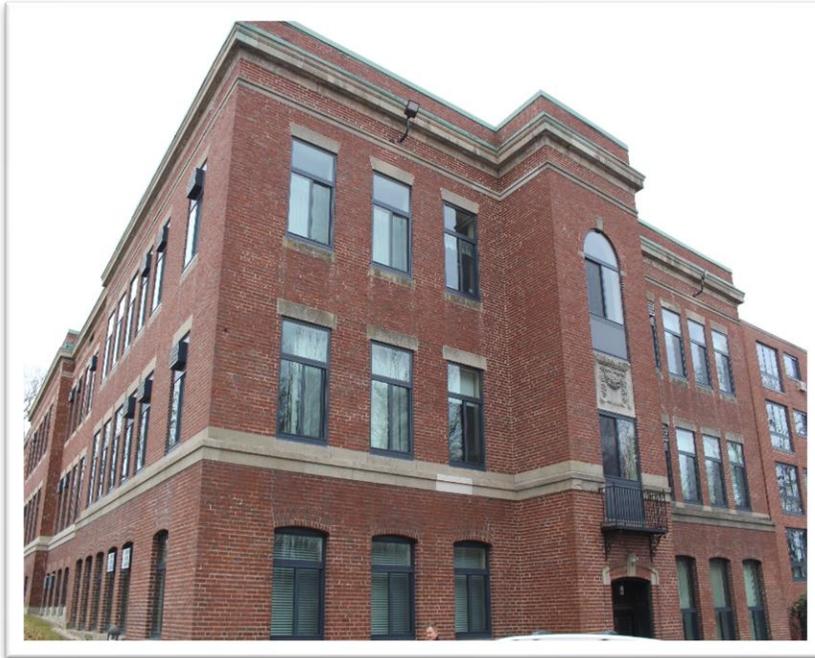
Photo 3: Photo shows a partial view of the building constructed in 1920.

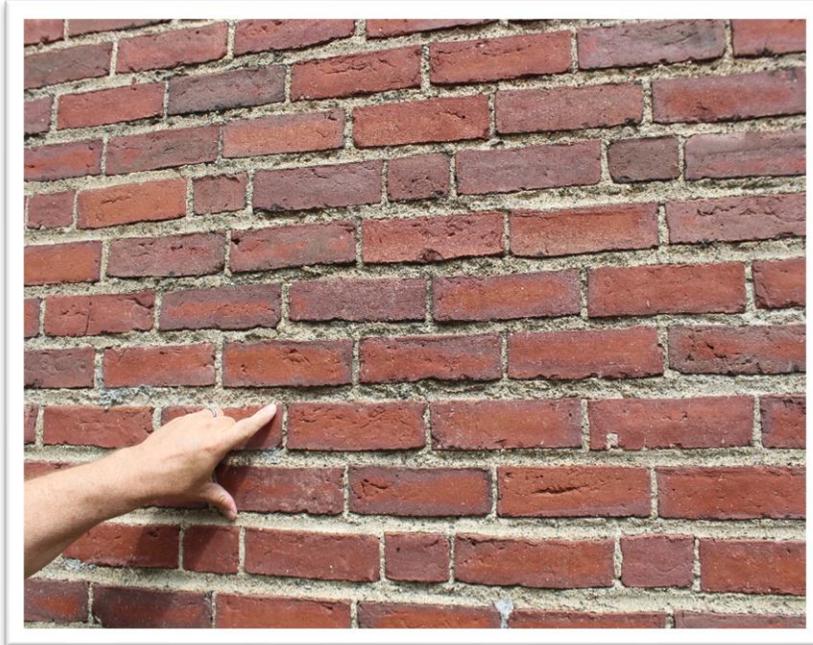
Photo 5: This photo shows a typical section of old brick masonry wall.

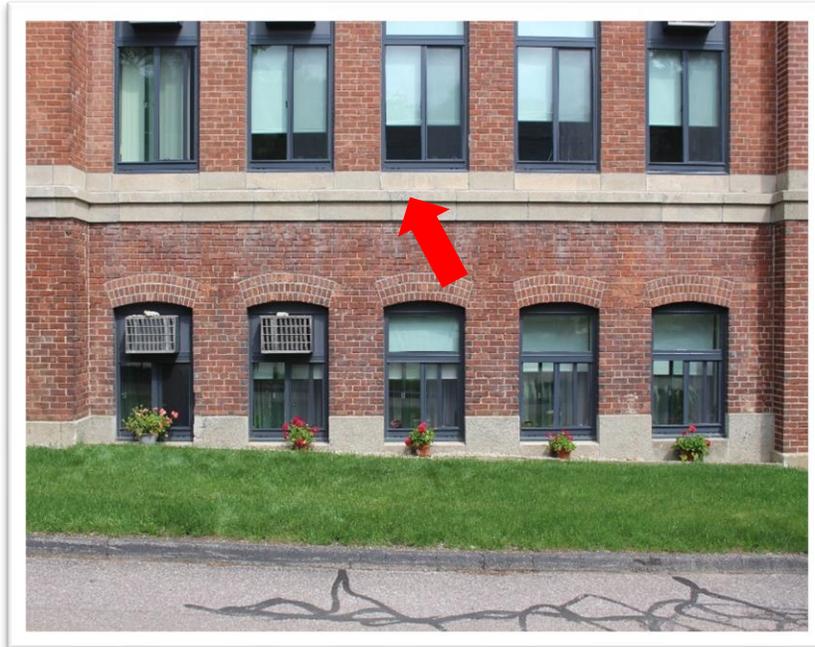
Photo 20: Photo shows precast concrete band along lower portions of historic building.

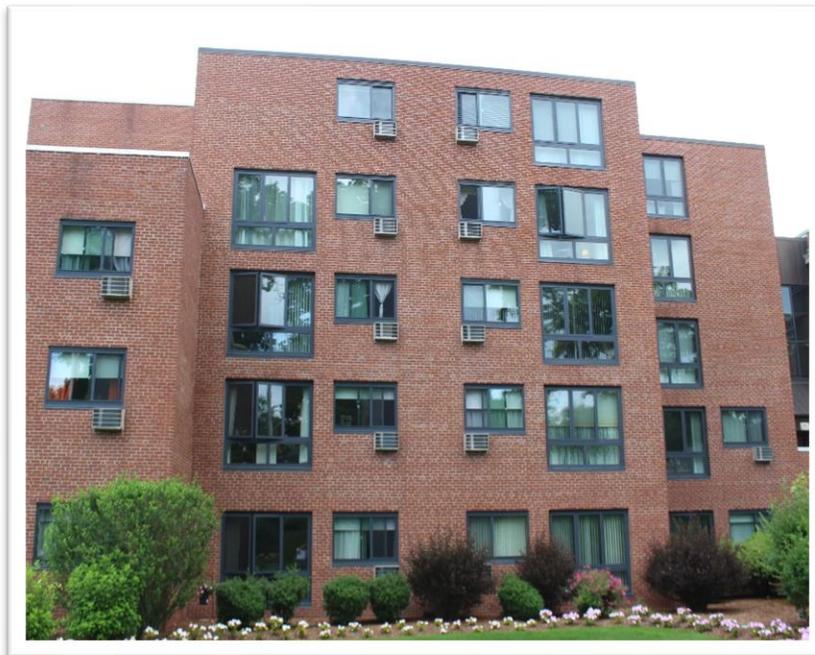
Photo 29: This photo shows a partial view of the building constructed in 1980.

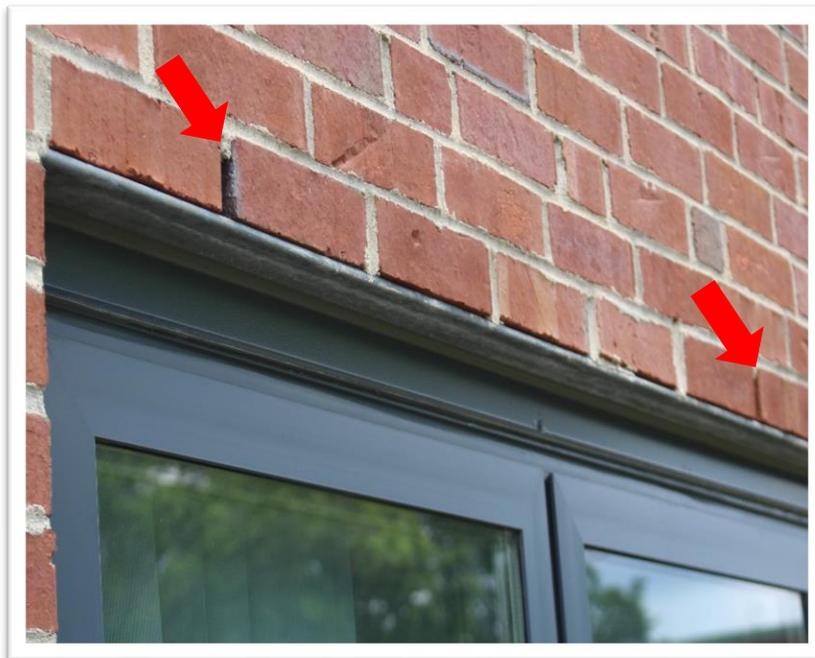
Photo 31: Weep slots and proper drainage provisions are provided at fenestrations.

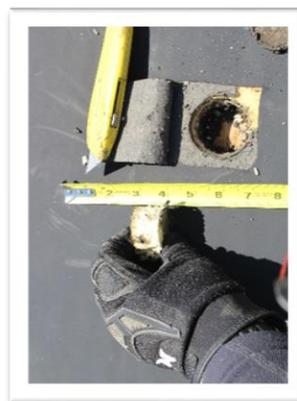
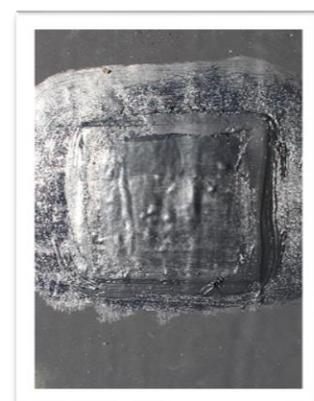
Roof Core Test Roof A:

Core samples were taken from both roof sections A & B to document the current roof system composition down to the substrate. These core cuts were properly repaired (see photos). Following are photos and a description of the composition of the existing roof assemblies.

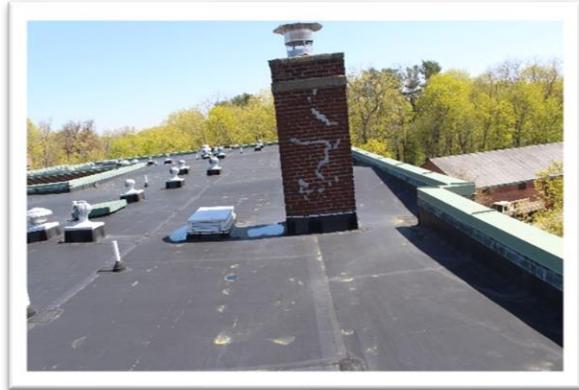
Overview Roof A

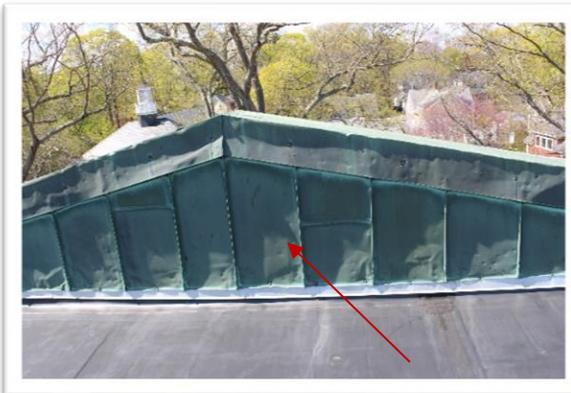
Overview showing copper wall panels

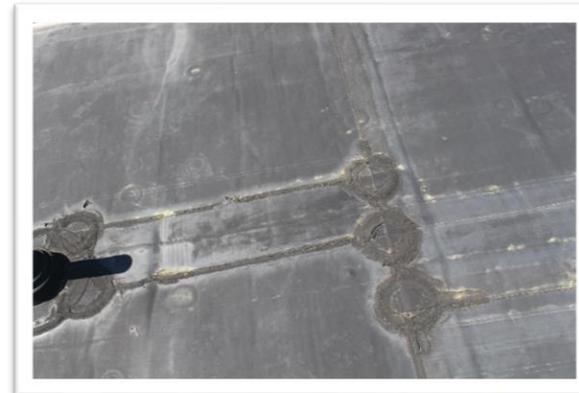
Typical membrane patches

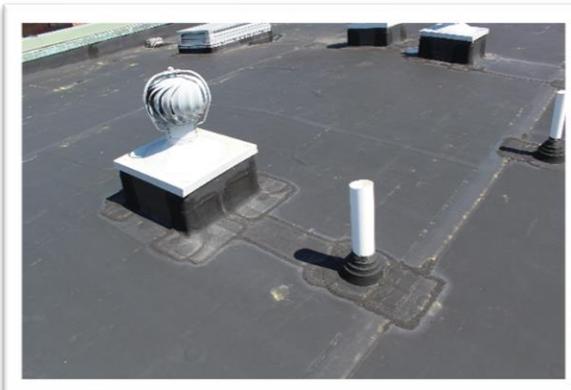
Typical fan curbs and vent pipes

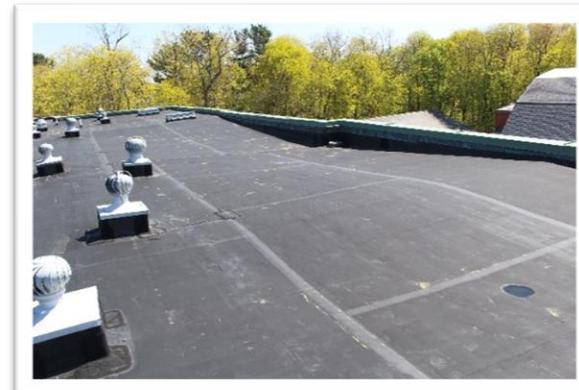
Photo shows positive drainage

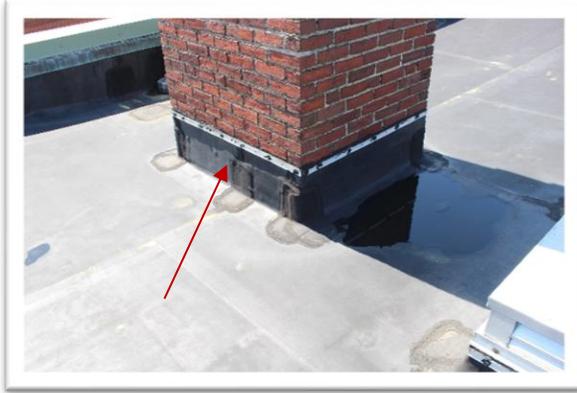
Typical masonry termination

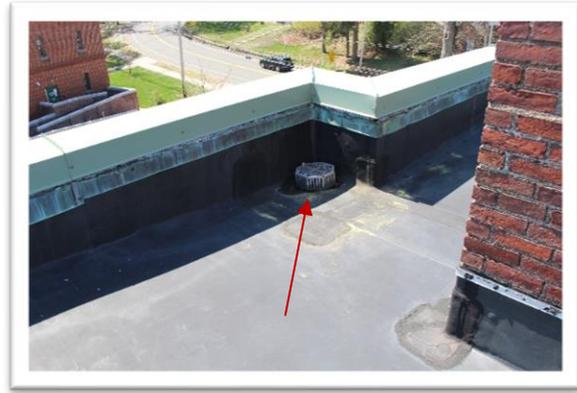
Typical retrofit drain

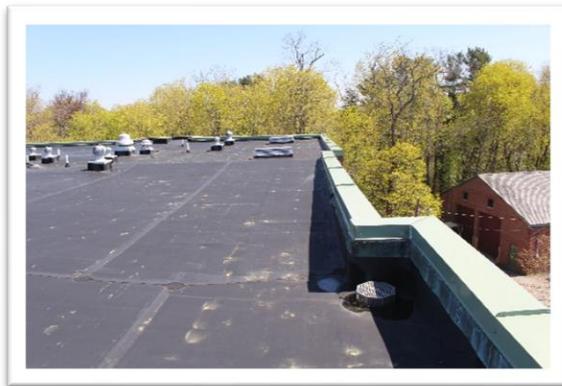
Overview of coping cap

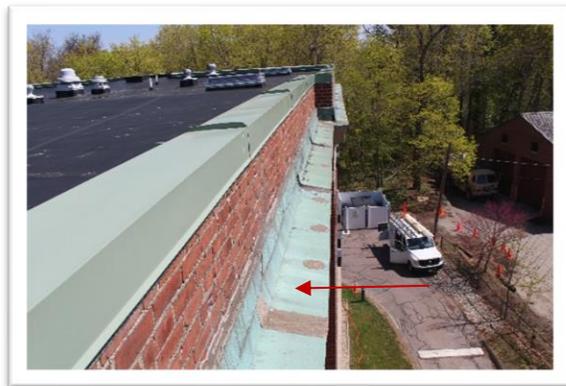
Copper wrapped exterior parapet ledge.

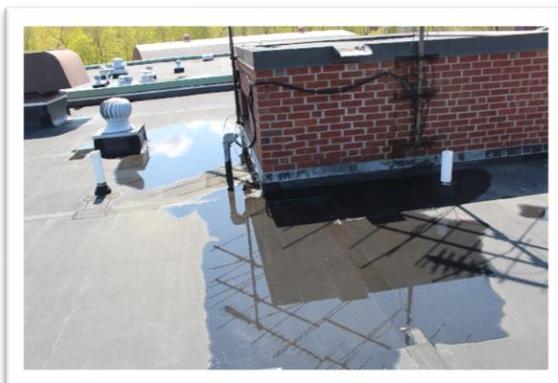
Overview showing ponding water

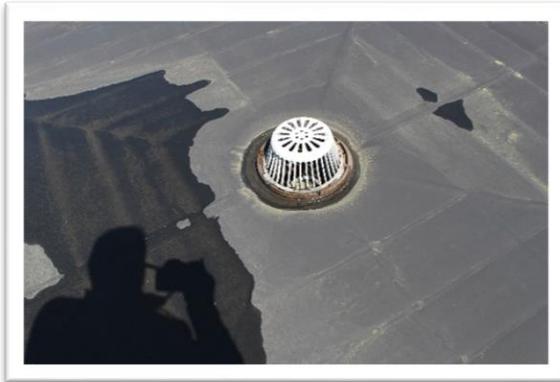
Typical internal drain

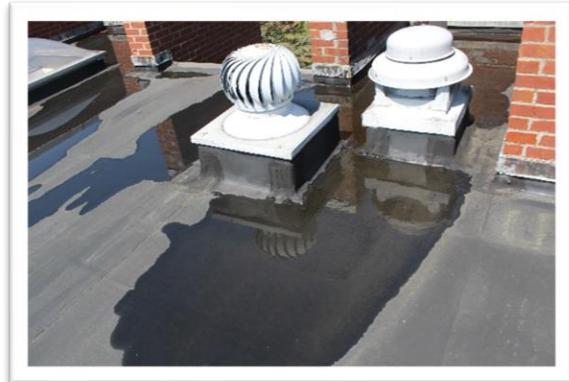
Ponding/puddling water – Typical

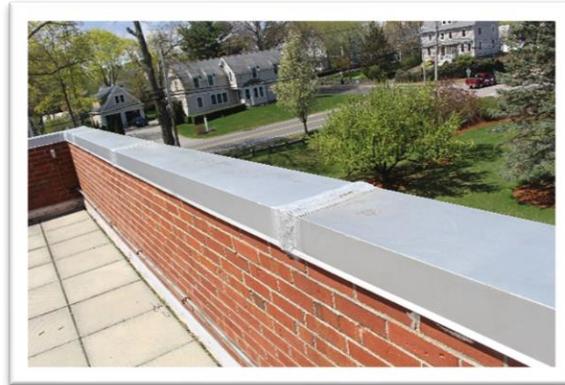
Section C has typical raised masonry parapet walls which have shop fabricated, coping cap installed. Overall, the condition and installation quality of the metal coping system is poor (see photos).

Typical masonry wall termination detail with metal coping cap on wall top

The plaza deck roof section C should have the parapet coping cap seams repaired, and ongoing maintenance to maximize the remaining life of the roof.
