HINGHAM AFFORDABLE
HOUSING TRUST FY 2027
CPA FUNDS REQUEST

Hingham Affordable Housing Trust

In late June of 2023, BEA performed a Building Envelope Inspection at Lincoln School Apartments in Hingham, Massachusetts. The purpose of this Condition Survey was to assess the condition of the building envelope components and identify exterior deficiencies. The report summarizes our findings, conclusions, recommendations, and associated repair/restoration cost budget estimates.

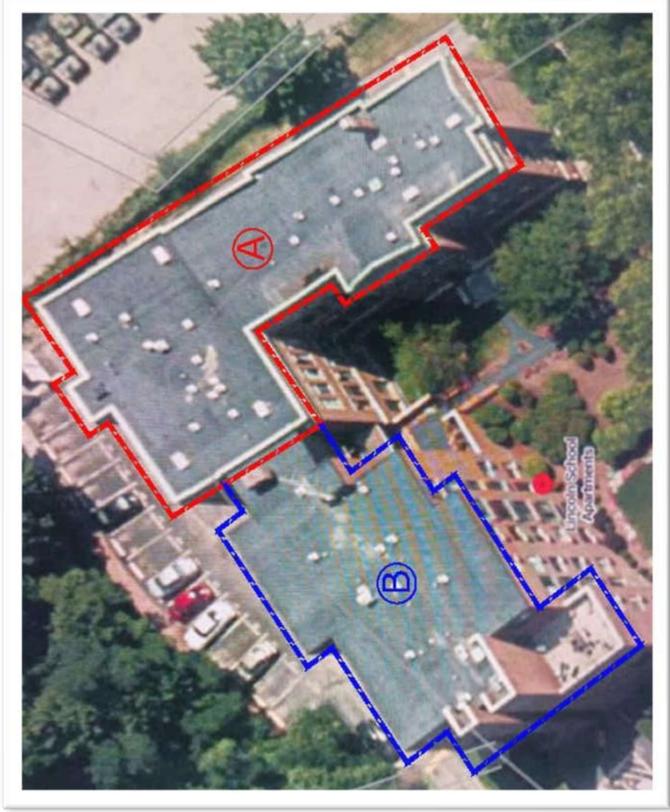
Photo 1: Lincoln School Apartments / Section 'A' (Built in 1920) / Section 'B' (Built in 1980).

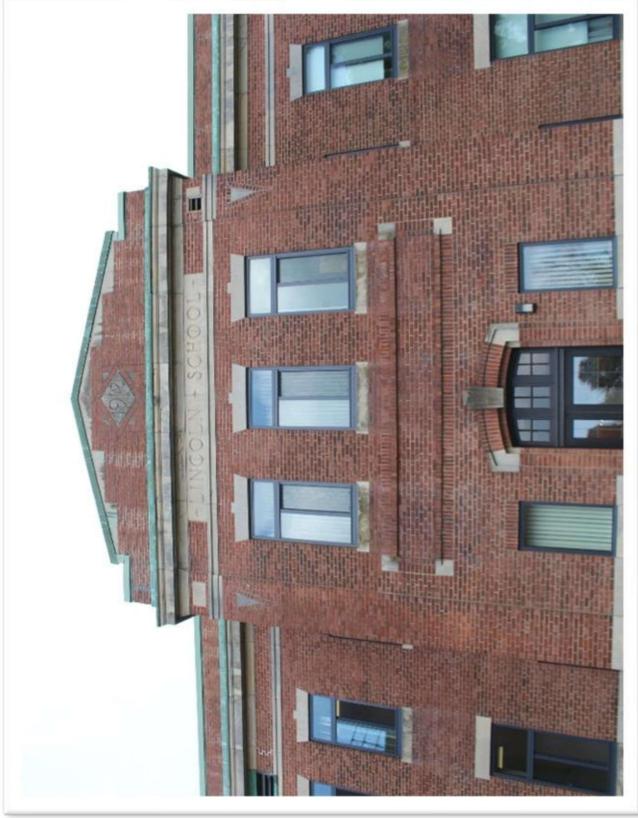
Photo 2: View of the old Lincoln School entrance.

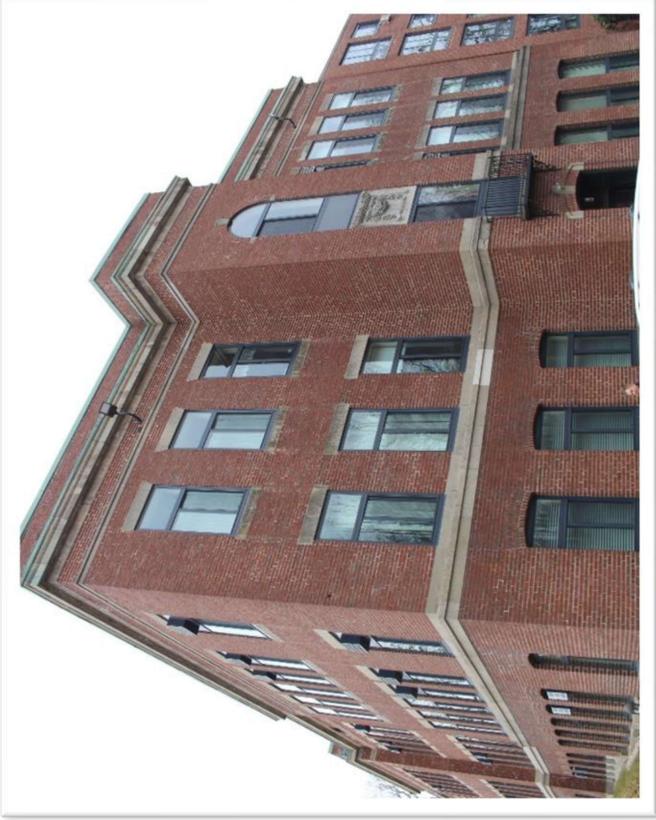
Photo 3: Photo shows a partial view of the building constructed in 1920.

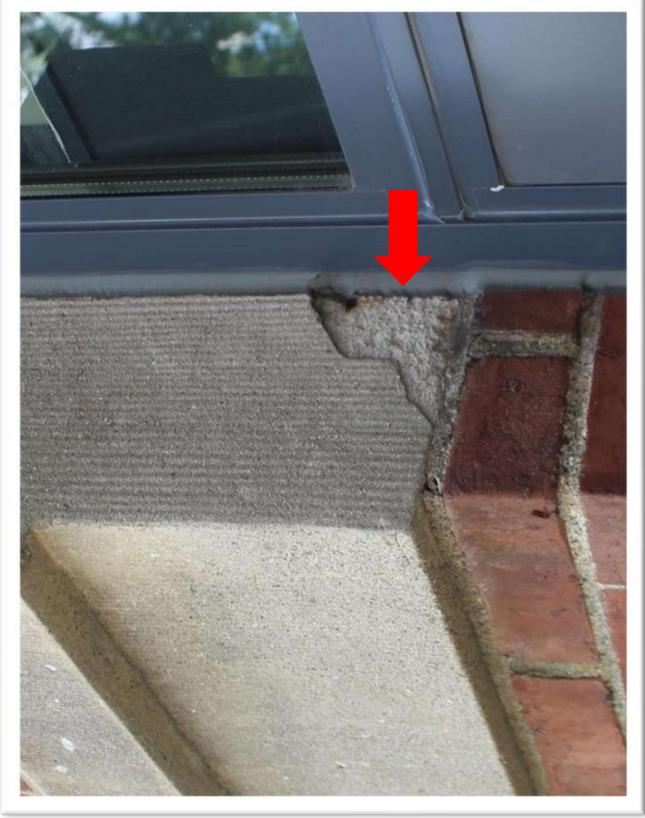
Photo 28: Cracked and chipped precast concrete randomly observed.

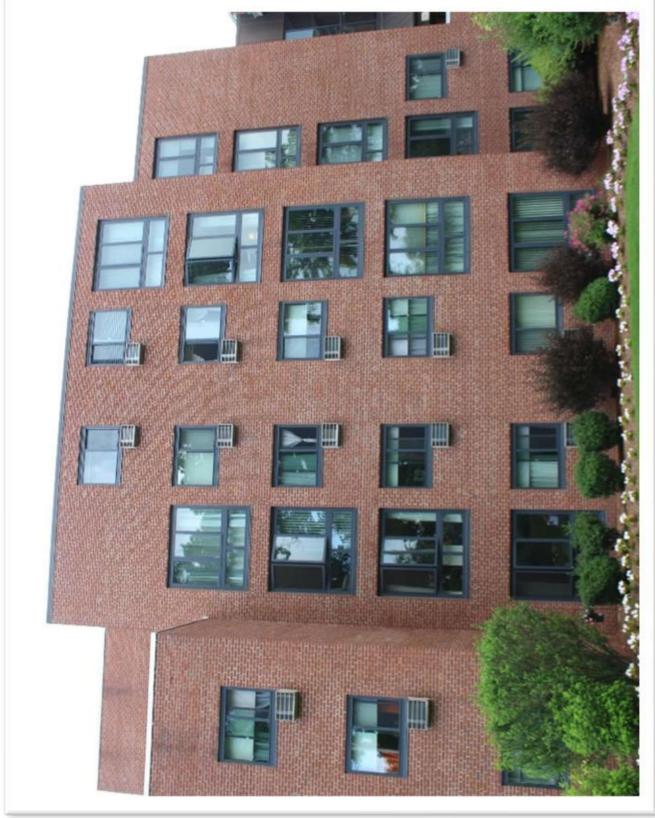
Photo 29: This photo shows a partial view of the building constructed in 1980.

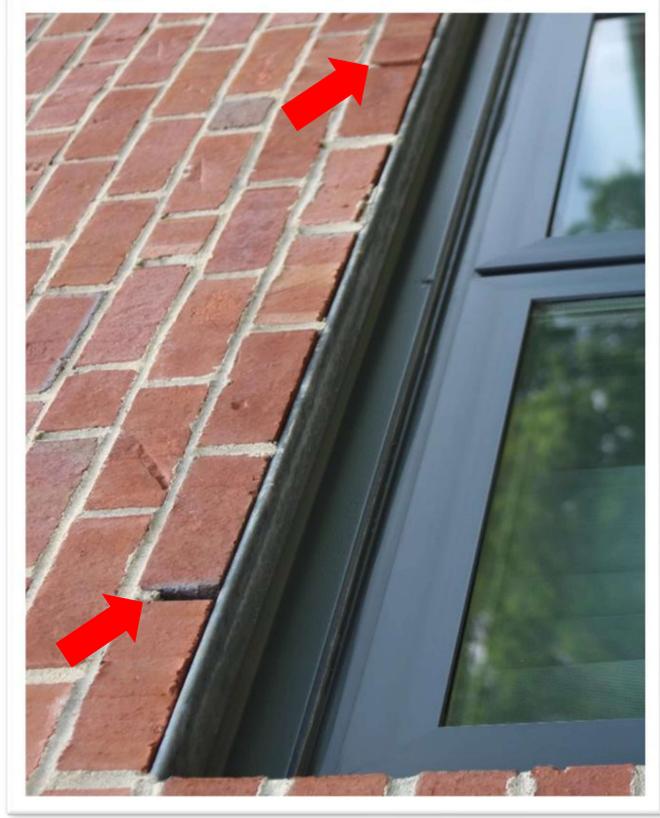
Photo 31: Weep slots and proper drainage provisions are provided at fenestrations.

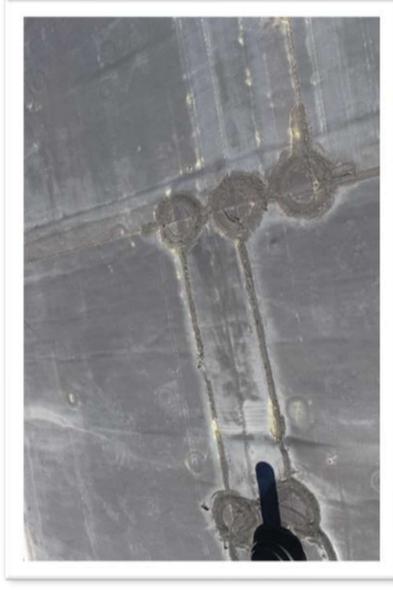
Typical membrane patches

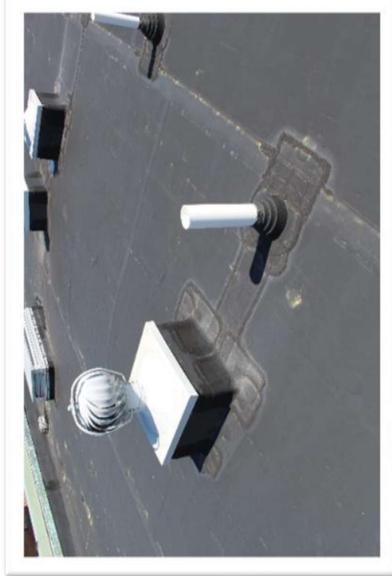
Typical fan curbs and vent pipes

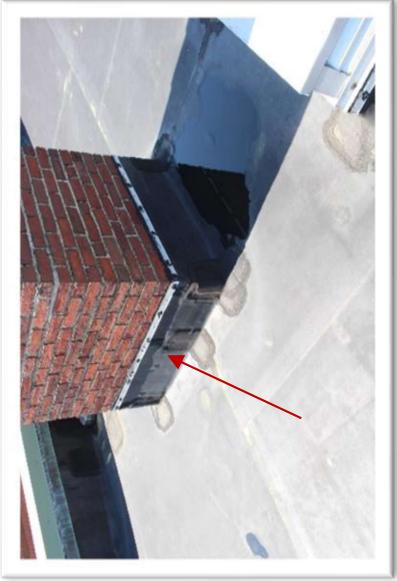
Typical masonry termination

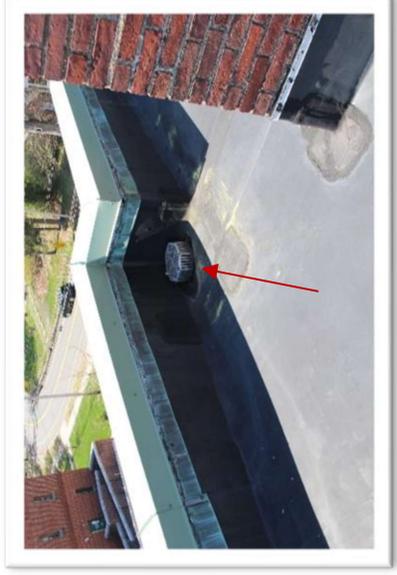
Typical retrofit drain

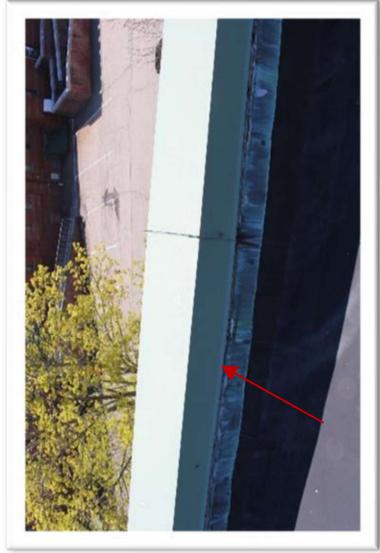
Typical steel coping cap pinned over concrete coping stone.

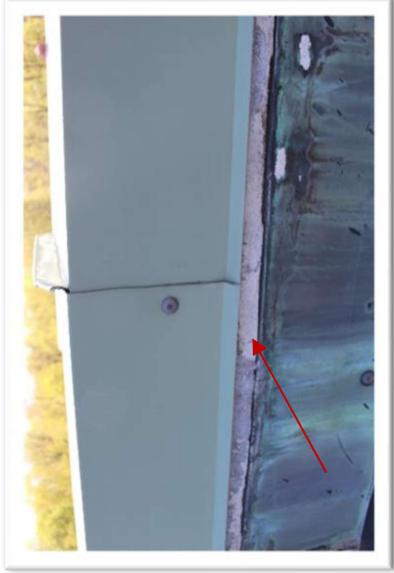
Overview of coping cap

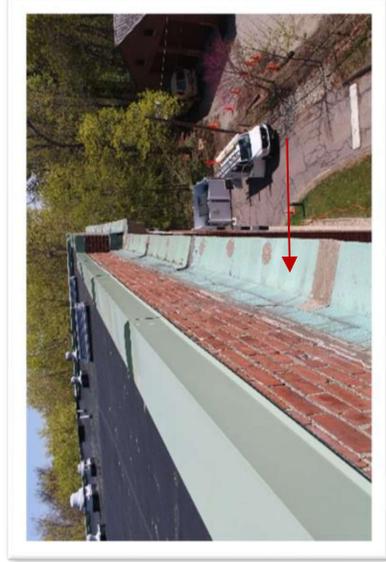
Copper wrapped exterior parapet ledge.

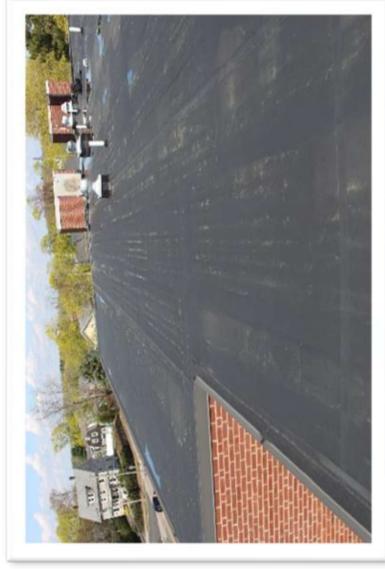
Overview of roof B

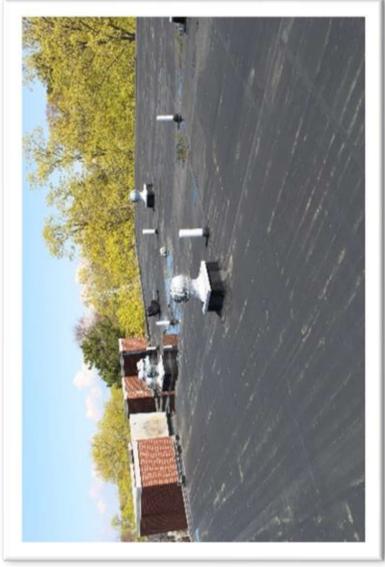
Overviews of roof B

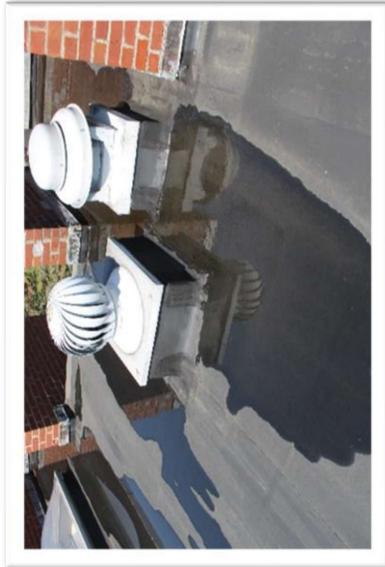
Typical internal drain

Ponding/puddling water – Typical

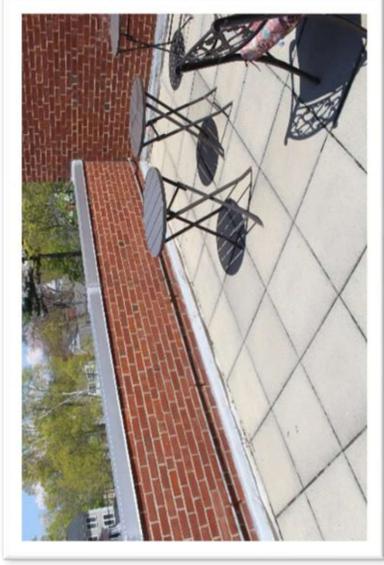
Overviews of roof C plaza deck

Section C, is in overall "Fair" condition with typical degraded conditions observed on the parapet wall coping cap. We were not able to determine the age of this PVC system, but believe it is likely at least as old as the roof sections above. The patio pavers are in good condition for their suspected age. The coping cap flashing is in poor conditions and should be properly repaired. We believe this roof section should be considered for replacement in the next 5 to 8 years.

The plaza deck roof section C should have the parapet coping cap seams repaired, and ongoing maintenance to maximize the remaining life of the roof.

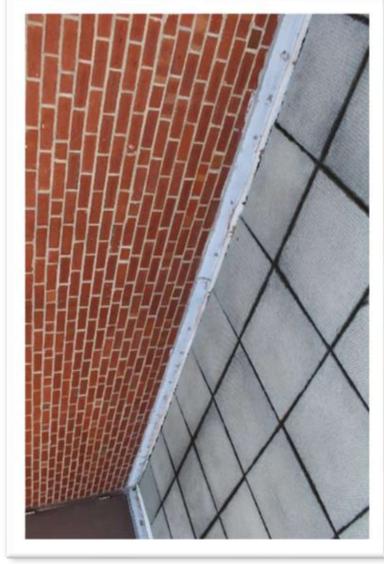
Typical masonry wall termination detail
