South Shore Country Club  
 Engineering Facility Study  
 Cubellis Associates

**APPENDIX B**  
**PHOTOGRAPHS**

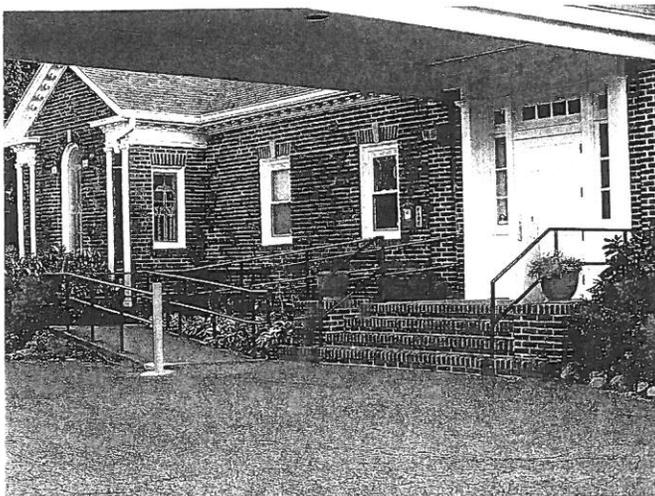
ENTRANCE TO THE HINGHAM ROOM

* Upgrade fire extinguishers throughout	10	Ea.	225.00	2,250.00
* Rebuild the entrance ramp at the Hingham Room	64	L.F.	550.00	35,200.00
* Relocate the main electrical equipment or reconfigure the enclosures	1	Ea.	9,000.00	9,000.00
				88,550.00
<b>Priority 3 - Replacements and Upgrades</b>

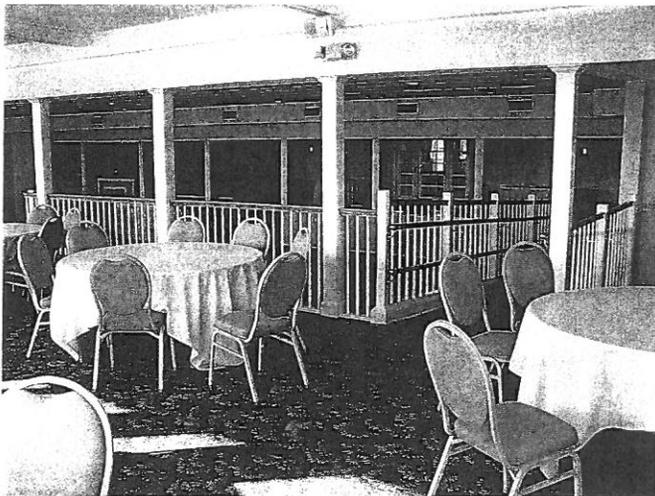
HINGHAM ROOM LEVEL CHANGE

* Replace the Hearthiside Room handicap lift	1	Ea.	16,400.00	16,400.00
* Install a power operator on the main entrance door	1	Ea.	4,100.00	4,100.00
* Address the floor level change in the Hingham Room	400	S.F.	11.00	4,400.00

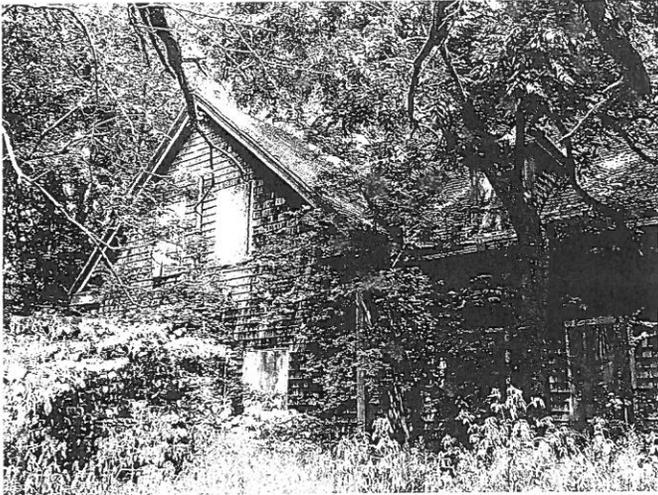
OVERGROWTH IN LATE SUMMER

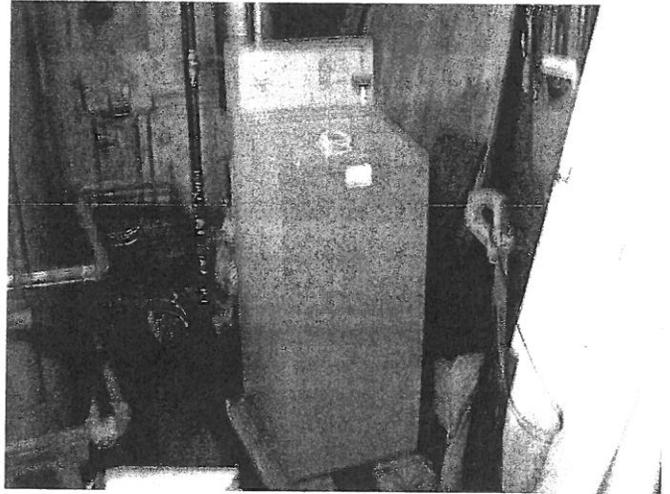
WATER HEATER - CLUB HOUSE

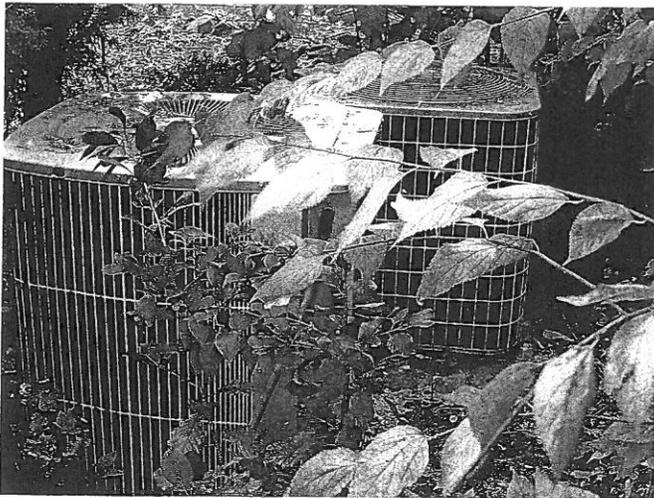
AIR CONDITIONER CONDENSING UNITS

* Several of the existing A/C RTU's should be budgeted for replacement in the next 3 - 5 years	3	EA	6,000.00	18,000.00
* Budget for a new HVAC system to serve the Pro Shop with heating and cooling provided by a simple ductwork distribution	900	S.F.	35.00	31,500.00

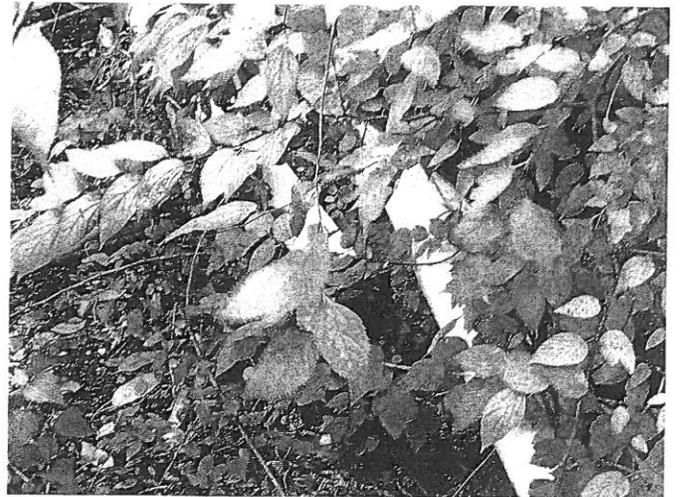
ROOF DRAIN

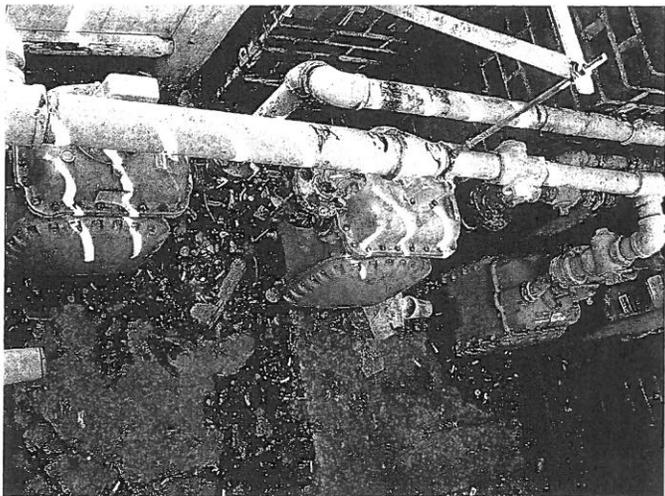
GAS METERS
